BROWARD COUNTY BUILDING SAFETY INSPECTION PROGRAM

Permit #: 22-00004:15 Date: 12/19/22

Inspection Firm or Individual Name: G. BATISTA E	ENGINEERING & CONST.	
Address: 3731 SW 47TH AVENUE, DAVIE, FL 333		— MARGATE
Telephone Number: 954-434-2053	_	Together We Make It Great Approved
Inspection Commenced Date: 06/25/2021	_ Inspection Completed Date: _	11/23/2022 Department
No Repairs Required Repairs are r	required as outlined in the attac	ched inspection report
Licensed Professional,	DE	
Engineer/Architect Name: GREGORIO BATISTA,	<u>PE</u>	
License Number: 52349		
I am qualified to practice in the discipline in which I am here! Signature Digitally signed by Gregorio Batista Date: 2022.12.14 10:54:32 -05:00: Date		
This report has been based upon the minimum inspection guidelin of Rules and Appeals' Policy #05-05. To the best of my knowledge condition of the structure, based upon careful evaluation of observ	es for building safety inspection as listed and ability, this report represents an acc	curate appraisal of the present

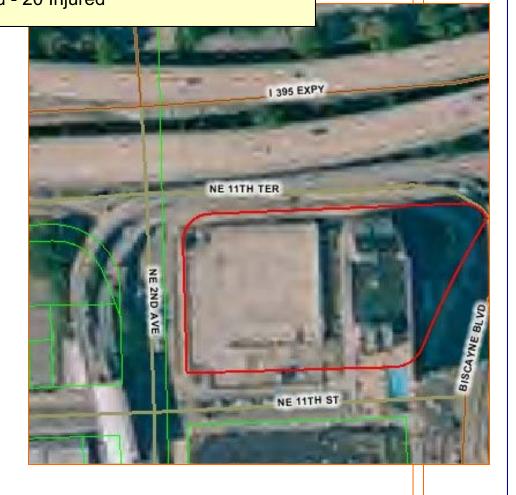
Federal Drug Administration Regional Office Downtown Miami Garage collapsed in August 1974 7 dead - 20 Injured

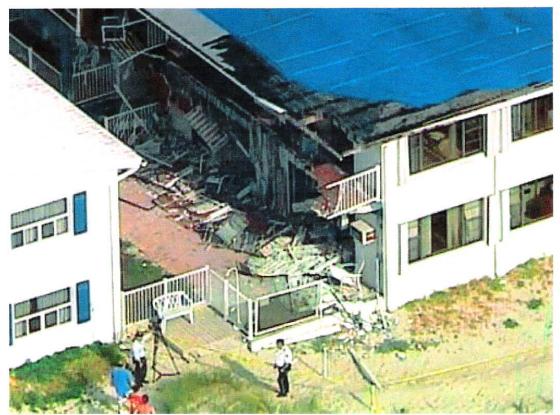
1996 4111 South Ocean Drive, Hollywood, Fl. **Balcony Collapse**
