STRUCTURAL INTEGRITY RESERVE STUDY

***Oriole Golf & Tennis Club Condominium One
Bldg. A (7877)***

7877 Golf Circle Drive, Margate, FL 33063

Inspected on: September, 2023

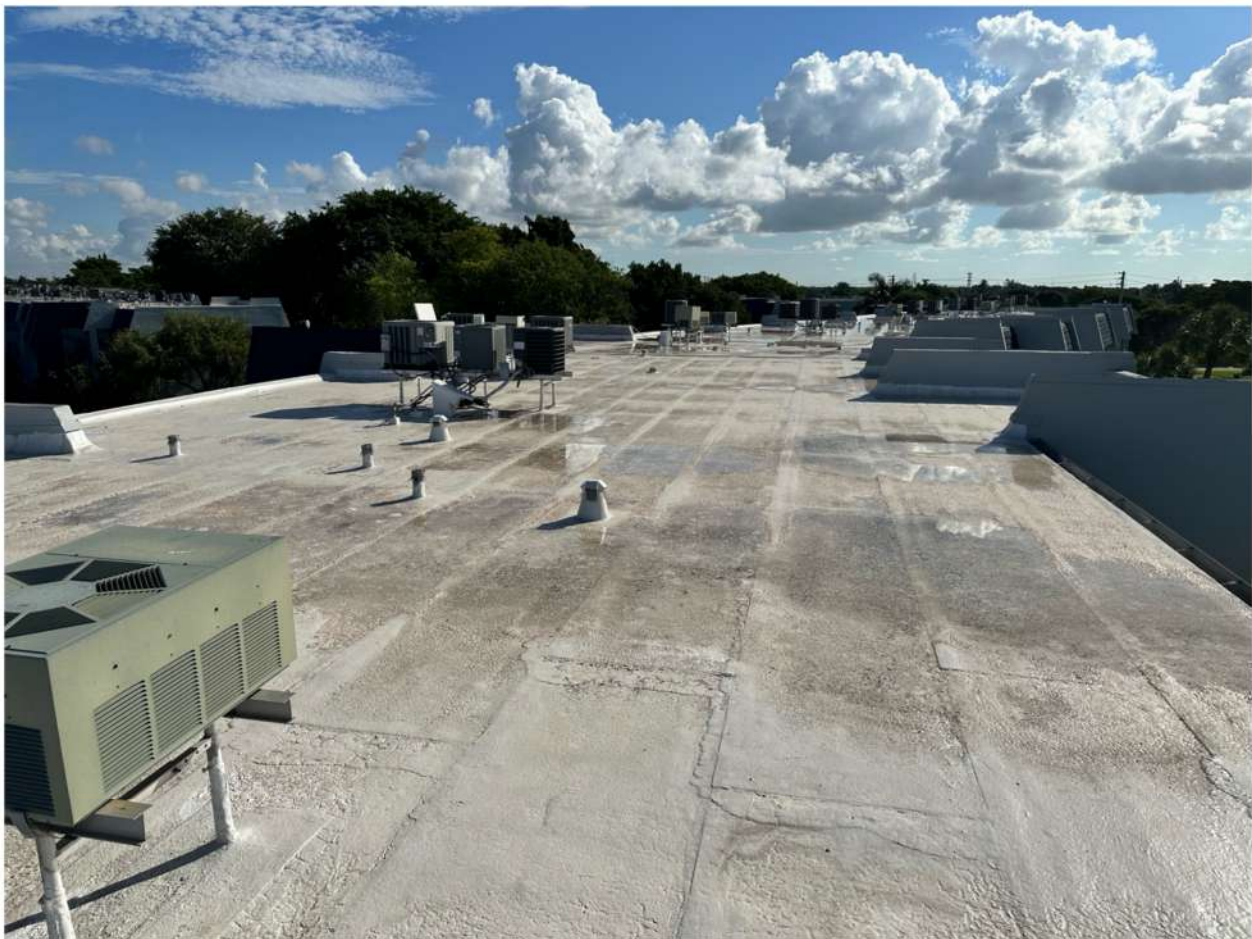
Condition: The roof surface appears to be in satisfactory condition with slight surface deterioration or granule loss. According to the information provided, all the roofs of the Oriole Golf & Tennis Club One have been provided with a silicone reflective coating within the last 5-years. The addition of the reflective coating can extend the useful life of the roof surface if proper maintenance is given.

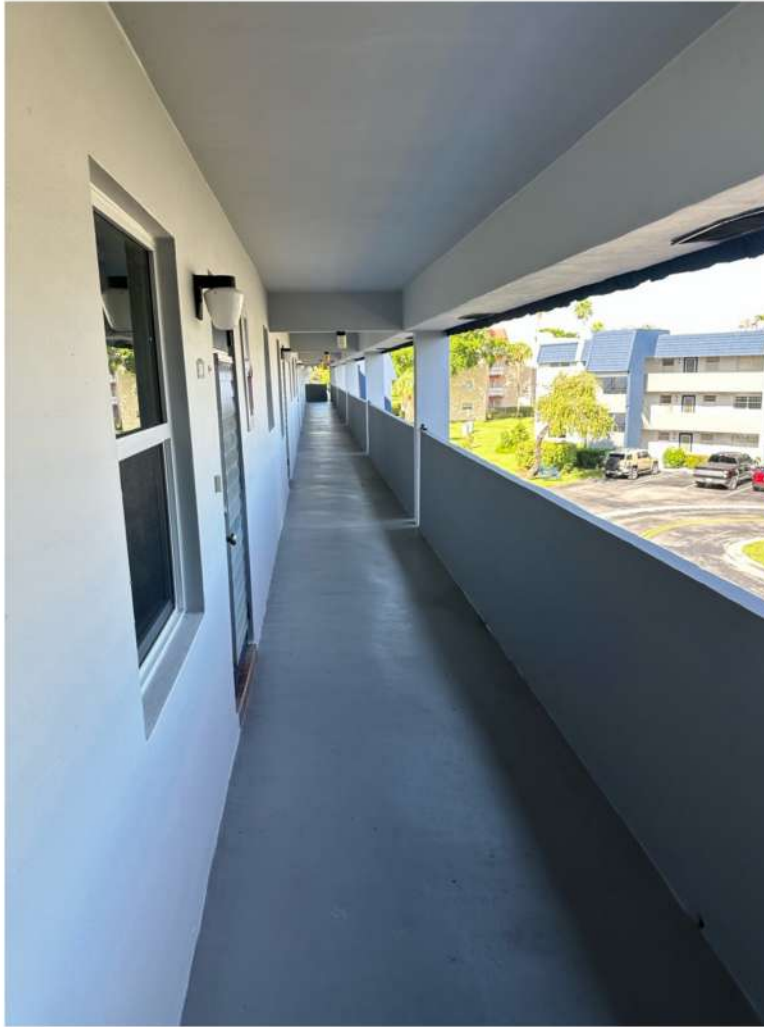
Condition: The general condition of the concrete load bearing structural systems, including visible the framing columns, tie-beams, and concrete floor systems appears to be in satisfactory condition have been found in satisfactory condition. However, conspicuous signs of concrete spalling requiring concrete repairs have been noted in the exterior corridors/catwalks of the building.

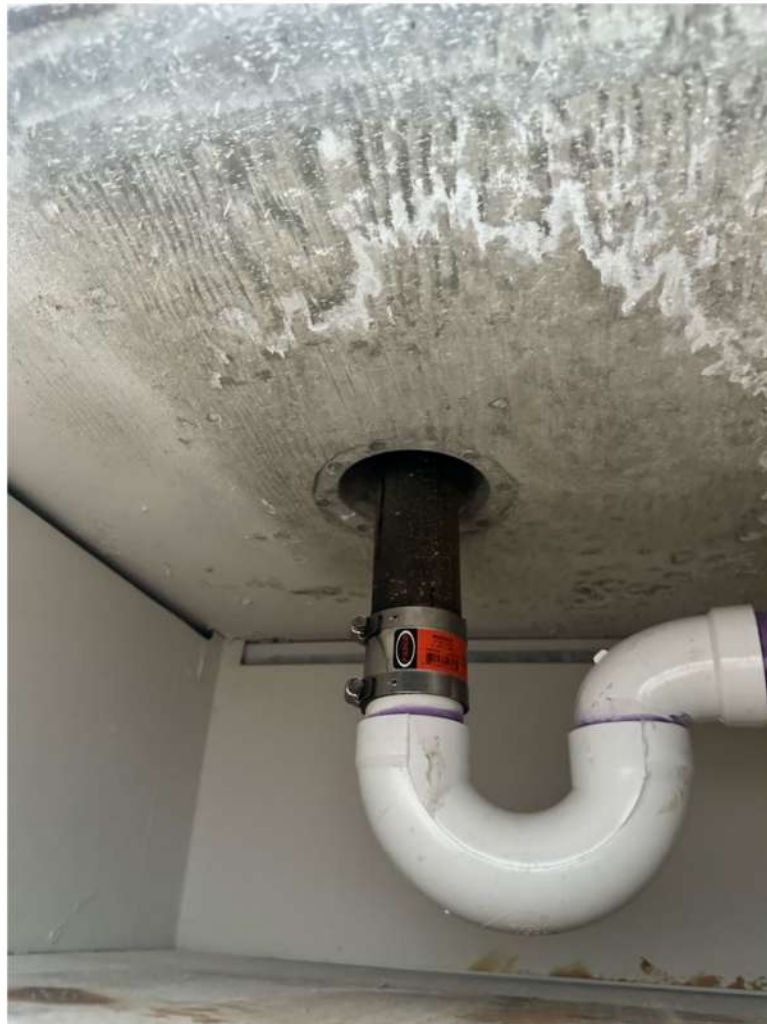
Condition: The plumbing system appears to be in satisfactory condition. It is important to note that it is rarely possible to visually inspect and examine all the concealed construction, nor should be generally necessary. Our conclusions are based upon our experience and deficiencies found in the visible and readily accessible areas.

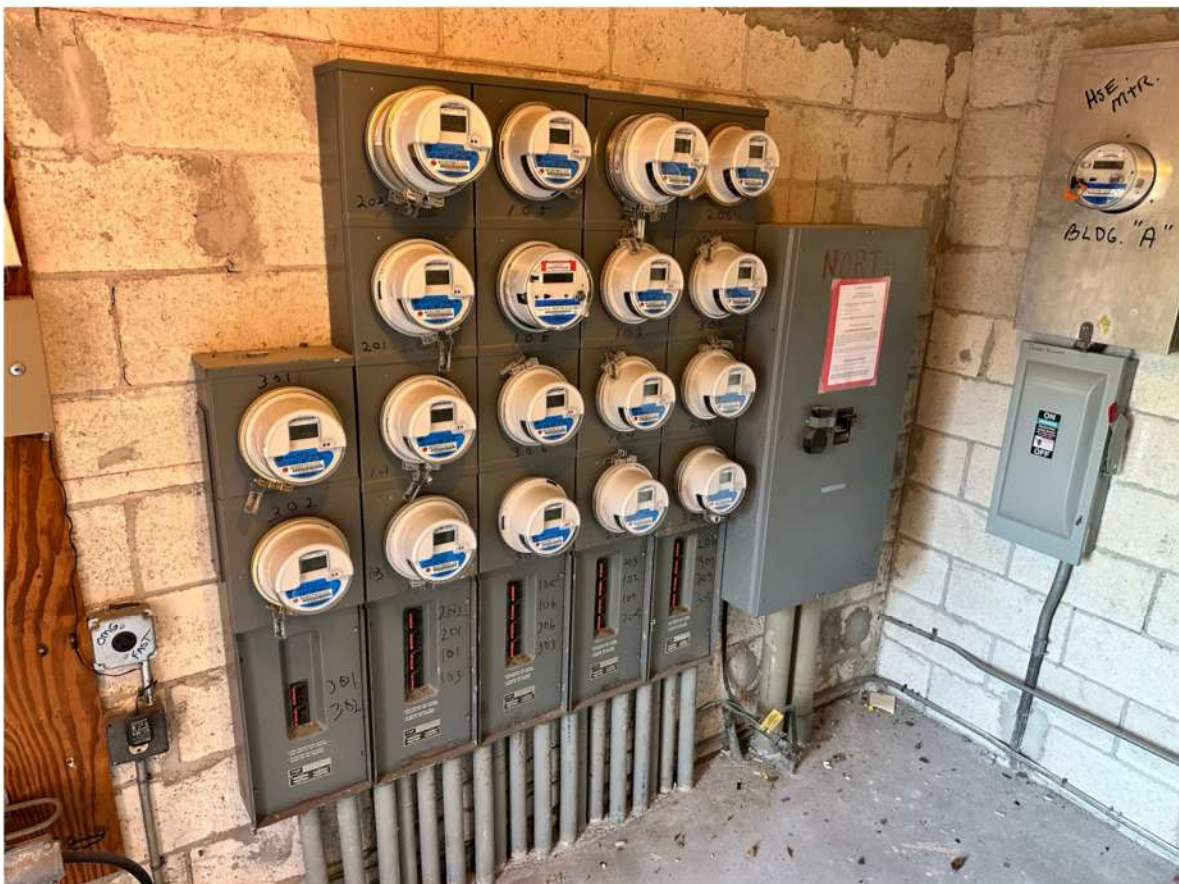
Condition: The electrical system(s) appears to be in satisfactory condition.

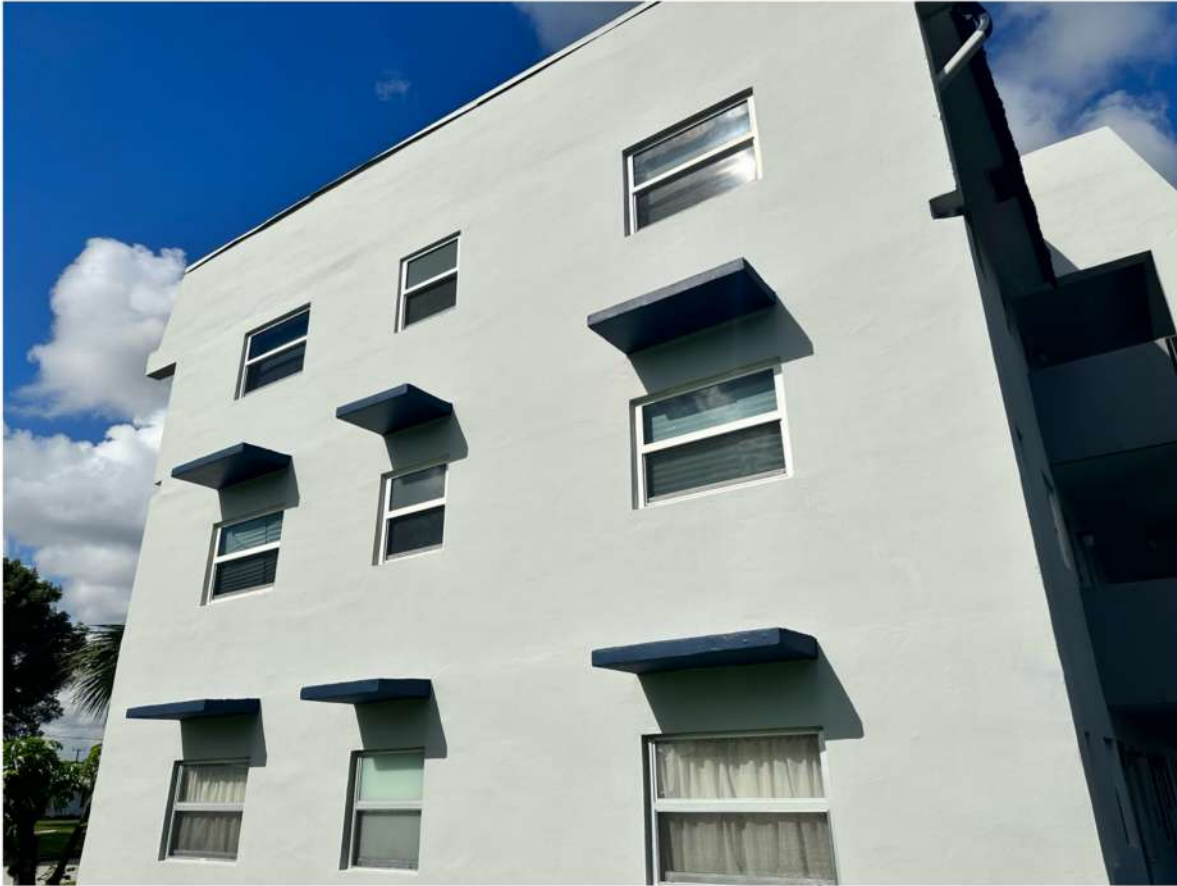
Condition: The exterior stucco surface appears to be in satisfactory condition. However, stucco delamination and conspicuous signs of concrete spalling have been noted in the exterior corridors/catwalks of the building.

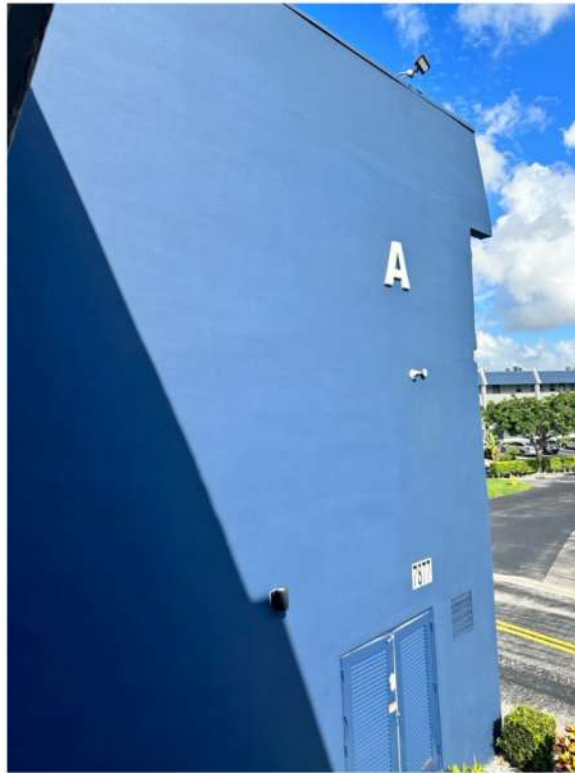
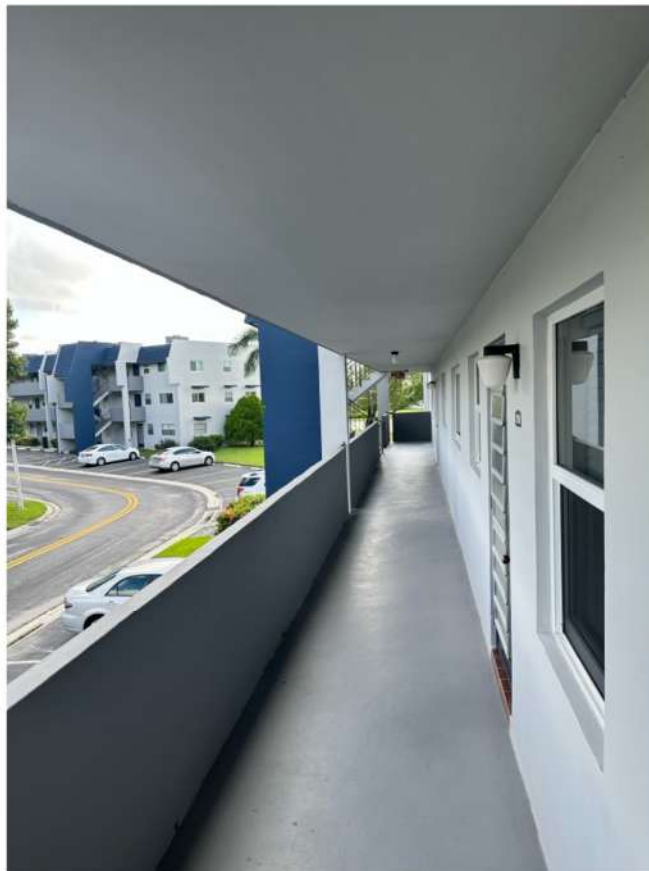
Condition: The exterior surface paint & exterior waterproofing appear to be in satisfactory condition.

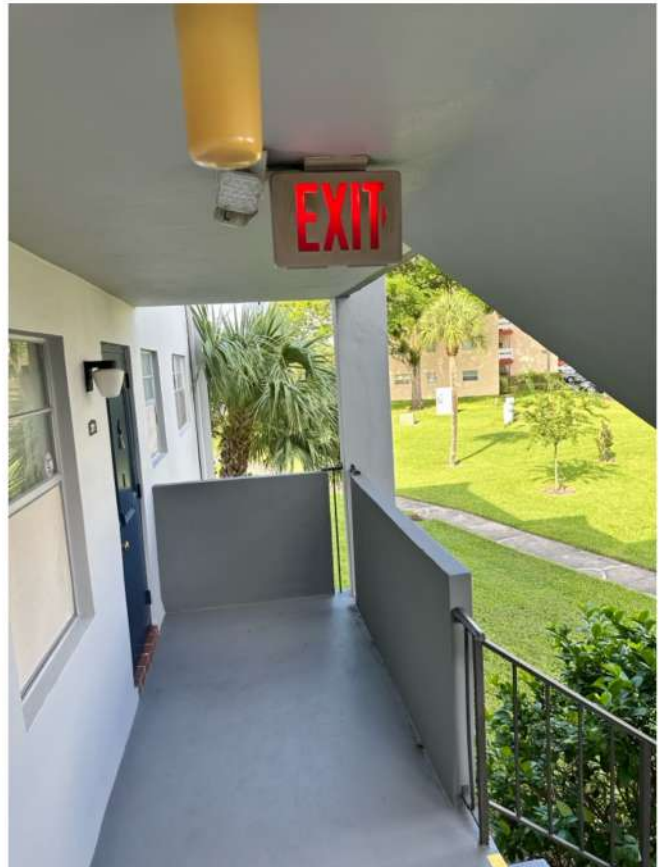
Condition: The fire protection systems appear to be in satisfactory condition.

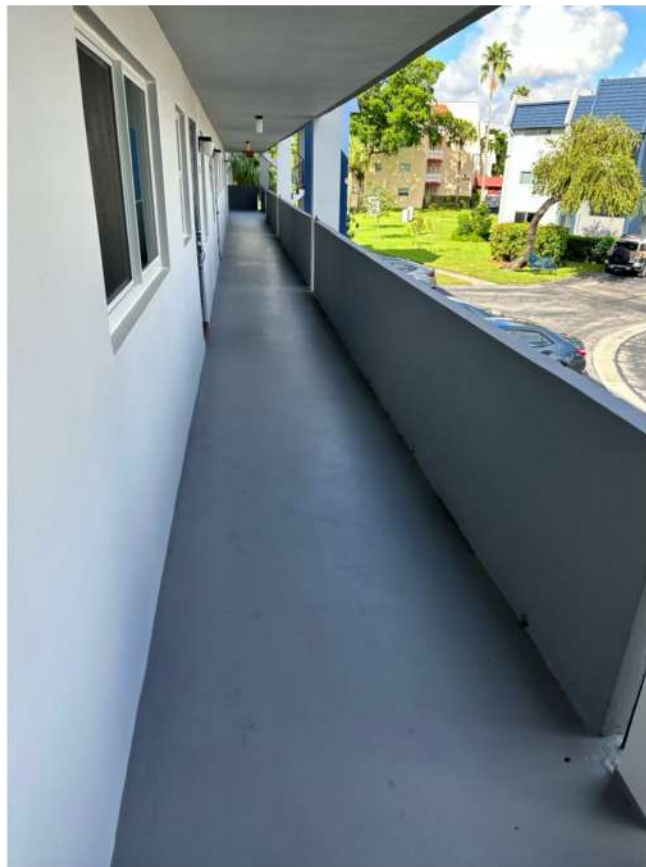
Condition: The railings appear to be in satisfactory condition.
