STRUCTURAL INTEGRITY RESERVE STUDY

***Oriole Golf & Tennis Club Condominium One
Bldg. B (7867)***

7867 Golf Circle Drive, Margate, FL 33063

Inspected on: September, 2023

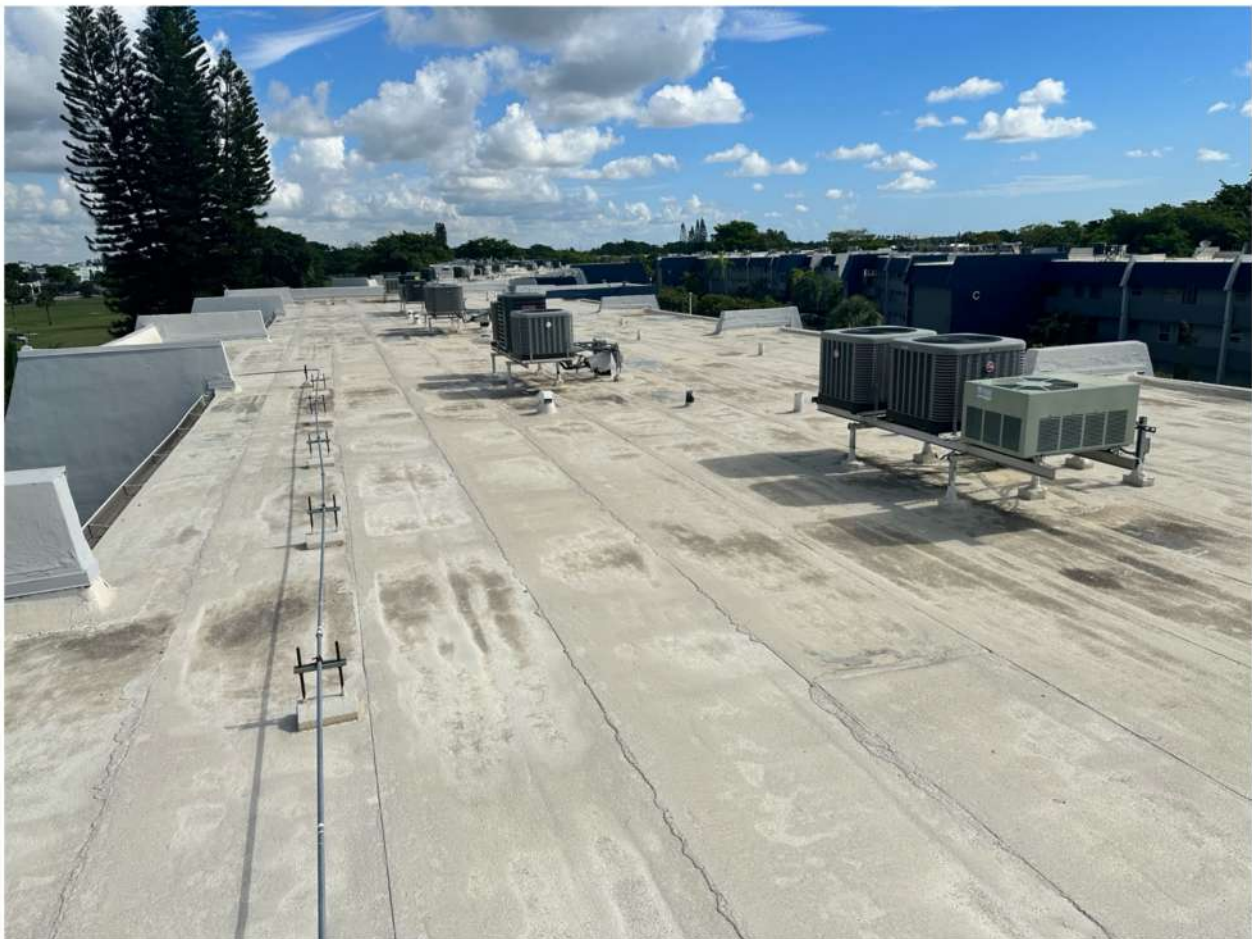
Condition: The roof surface appears to be in satisfactory condition with slight surface deterioration or granule loss. According to the information provided, all the roofs of the Oriole Golf & Tennis Club One have been provided with a silicone reflective coating within the last 5-years. The addition of the reflective coating can extend the useful life of the roof surface if proper maintenance is given.

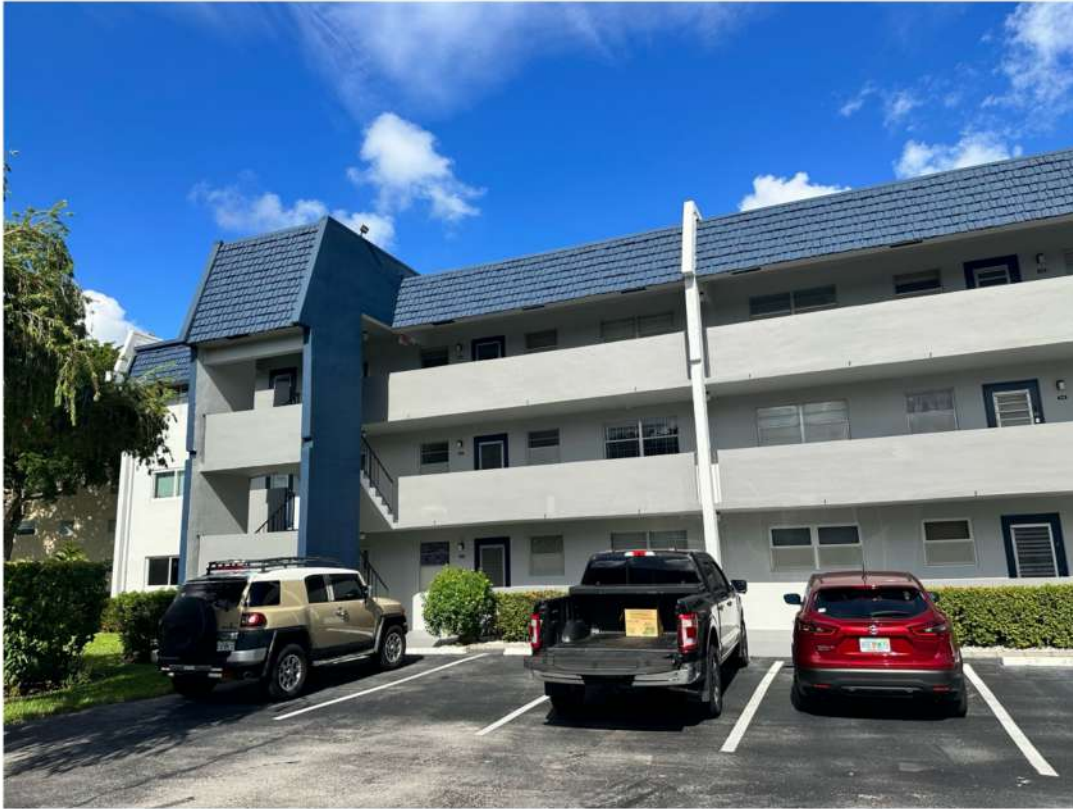
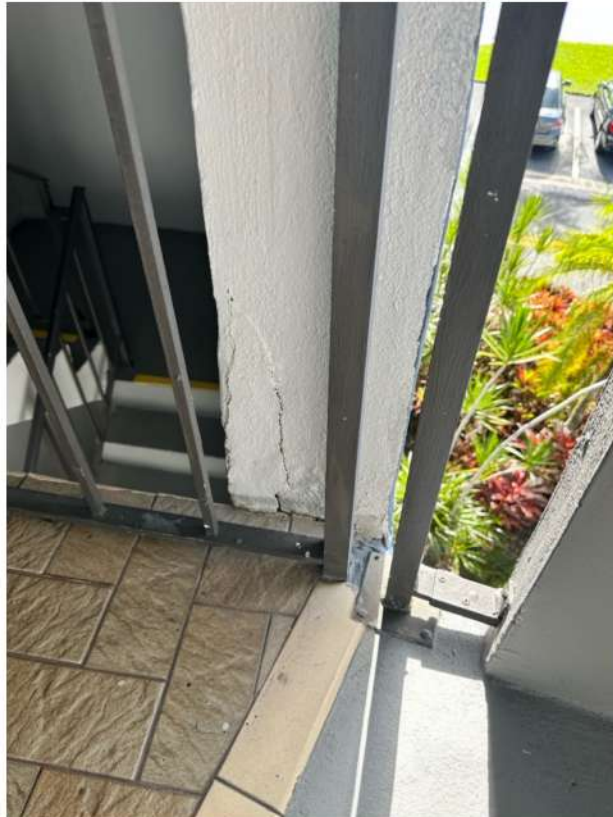
Condition: The general condition of the concrete load bearing structural systems, including visible the framing columns, tie-beams, and concrete floor systems appears to be in satisfactory condition have been found in satisfactory condition. However, conspicuous signs of concrete spalling requiring concrete repairs have been noted in the exterior corridors/catwalks of the building.

Estimated Cost of Replacement: Concrete repairs are typically done on a unit-price basis and should be repaired as damages appear. Refer to the table presented at the end of this report for our recommendation based on our experience and the size of the building.

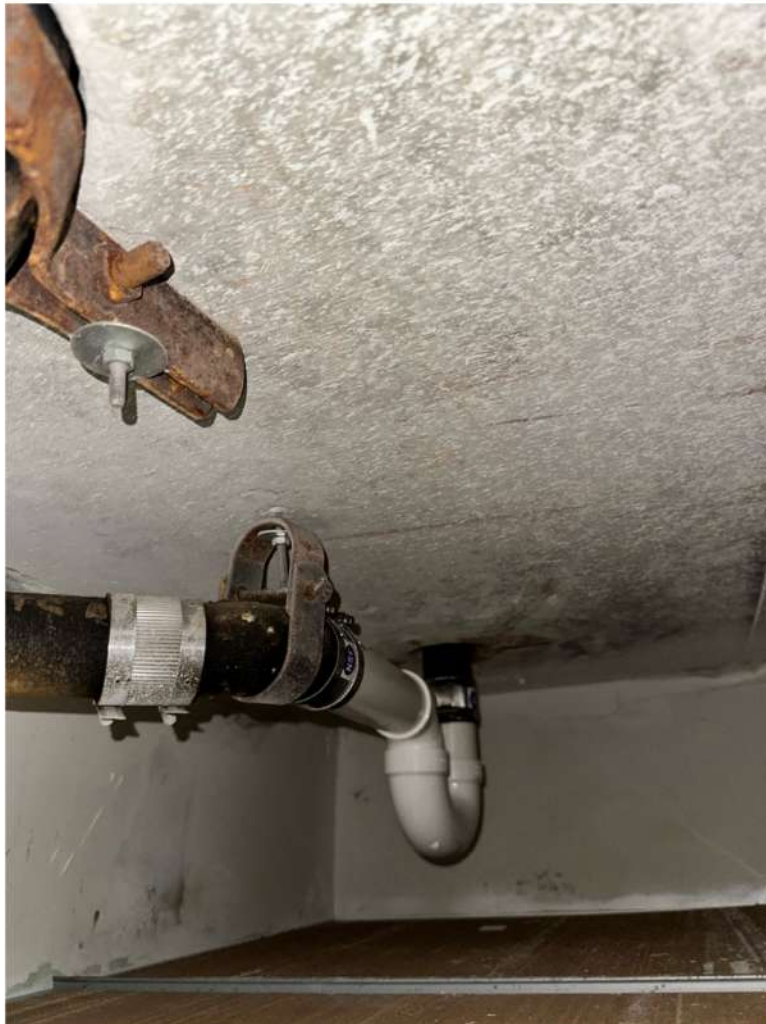
Condition: The plumbing system appears to be in satisfactory condition. It is important to note that it is rarely possible to visually inspect and examine all the concealed construction, nor should be generally necessary. Our conclusions are based upon our experience and deficiencies found in the visible and readily accessible areas.

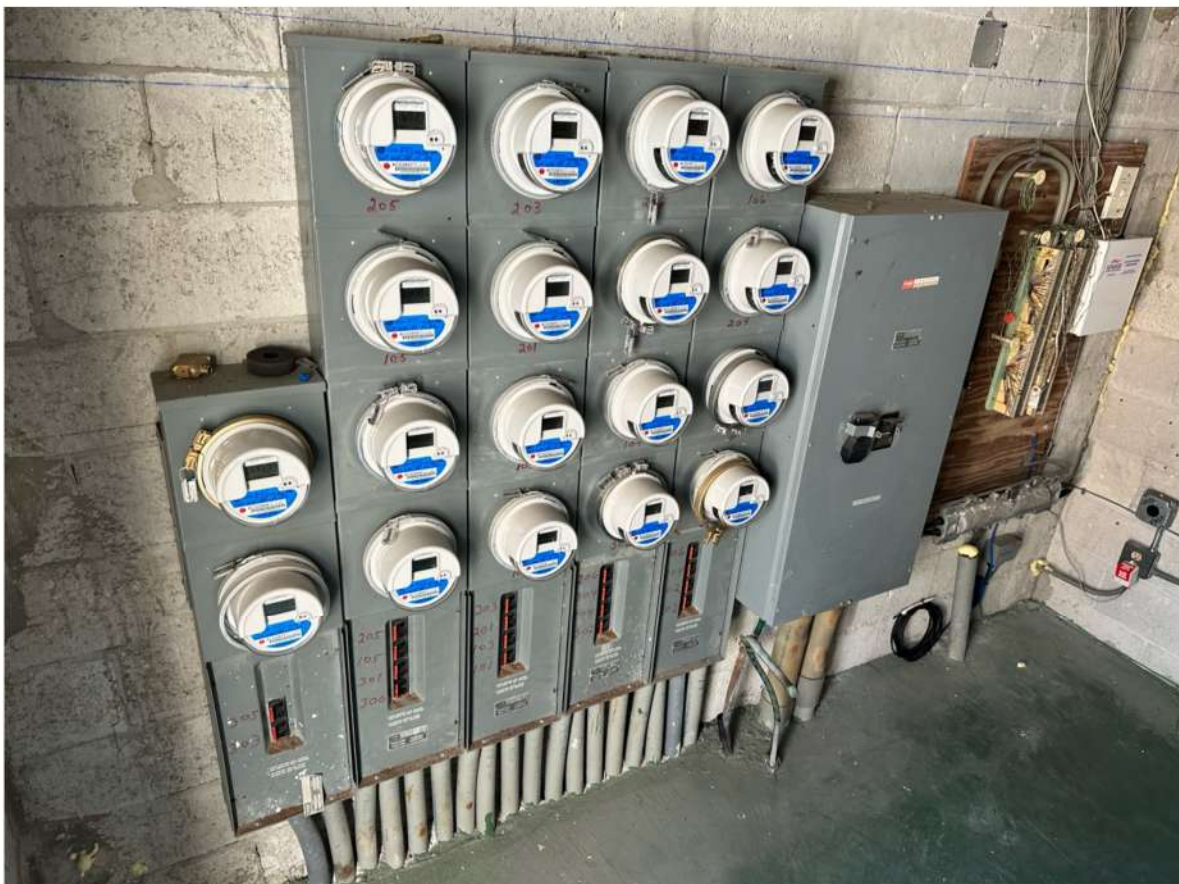
Condition: The electrical system(s) appears to be in satisfactory condition.

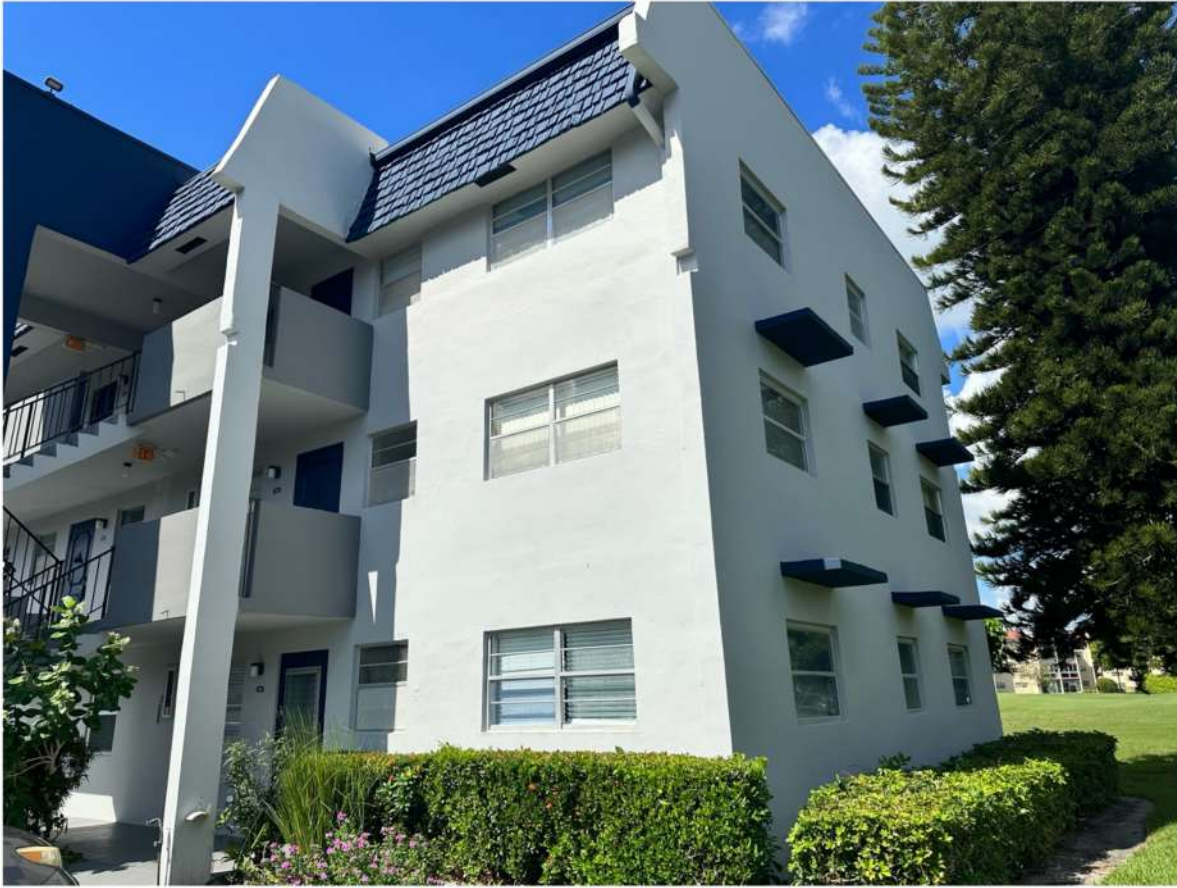
Condition: The exterior stucco surface appears to be in satisfactory condition. However, stucco delamination and conspicuous signs of concrete spalling have been noted in the exterior corridors/catwalks of the building.

Estimated Cost of Replacement: The removal and replacement of all the stucco finish is rarely required. It is typically repaired as required in the building for general maintenance. Therefore, we assume that 10% of all exterior surfaces are required to be replaced at once. See the table presented at the end of this report for our recommendation based on our experience and the size of the building. (The exact amount of area needing replacement will be discretionary based on the actual future conditions and the desired appearance).

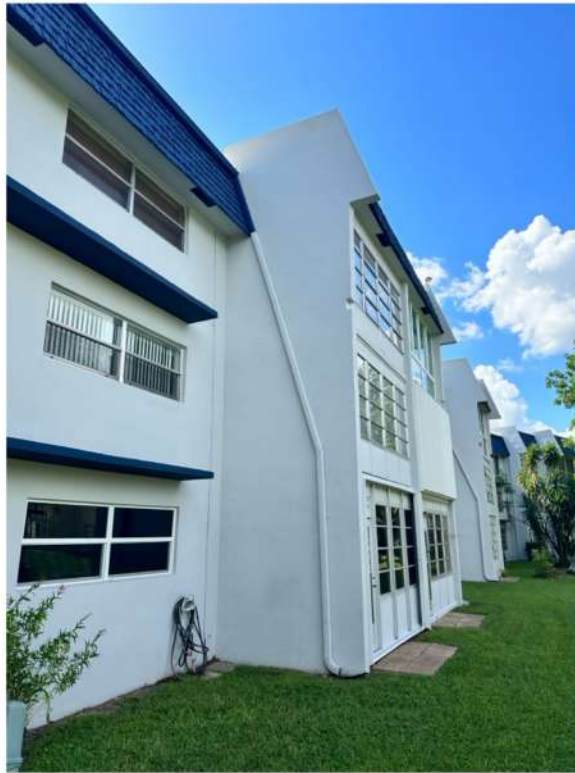
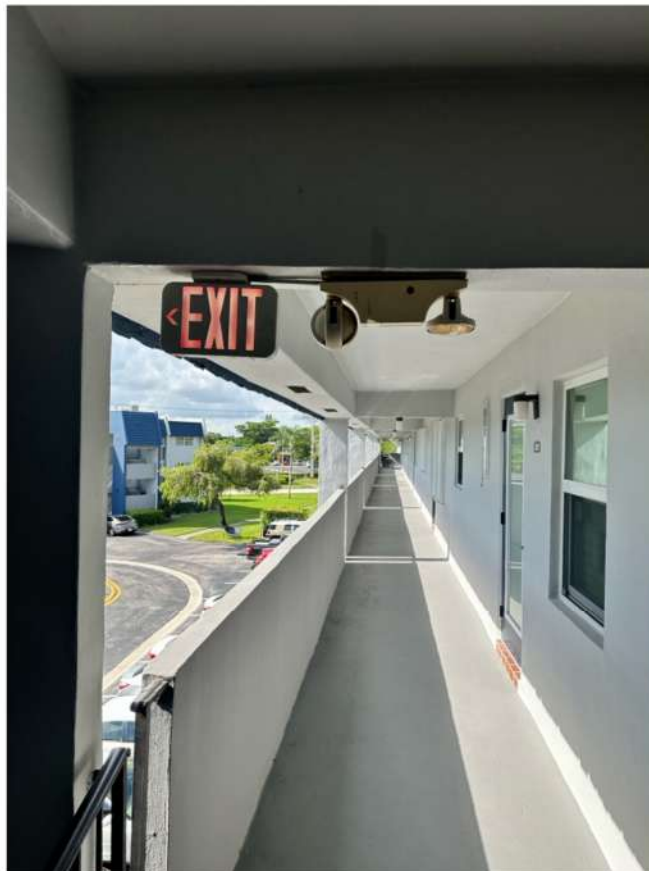
Condition: The exterior surface paint & exterior waterproofing appear to be in satisfactory condition.

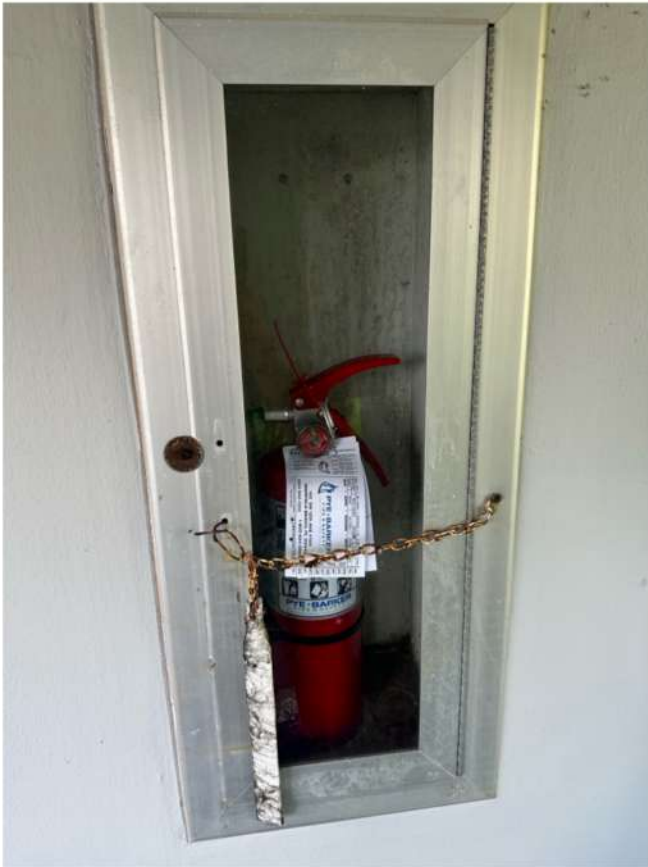
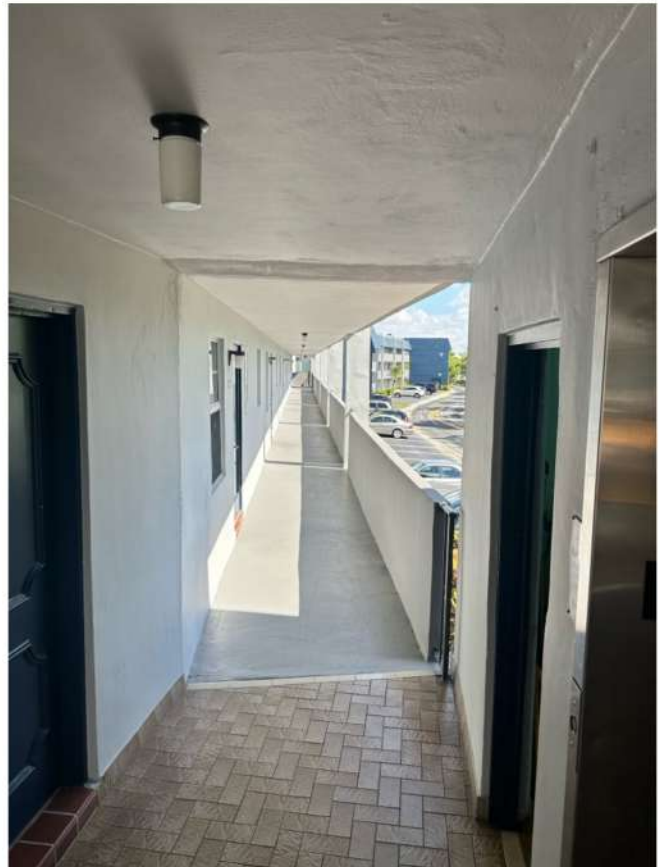
Condition: The fire protection systems appear to be in satisfactory condition.

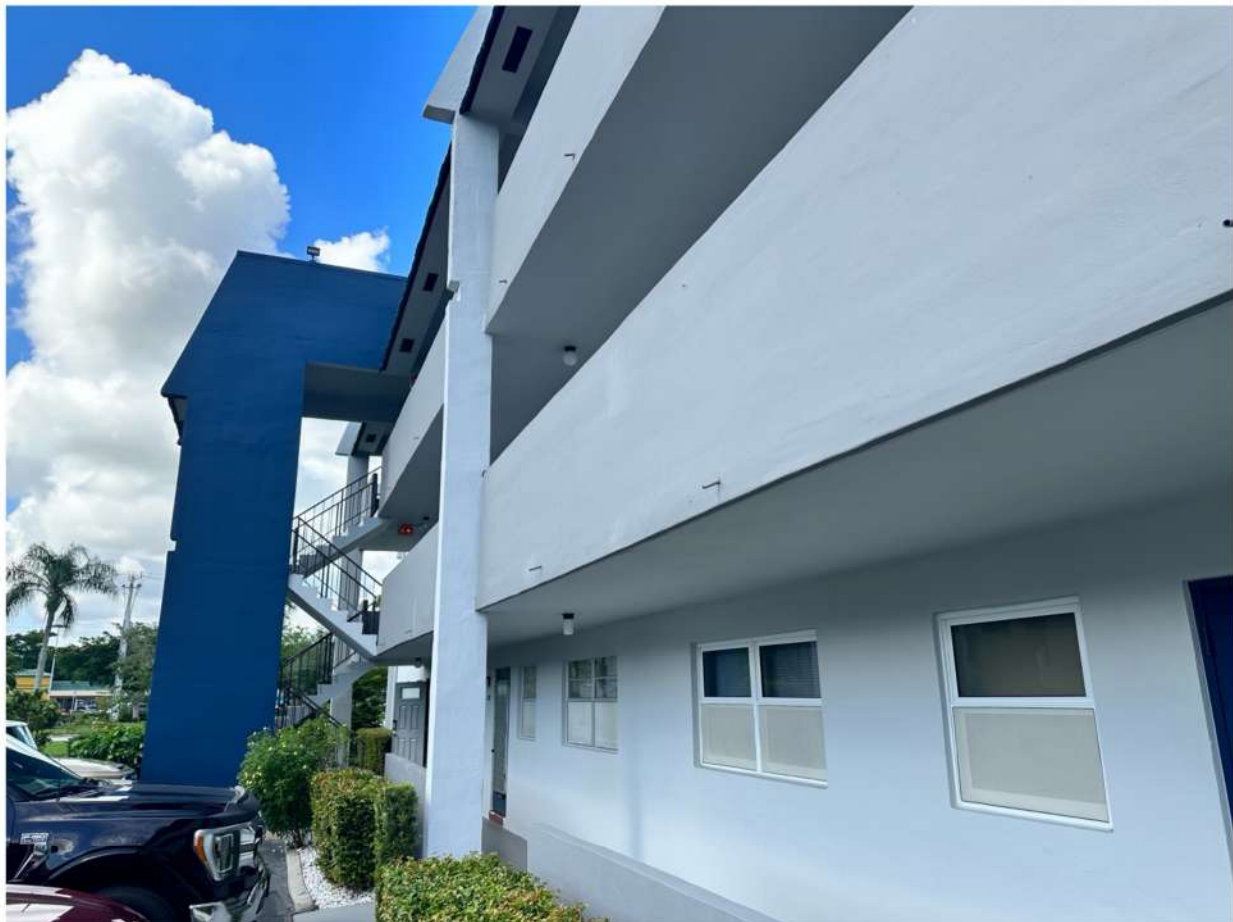
Condition: The railings appear to be in satisfactory condition.
