STRUCTURAL INTEGRITY RESERVE STUDY

***Oriole Golf & Tennis Club Condominium One
Bldg. C (7857)***

7857 Golf Circle Drive, Margate, FL 33063

Prepared on: October, 2023

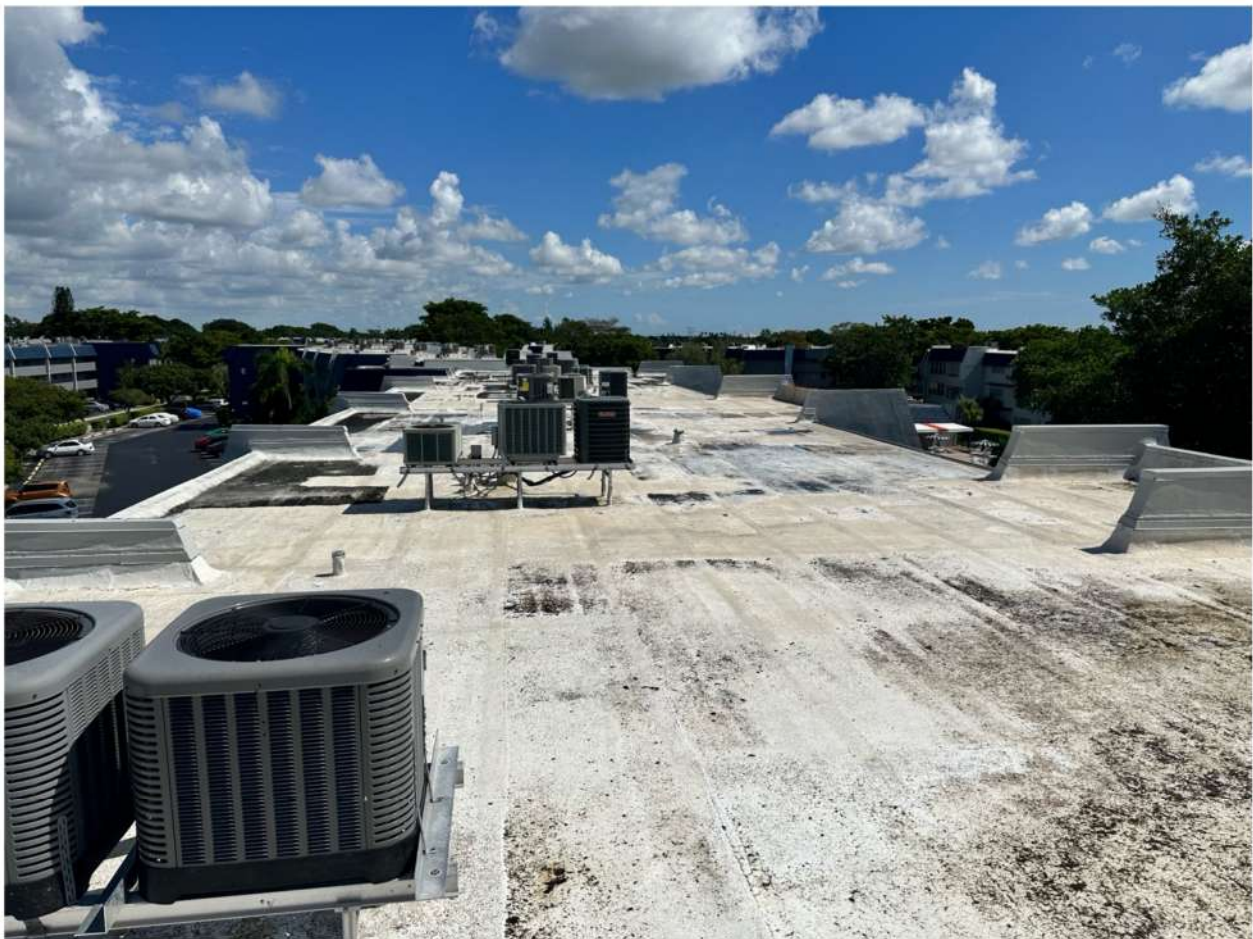
Condition: The roof surface appears to be in satisfactory condition with slight surface deterioration or granule loss. According to the information provided, all the roofs of the Oriole Golf & Tennis Club One have been provided with a silicone reflective coating within the last 5-years. The addition of the reflective coating can extend the useful life of the roof surface if proper maintenance is given.

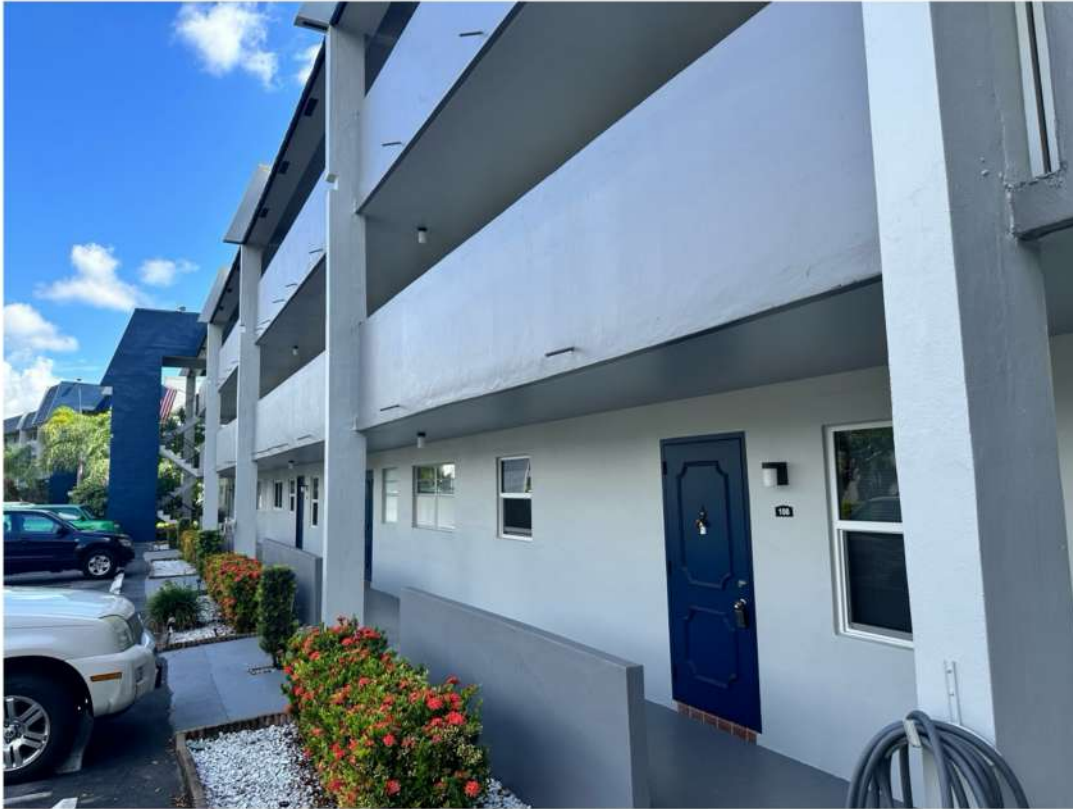
Condition: The general condition of the concrete load bearing structural systems, including visible the framing columns, tie-beams, and concrete floor systems appears to be in satisfactory condition have been found in satisfactory condition. However, conspicuous signs of concrete spalling requiring concrete repairs have been noted in the exterior corridors/catwalks of the building.

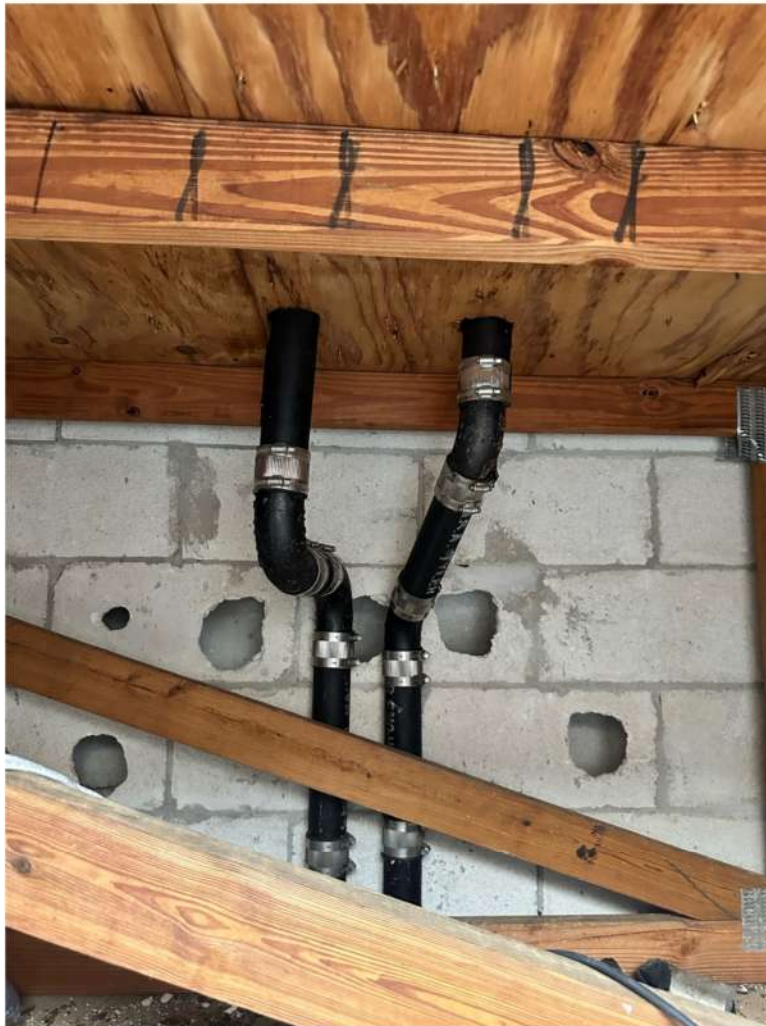
Condition: The plumbing system appears to be in satisfactory condition. It is important to note that it is rarely possible to visually inspect and examine all the concealed construction, nor should be generally necessary. Our conclusions are based upon our experience and deficiencies found in the visible and readily accessible areas.

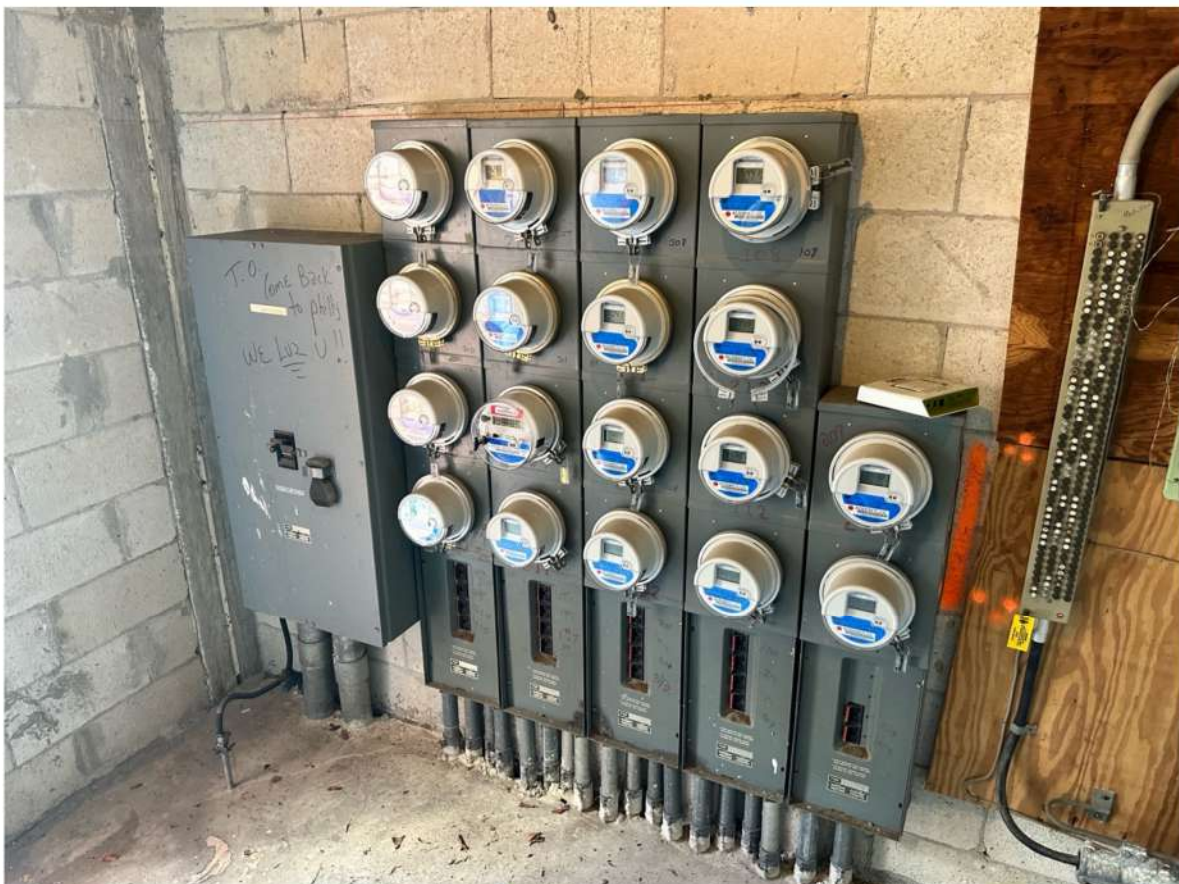
Condition: The electrical system(s) appears to be in satisfactory condition.

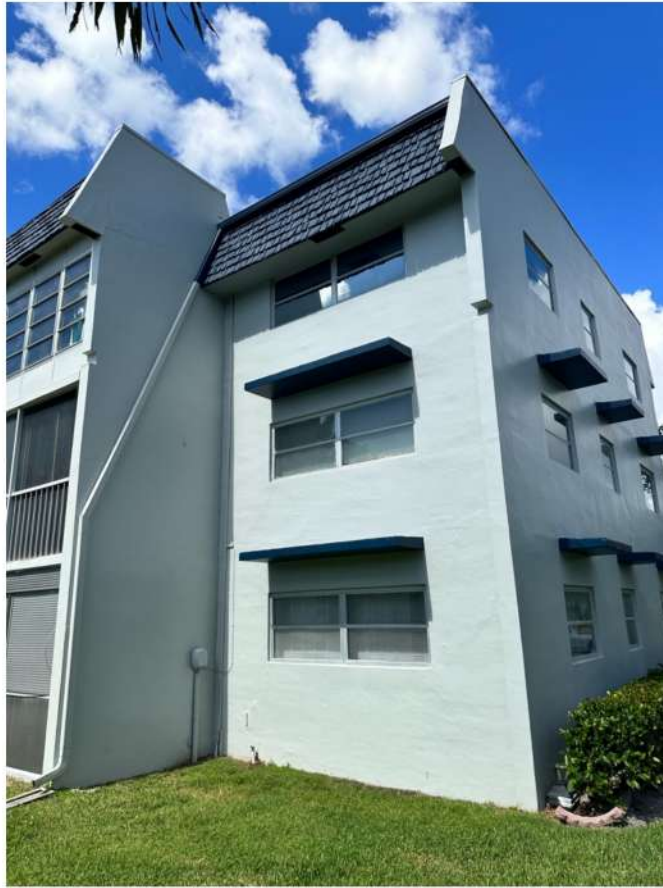
Condition: The exterior stucco surface appears to be in satisfactory condition. However, stucco delamination and conspicuous signs of concrete spalling have been noted in the exterior corridors/catwalks of the building.

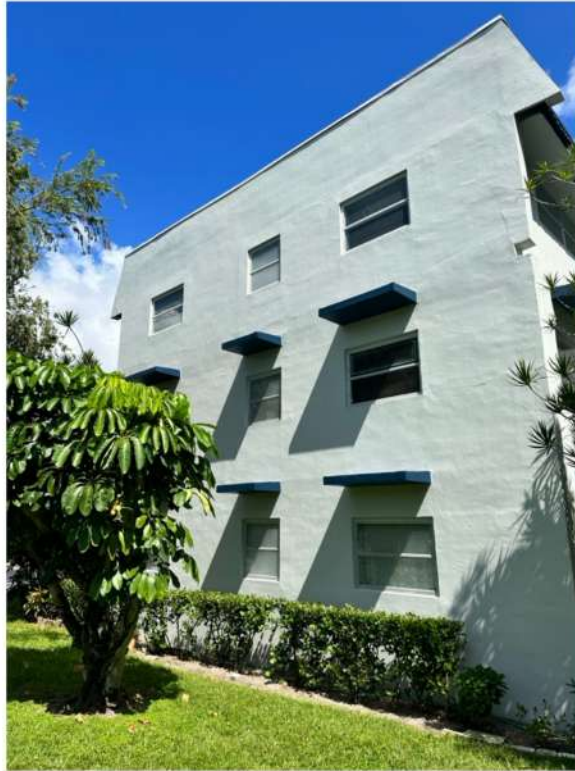
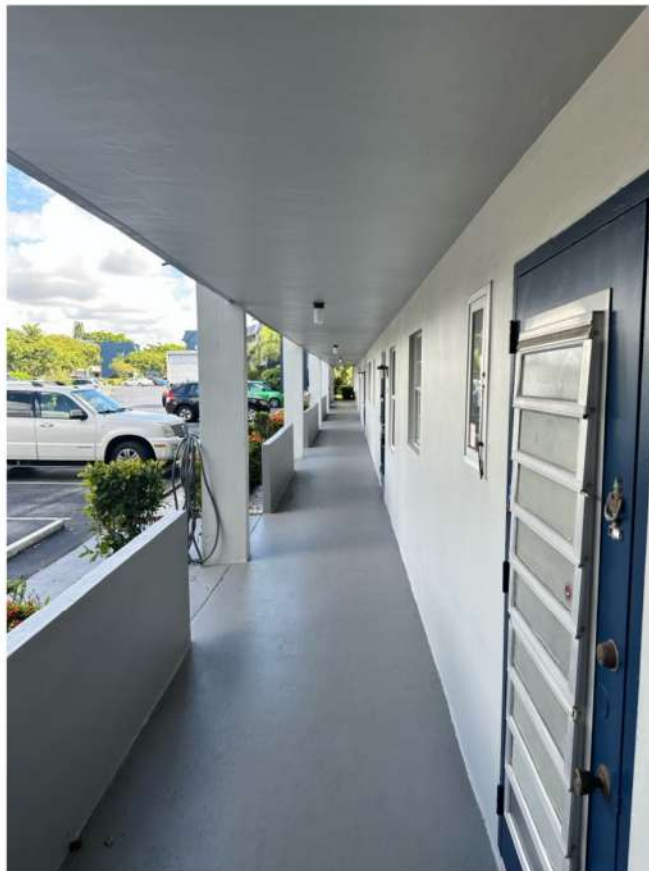
Condition: The exterior surface paint & exterior waterproofing appear to be in satisfactory condition.

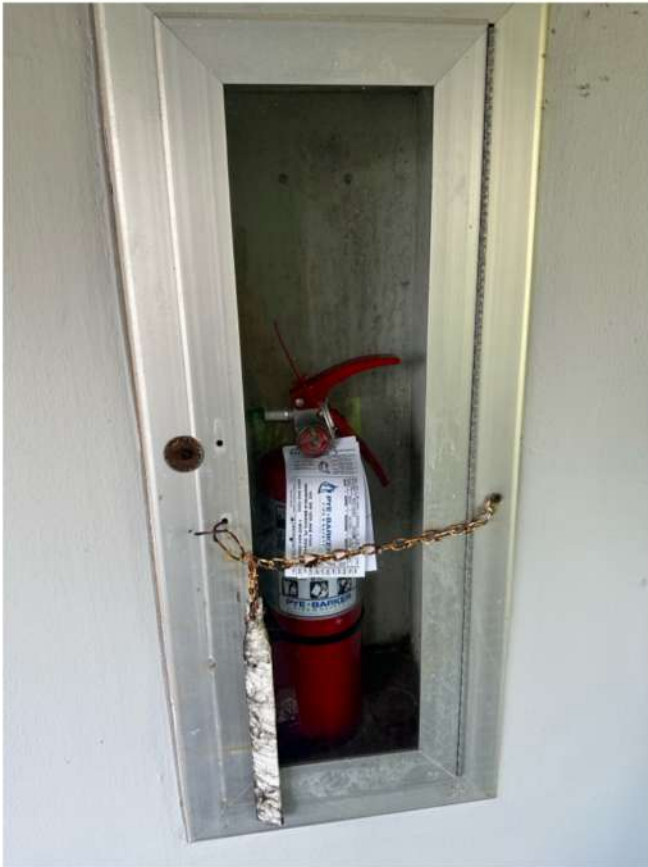
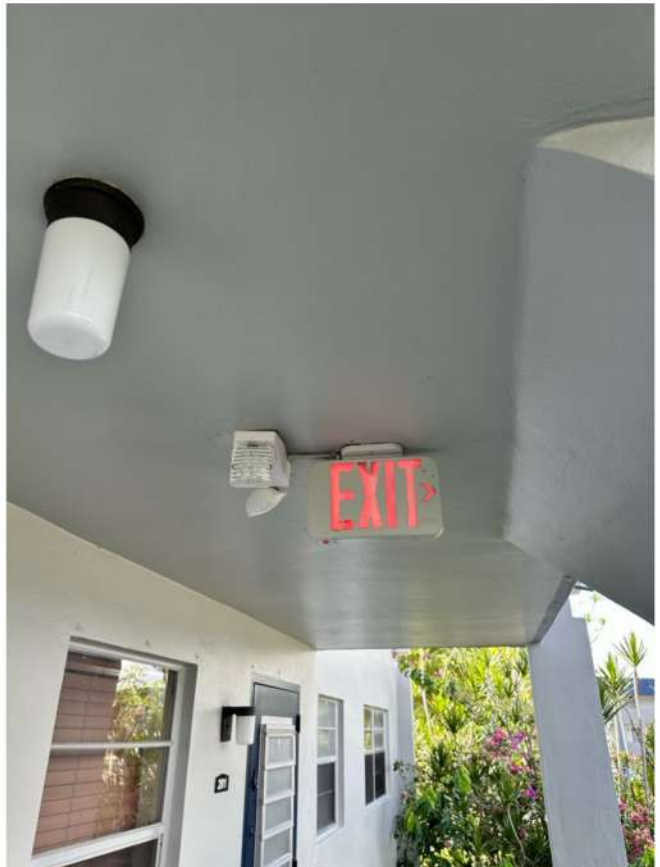
Condition: The fire protection systems appear to be in satisfactory condition.

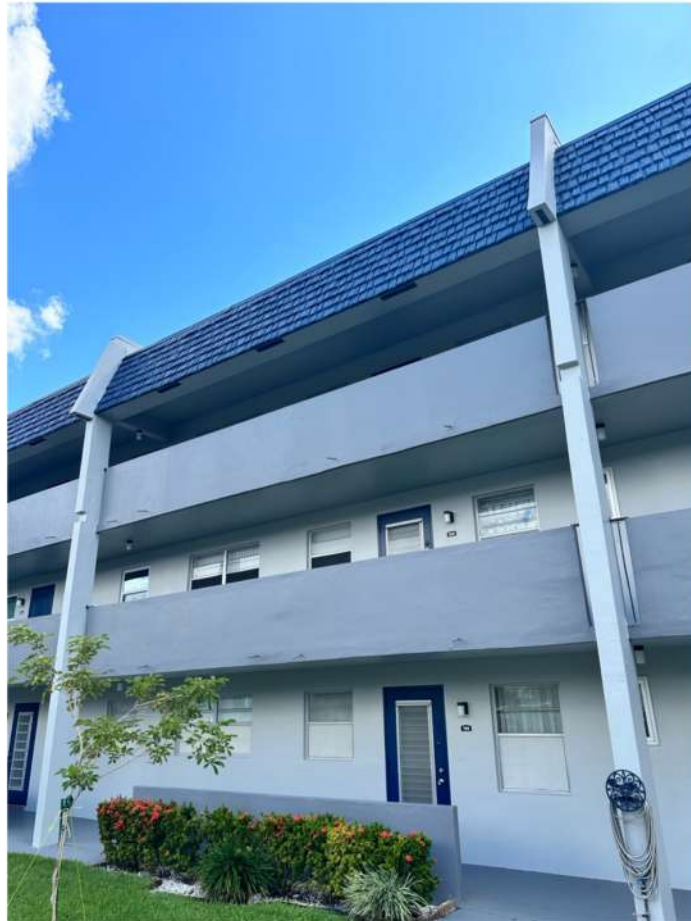
Condition: The railings appear to be in satisfactory condition.
