STRUCTURAL INTEGRITY RESERVE STUDY

***Oriole Golf & Tennis Club Condominium One
Bldg. D (7847)***

7847 Golf Circle Drive, Margate, FL 33063

Inspected on: September, 2023

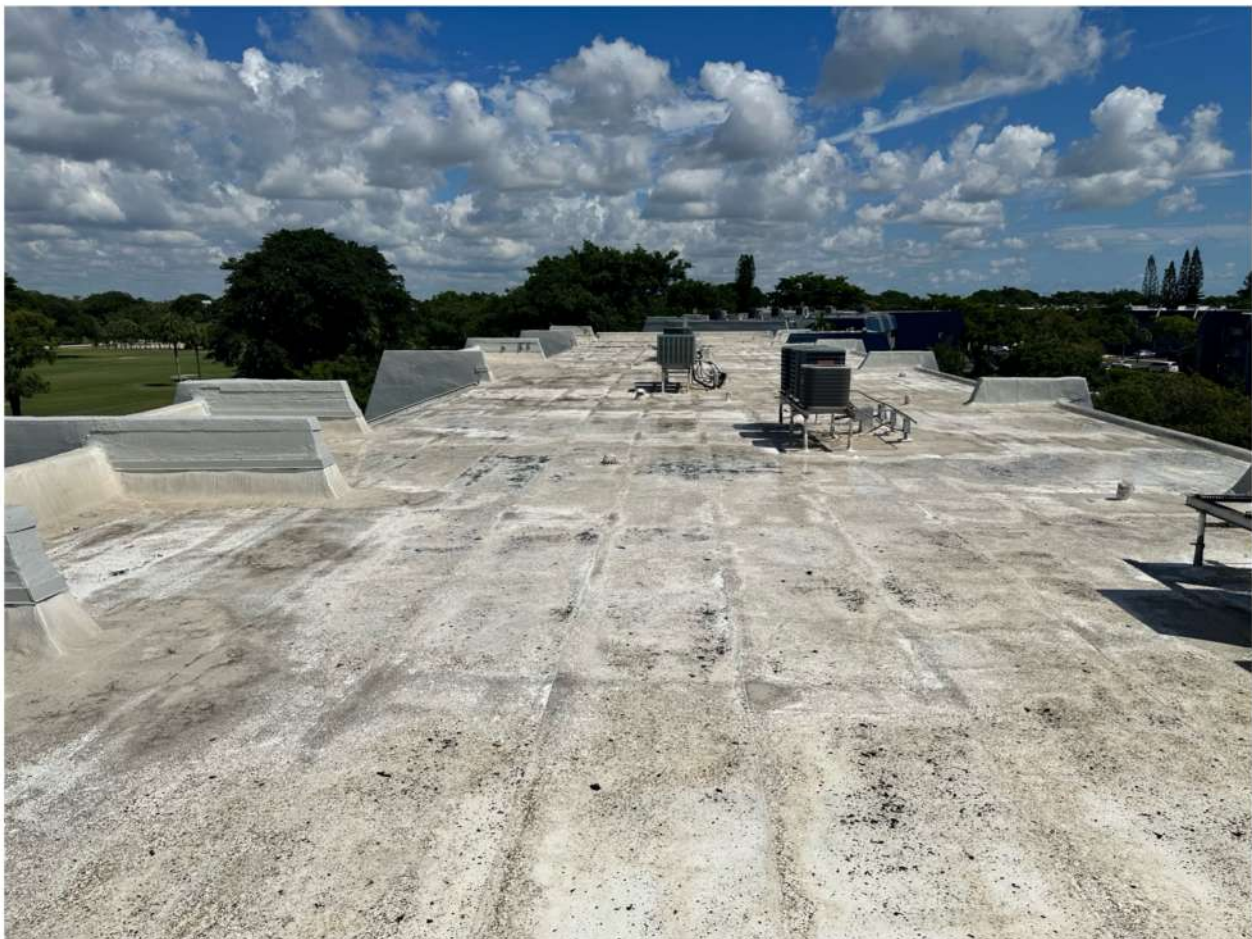
Condition: The roof surface appears to be in satisfactory condition with slight surface deterioration or granule loss. According to the information provided, all the roofs of the Oriole Golf & Tennis Club One have been provided with a silicone reflective coating within the last 5-years. The addition of the reflective coating can extend the useful life of the roof surface if proper maintenance is given.

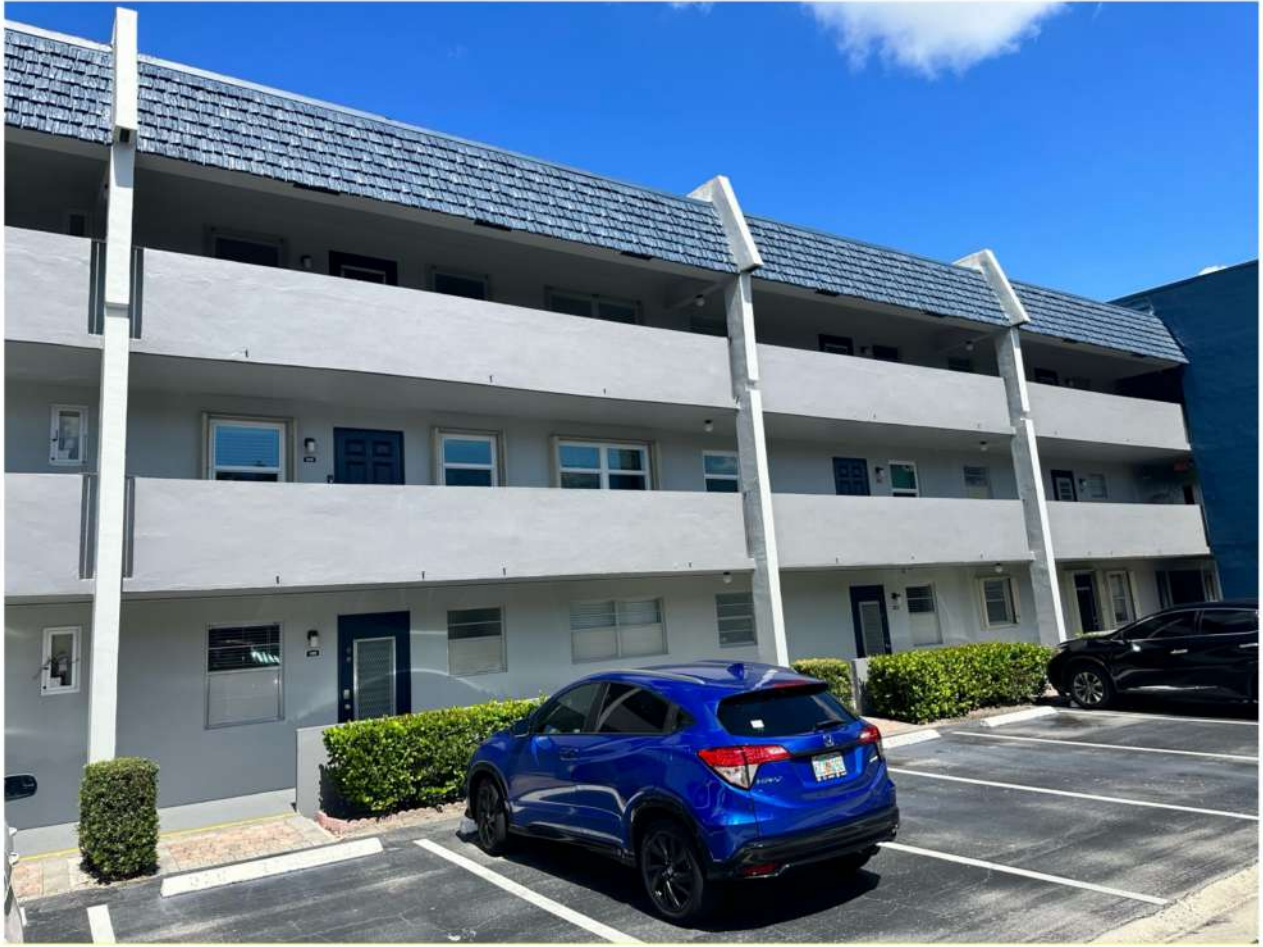
Condition: The general condition of the concrete load bearing structural systems, including visible the framing columns, tie-beams, and concrete floor systems appears to be in satisfactory condition have been found in satisfactory condition. However, conspicuous signs of concrete spalling requiring concrete repairs have been noted in the exterior corridors/catwalks of the building.

Estimated Cost of Replacement: Concrete repairs are typically done on a unit-price basis and should be repaired as damages appear. Refer to the table presented at the end of this report for our recommendation based on our experience and the size of the building.

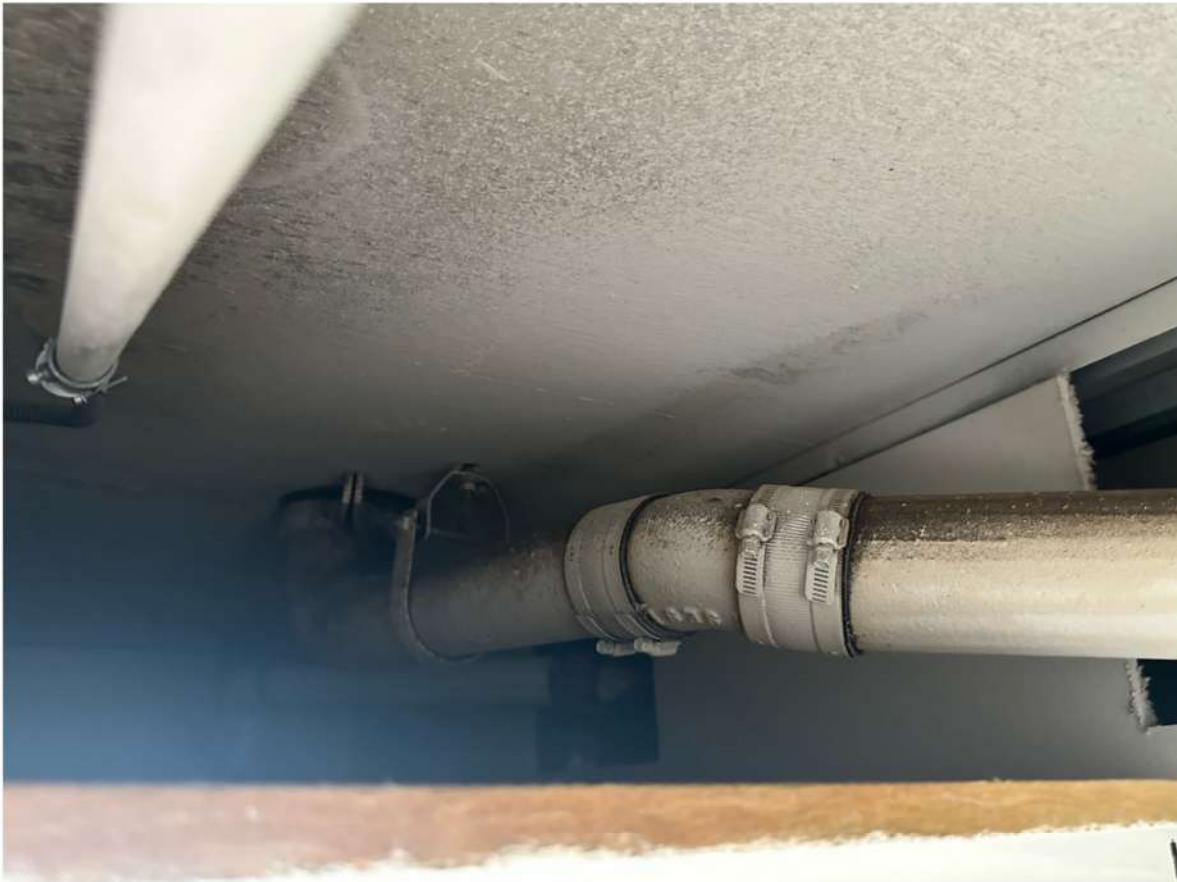
Condition: The plumbing system appears to be in satisfactory condition. It is important to note that it is rarely possible to visually inspect and examine all the concealed construction, nor should be generally necessary. Our conclusions are based upon our experience and deficiencies found in the visible and readily accessible areas.

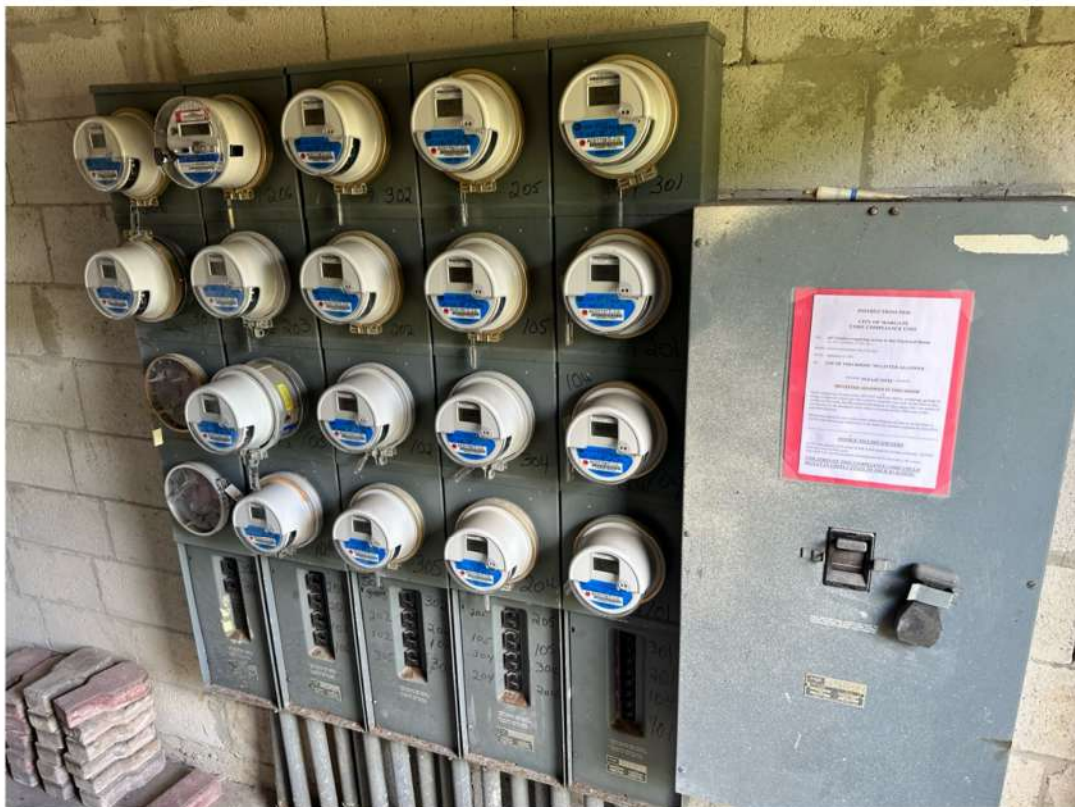
Condition: The electrical system(s) appears to be in satisfactory condition.

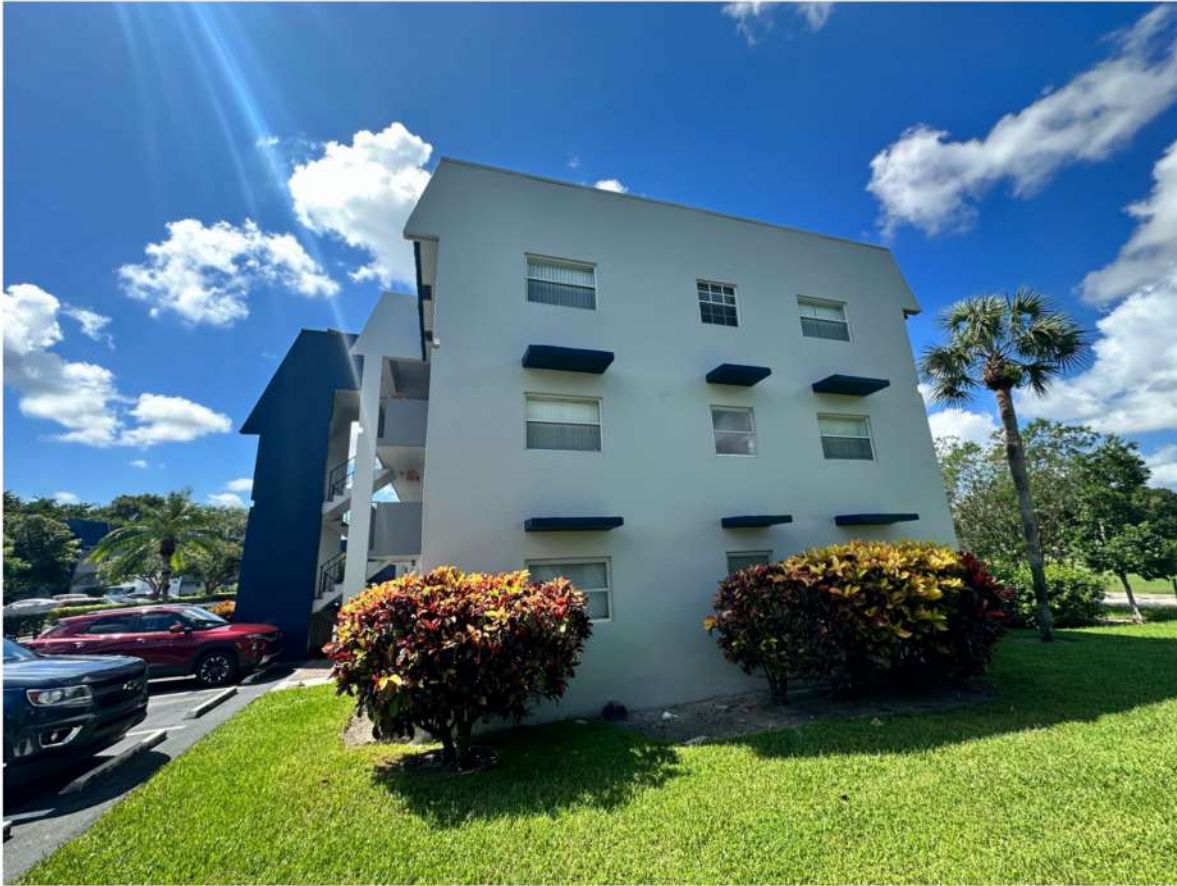
Condition: The exterior stucco surface appears to be in satisfactory condition. However, stucco delamination and conspicuous signs of concrete spalling have been noted in the exterior corridors/catwalks of the building.

Estimated Cost of Replacement: The removal and replacement of all the stucco finish is rarely required. It is typically repaired as required in the building for general maintenance. Therefore, we assume that 10% of all exterior surfaces are required to be replaced at once. See the table presented at the end of this report for our recommendation based on our experience and the size of the building. (The exact amount of area needing replacement will be discretionary based on the actual future conditions and the desired appearance).

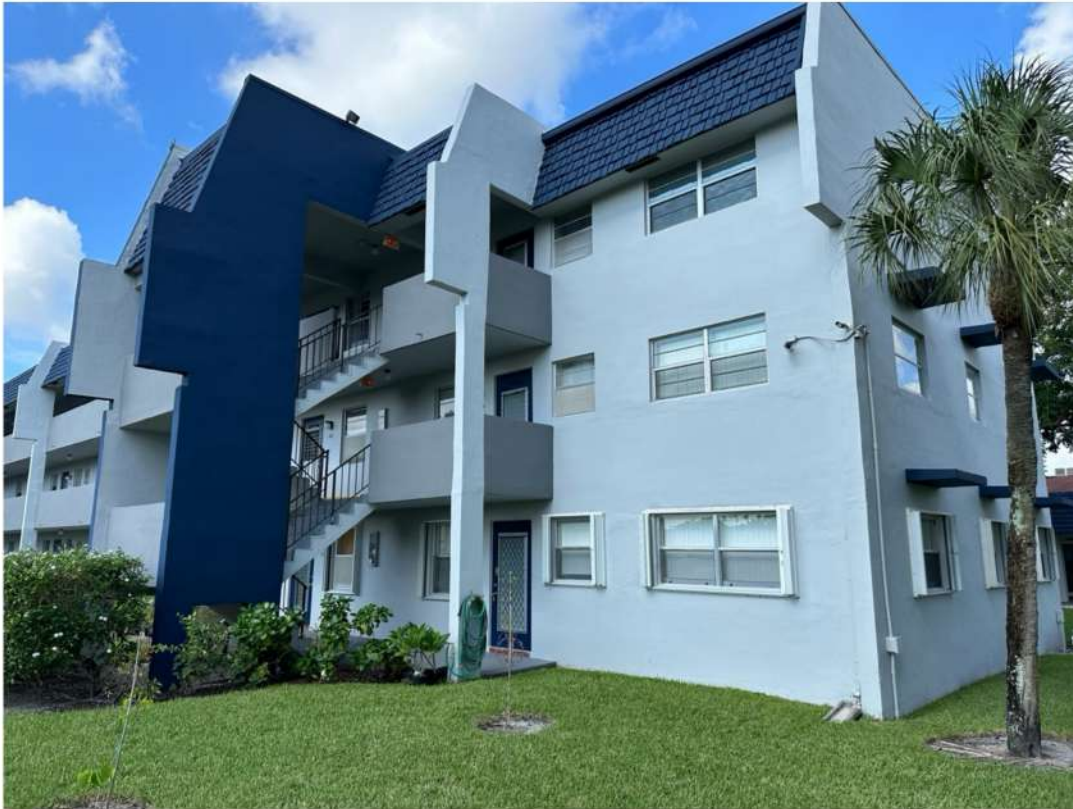
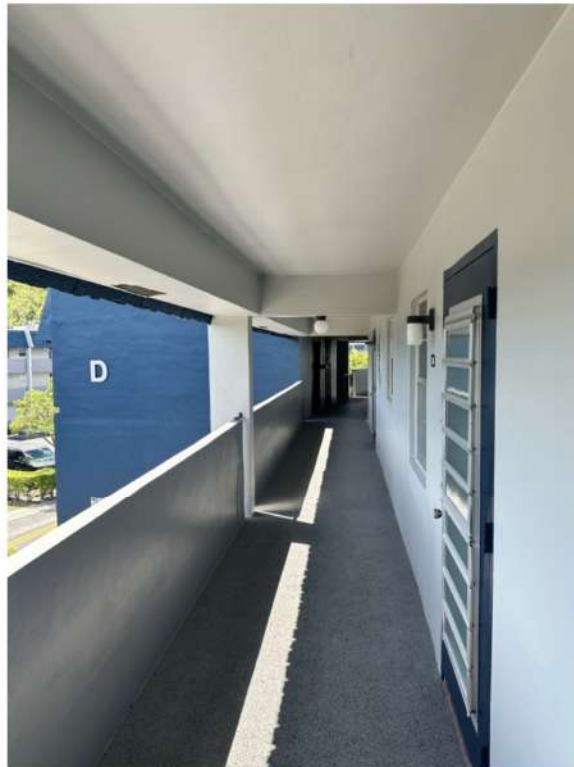
Condition: The exterior surface paint appear to be in satisfactory condition. The building has been recently painted. The exterior Chattahoochee appear to be in satisfactory condition. However, this type of floor finish promotes the accumulation of water, and it is widely known for hiding structural damage. Based on our experience, we highly recommend the exterior Chattahoochee floor finish to be removed and replaced with a sloped waterproofing system.

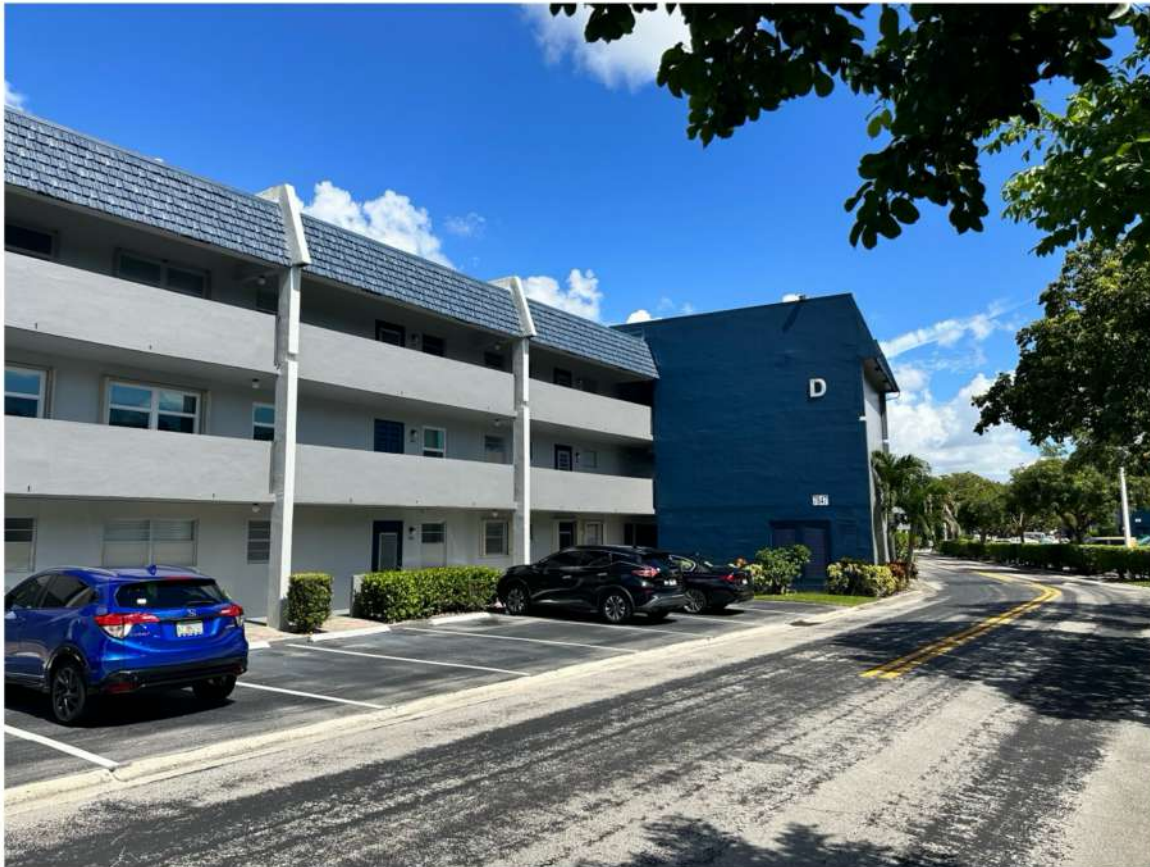
Condition: The railings appear to be in satisfactory condition.
