STRUCTURAL INTEGRITY RESERVE STUDY

***Oriole Golf & Tennis Club Condominium One
Bldg. E (7837)***

7837 Golf Circle Drive, Margate, FL 33063

Prepared on: October, 2023

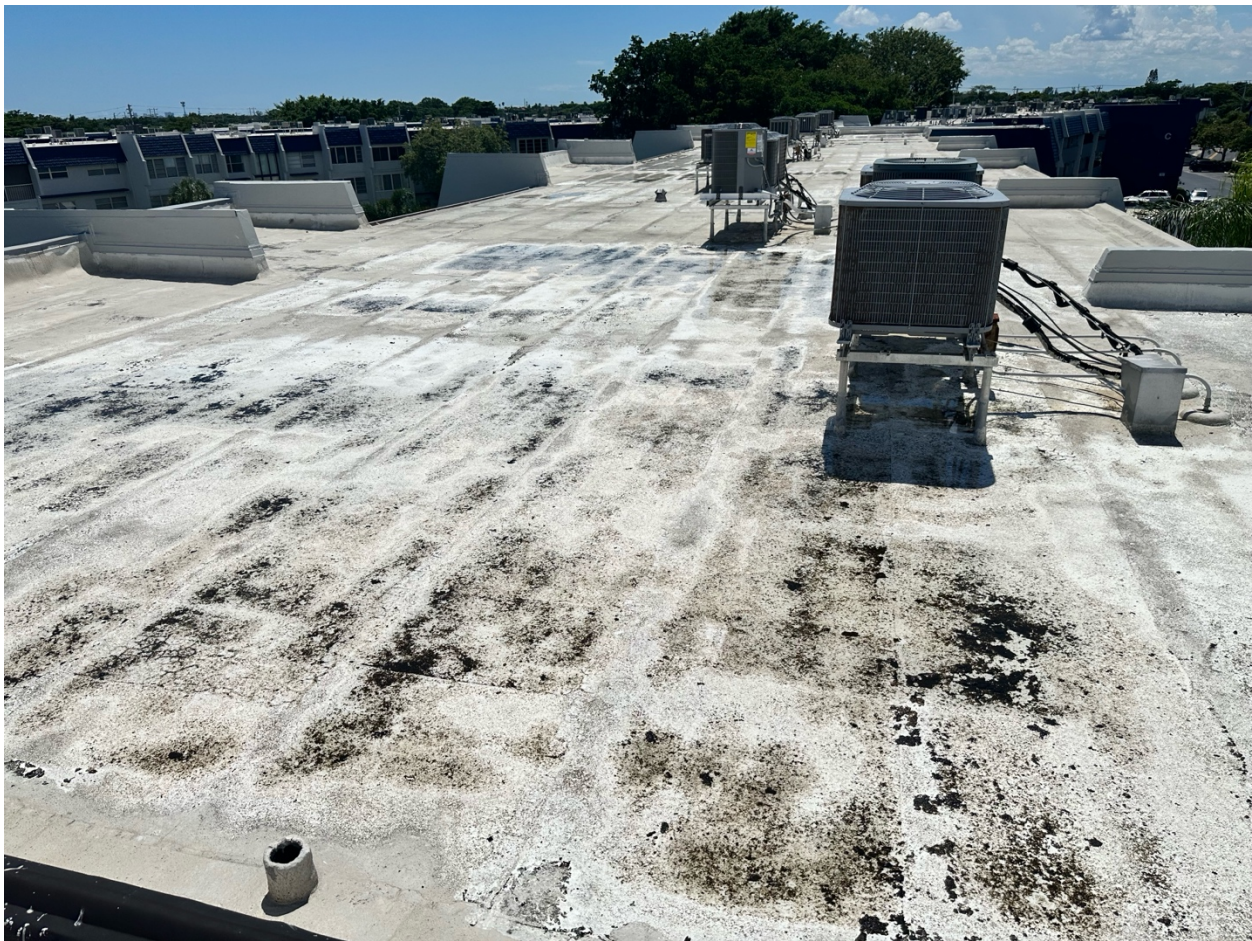
Condition: The roof surface appears to be in satisfactory condition with slight surface deterioration or granule loss. According to the information provided, all the roofs of the Oriole Golf & Tennis Club One have been provided with a silicone reflective coating within the last 5-years. The addition of the reflective coating can extend the useful life of the roof surface if proper maintenance is given.

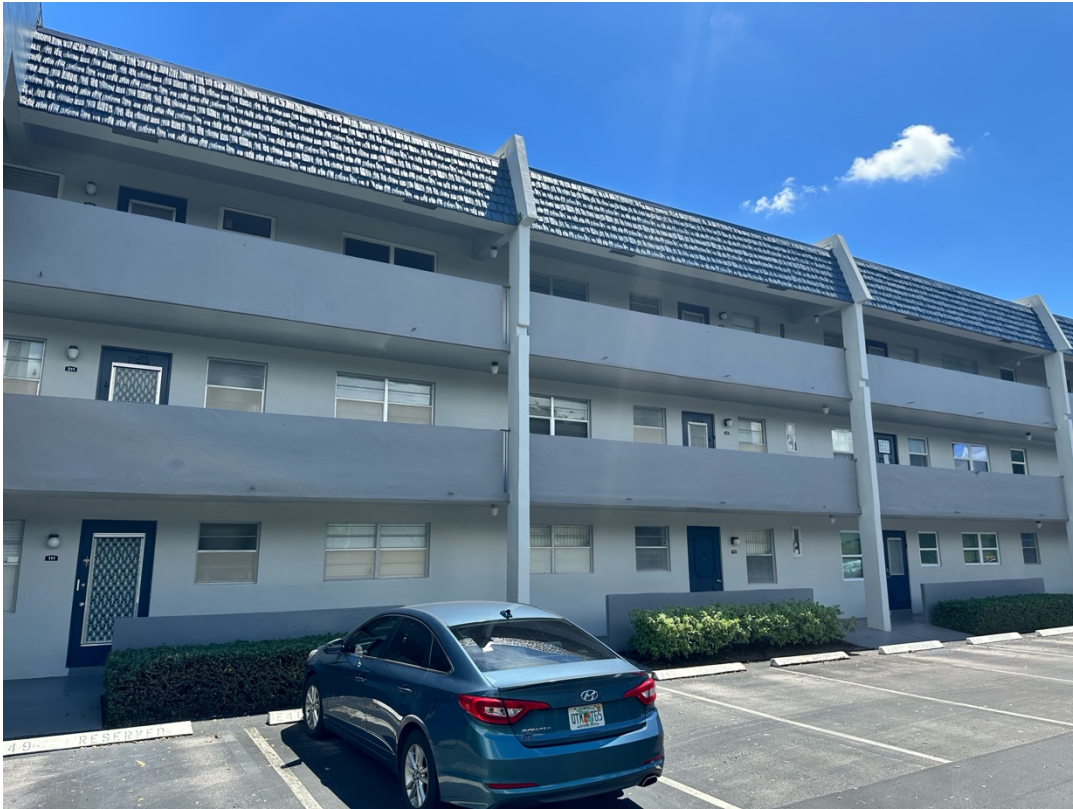
Condition: The general condition of the concrete load bearing structural systems, including visible the framing columns, tie-beams, and concrete floor systems appears to be in satisfactory condition have been found in satisfactory condition. However, conspicuous signs of concrete spalling requiring concrete repairs have been noted in the exterior corridors/catwalks of the building.

Remaining Lifespan: Although concrete is a very durable material, due to the location's proximity to the coast, spalling due to rebar corrosion usually manifests before the concrete naturally deteriorates. It is important to note that it is rarely possible to visually inspect and examine all the concealed construction, nor should be generally necessary. Our conclusions are based upon our experience and conditions examined in the exterior typical structural members of the building. Refer to the table presented at the end of this report.

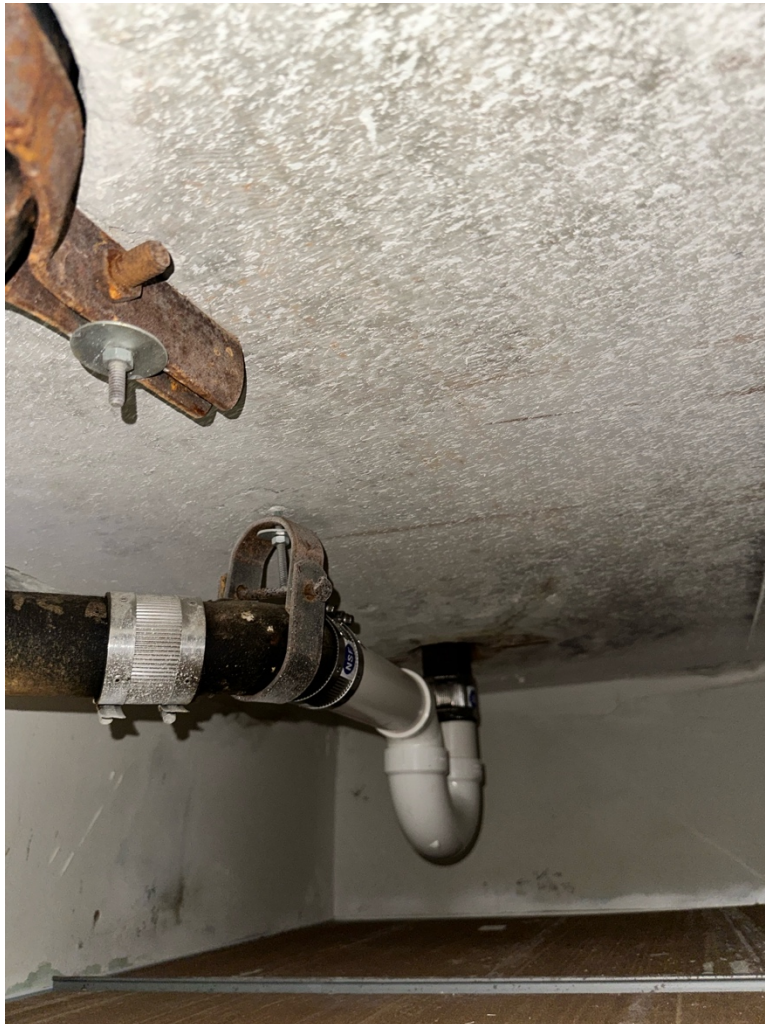
Condition: The plumbing system appears to be in satisfactory condition. It is important to note that it is rarely possible to visually inspect and examine all the concealed construction, nor should be generally necessary. Our conclusions are based upon our experience and deficiencies found in the visible and readily accessible areas.

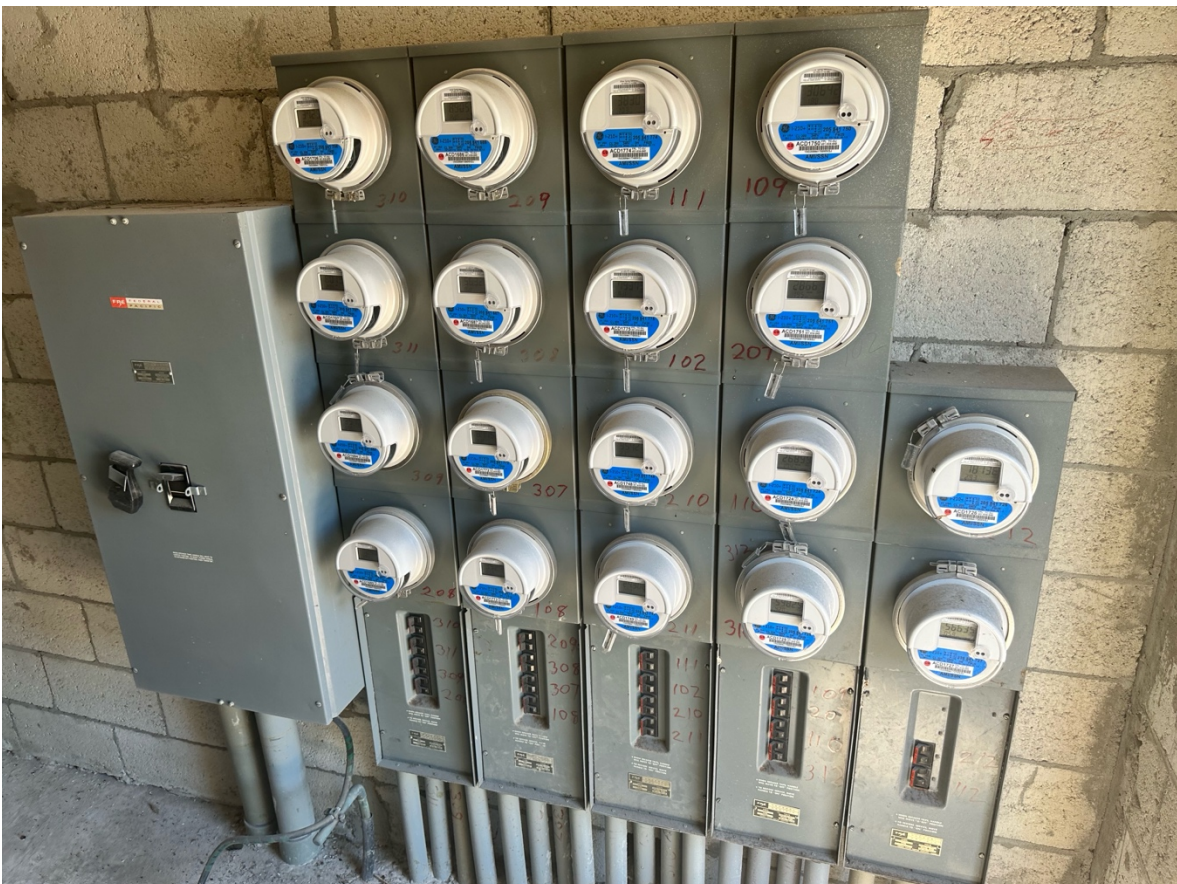
Condition: The electrical system(s) appears to be in satisfactory condition.

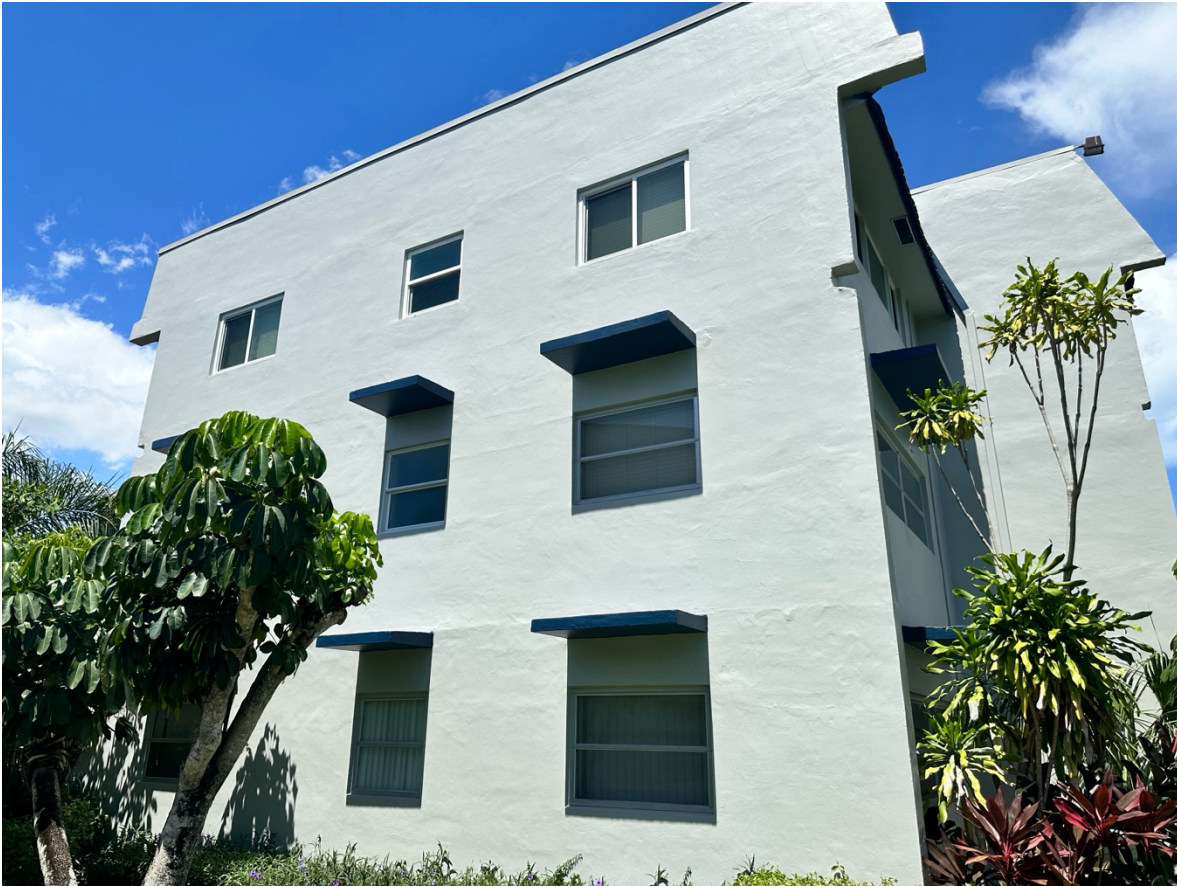
Condition: The exterior stucco surface appears to be in satisfactory condition. However, stucco delamination and conspicuous signs of concrete spalling have been noted in the exterior corridors/catwalks of the building.

Remaining Lifespan: Although the stucco is a very durable material, due to the location's proximity to the coast, spalling due to rebar corrosion usually manifests before the stucco naturally deteriorates. Refer to the table presented at the end of this report.

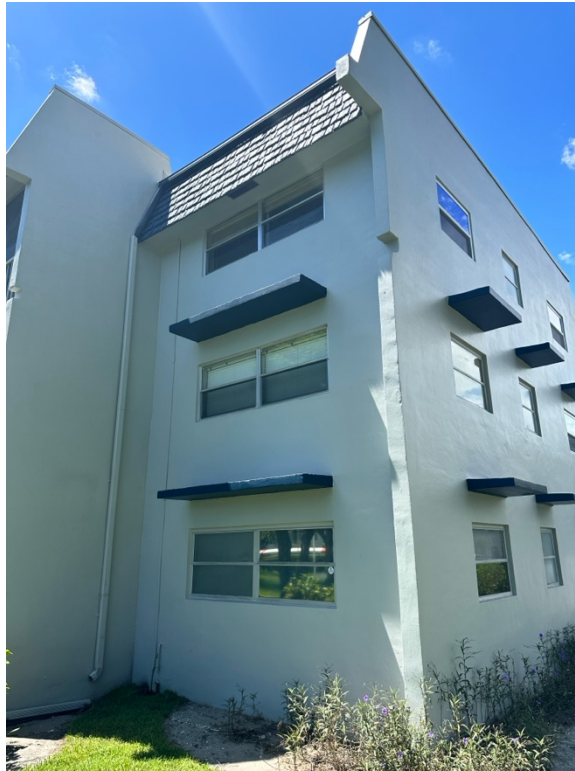
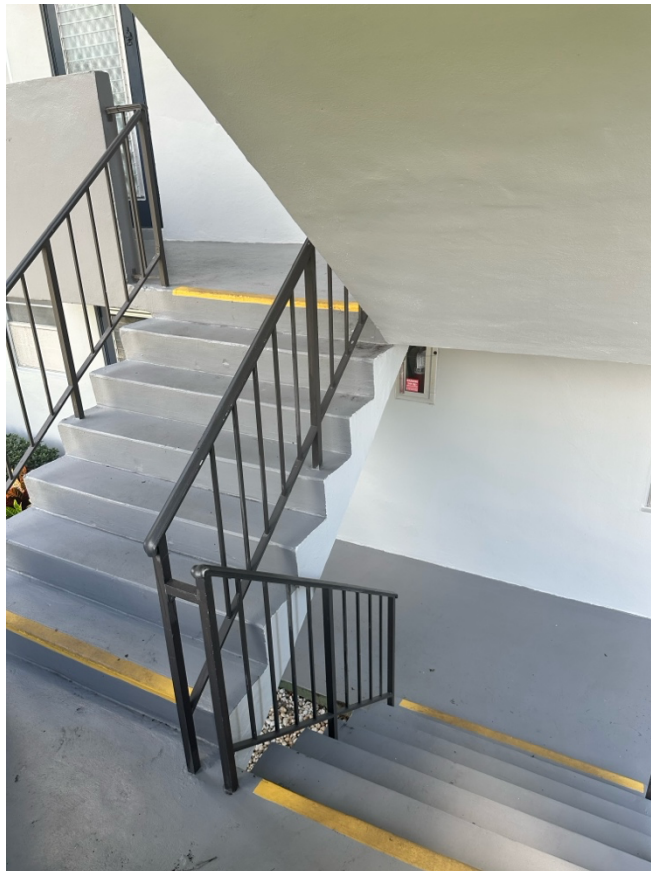
Condition: The exterior surface paint & exterior waterproofing appear to be in satisfactory condition.

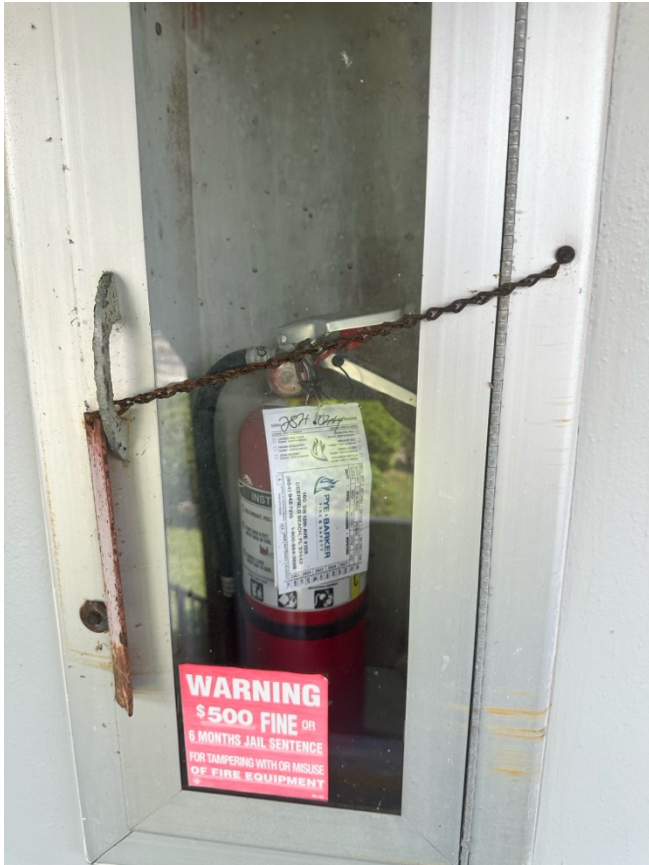
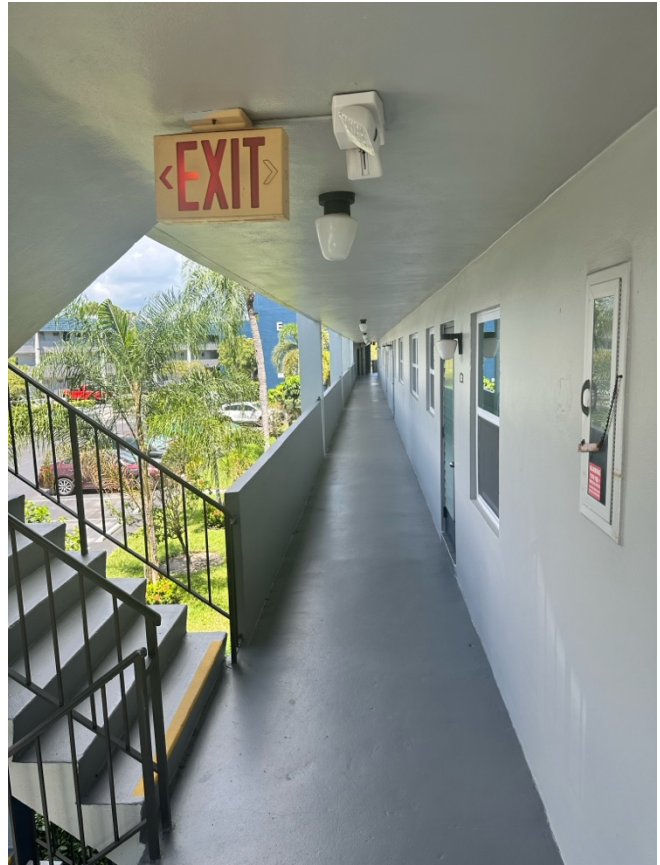
Condition: The fire protection systems appear to be in satisfactory condition.

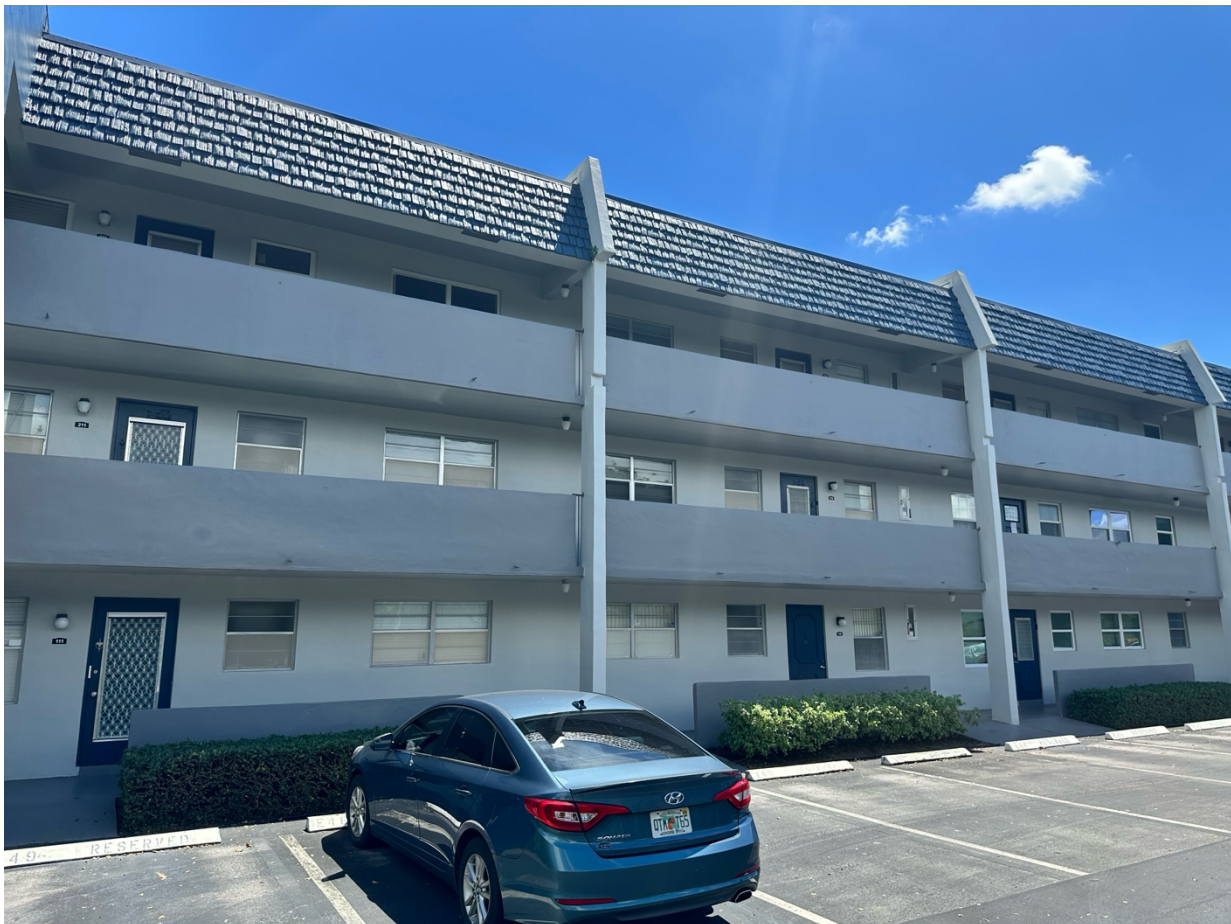
Condition: The railings appear to be in satisfactory condition.
