STRUCTURAL INTEGRITY RESERVE STUDY

***Oriole Golf & Tennis Club Condominium One
Bldg. F (7827)***

7827 Golf Circle Drive, Margate, FL 33063

Prepared on: October, 2023

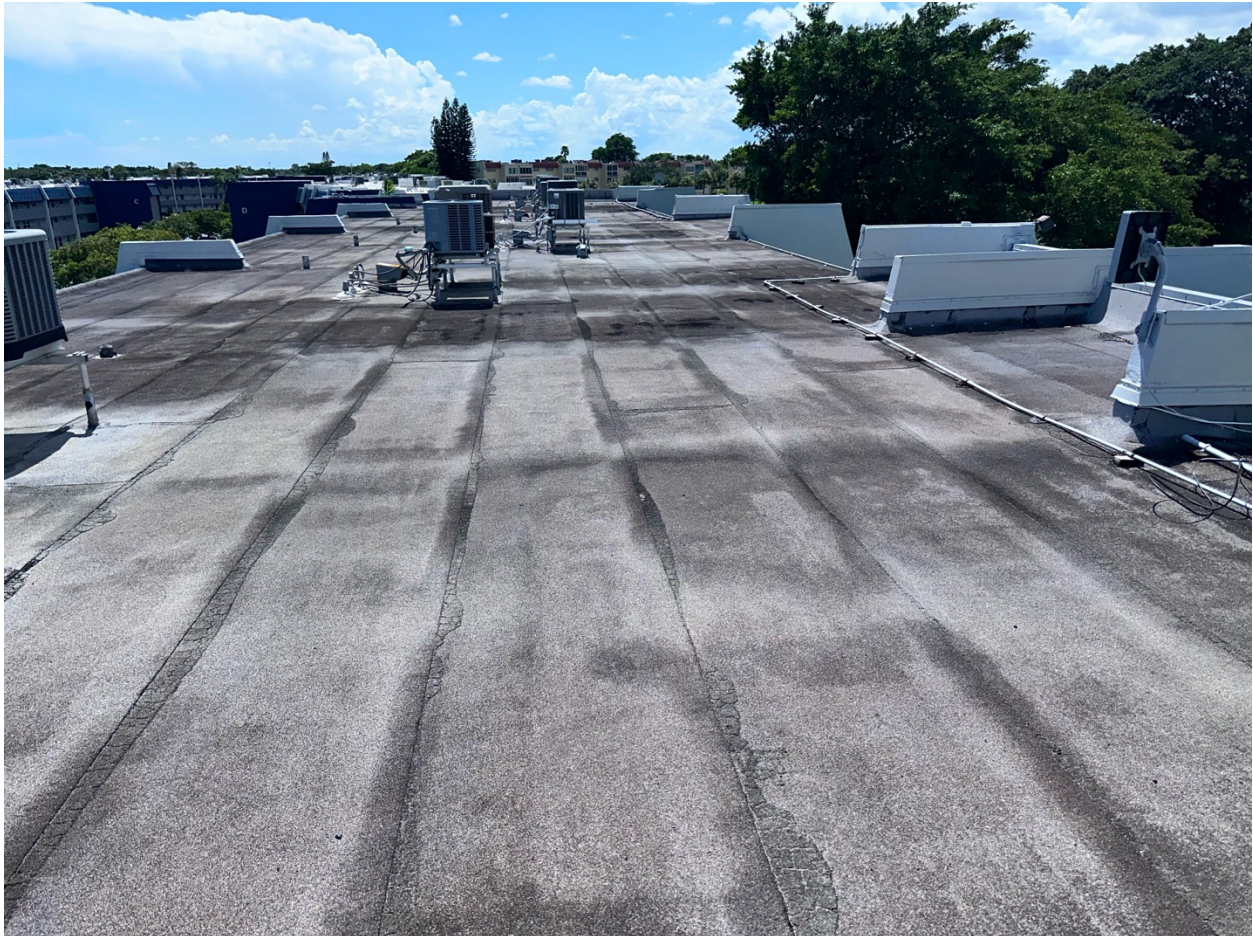
Condition: The roof surface appears to be in satisfactory condition with slight surface deterioration or granule loss.

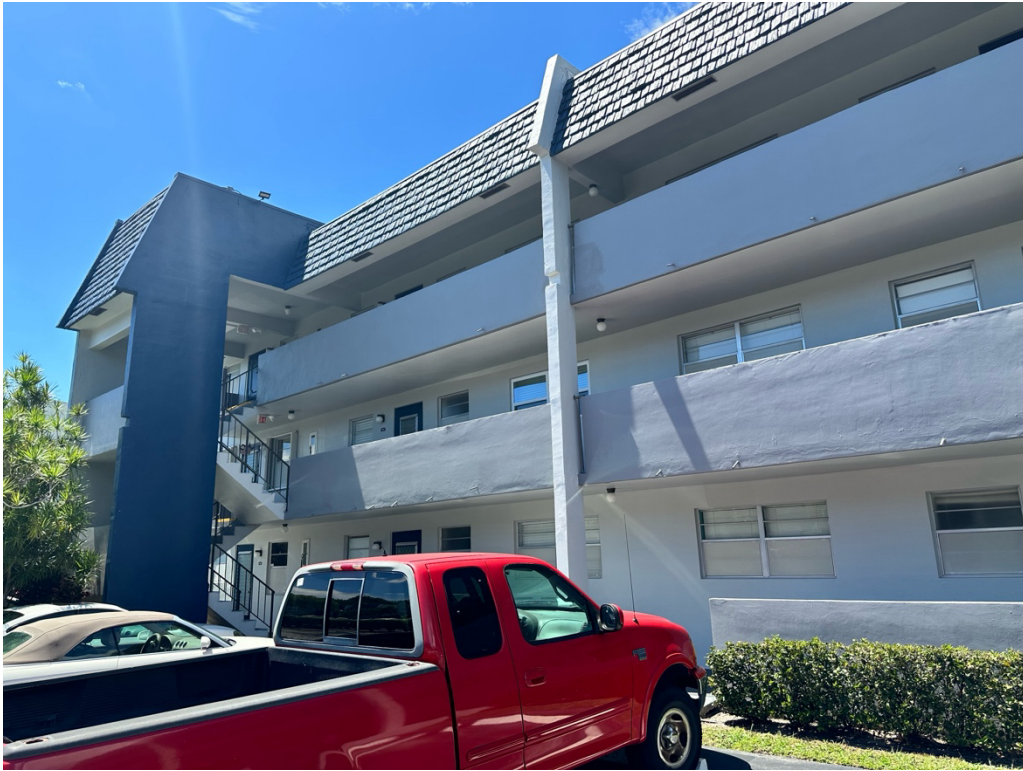
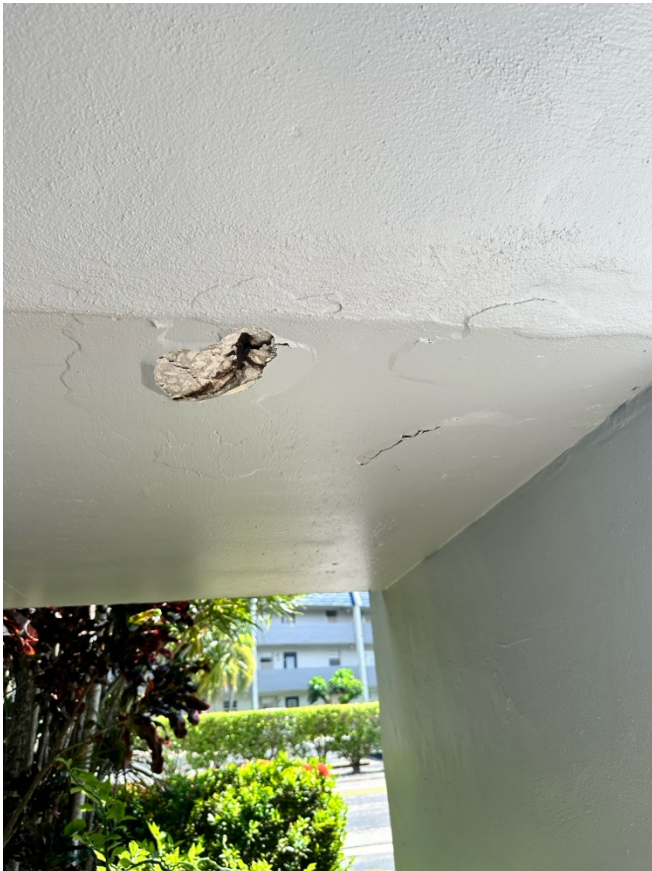
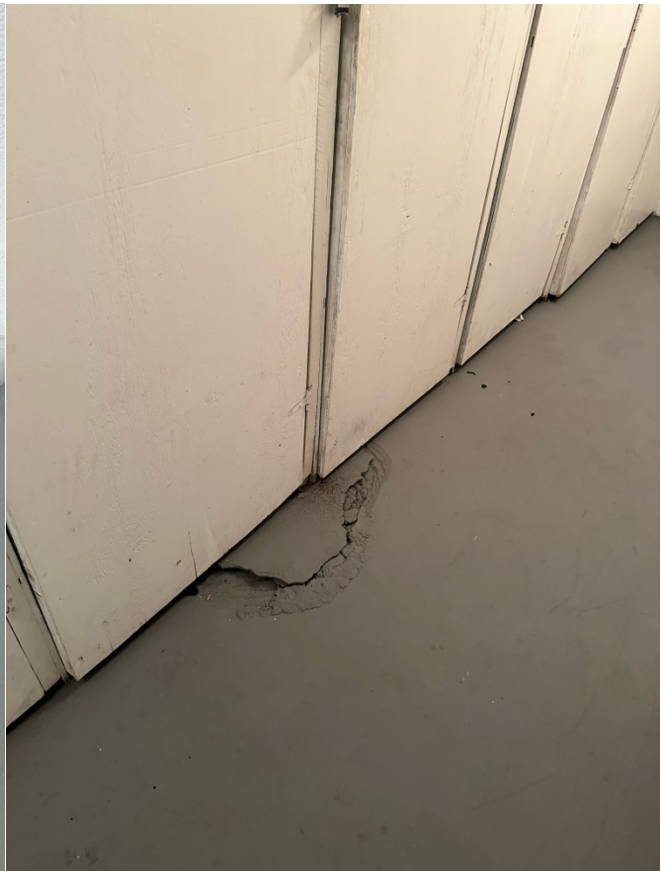
Condition: The general condition of the concrete load bearing structural systems, including visible the framing columns, tie-beams, and concrete floor systems appears to be in satisfactory condition have been found in satisfactory condition. However, concrete spalling and exposed rebar requiring concrete repairs have been noted in the exterior corridors/catwalks & storage rooms of the building.

Estimated Cost of Replacement: Concrete repairs are typically done on a unit-price basis and should be repaired as damages appear. Refer to the table presented at the end of this report for our recommendation based on our experience and the size of the building.

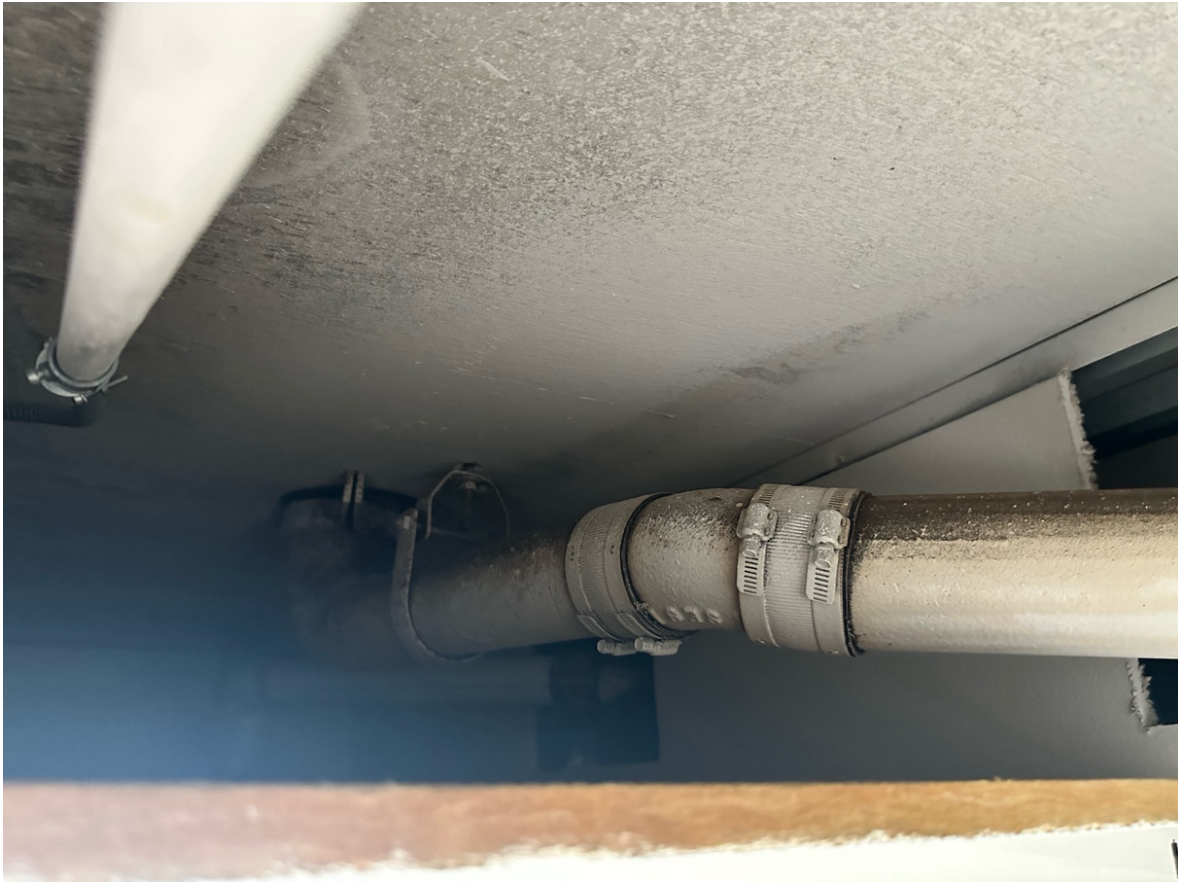
Condition: The plumbing system appears to be in satisfactory condition. It is important to note that it is rarely possible to visually inspect and examine all the concealed construction, nor should be generally necessary. Our conclusions are based upon our experience and deficiencies found in the visible and readily accessible areas.

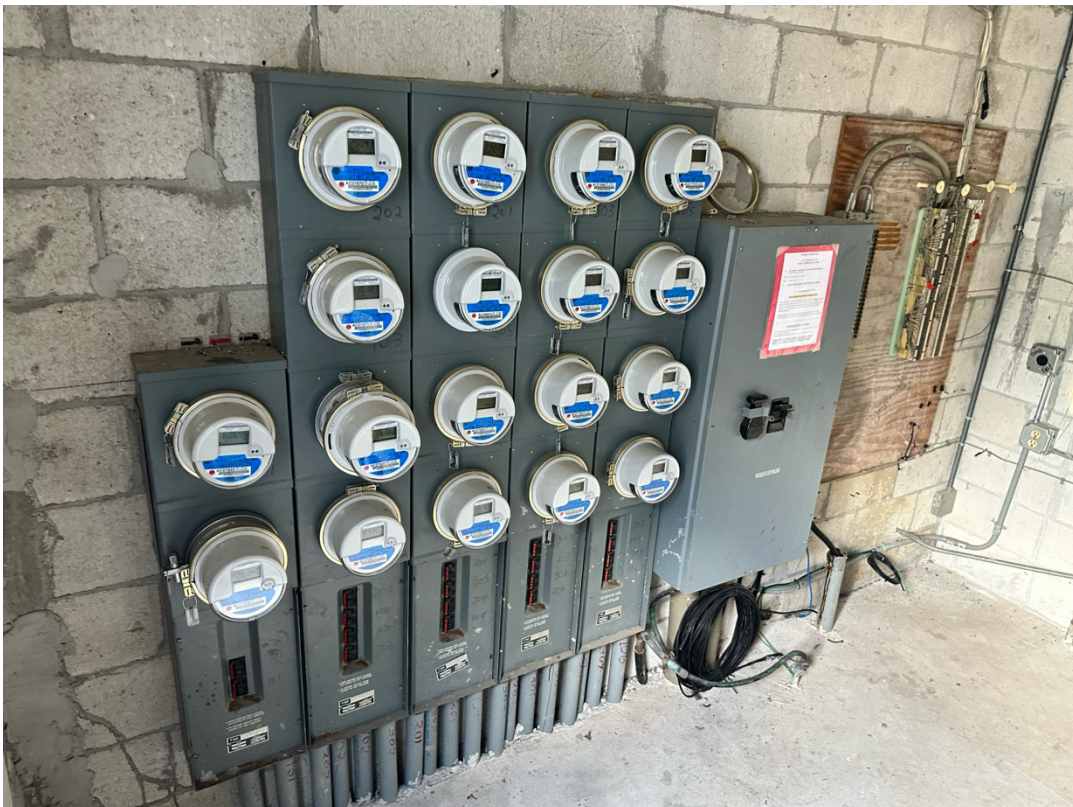
Condition: The electrical system(s) appears to be in satisfactory condition.

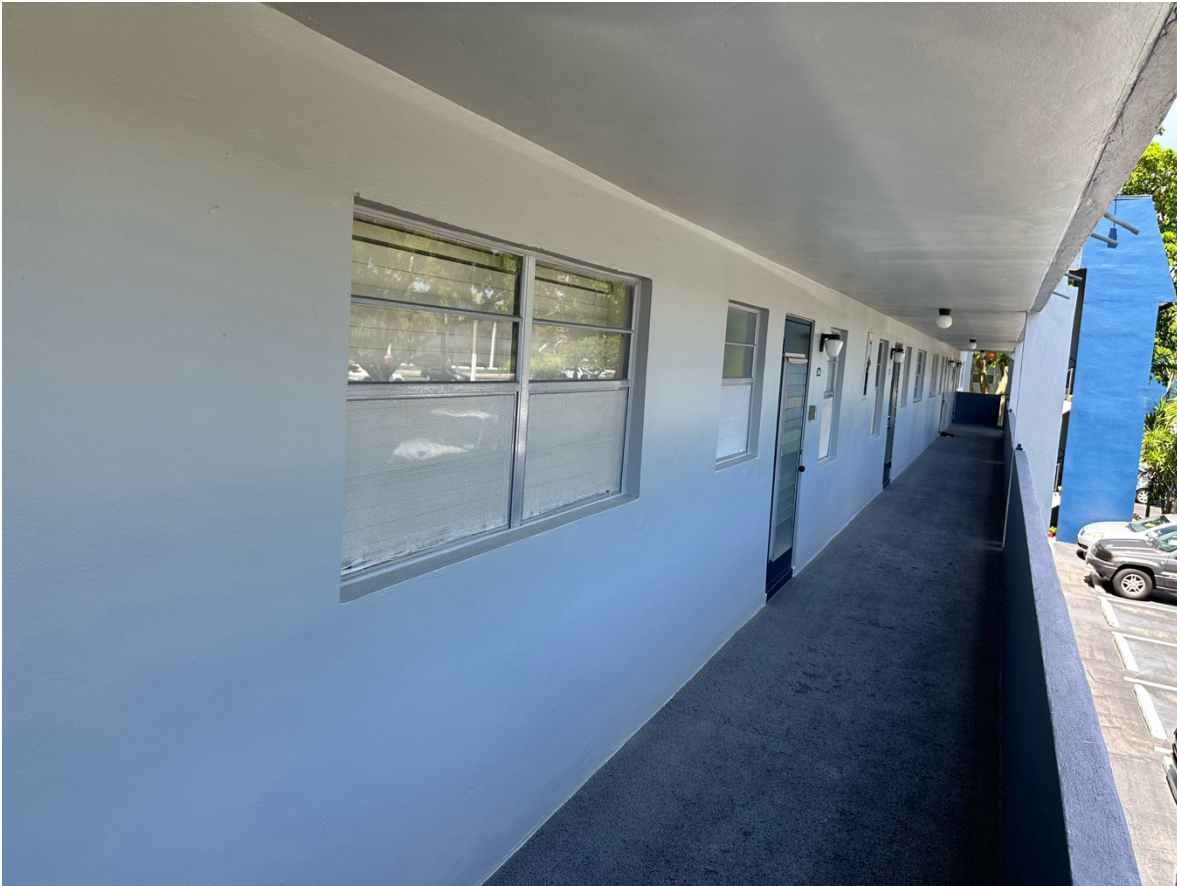
Condition: The exterior stucco surface appears to be in satisfactory condition. However, stucco delamination and conspicuous signs of concrete spalling have been noted in the exterior corridors/catwalks of the building.

Estimated Cost of Replacement: The removal and replacement of all the stucco finish is rarely required. It is typically repaired as required in the building for general maintenance. Therefore, we assume that 10% of all exterior surfaces are required to be replaced at once. See the table presented at the end of this report for our recommendation based on our experience and the size of the building. (The exact amount of area needing replacement will be discretionary based on the actual future conditions and the desired appearance).

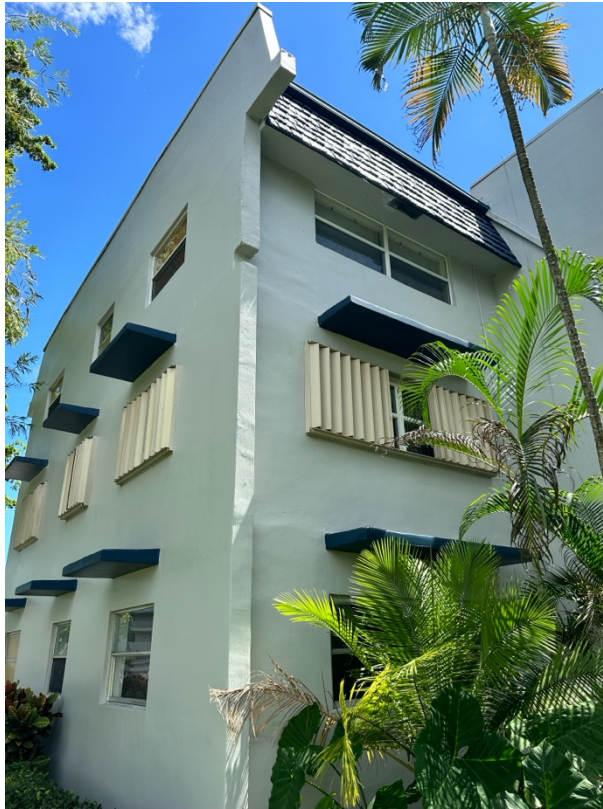
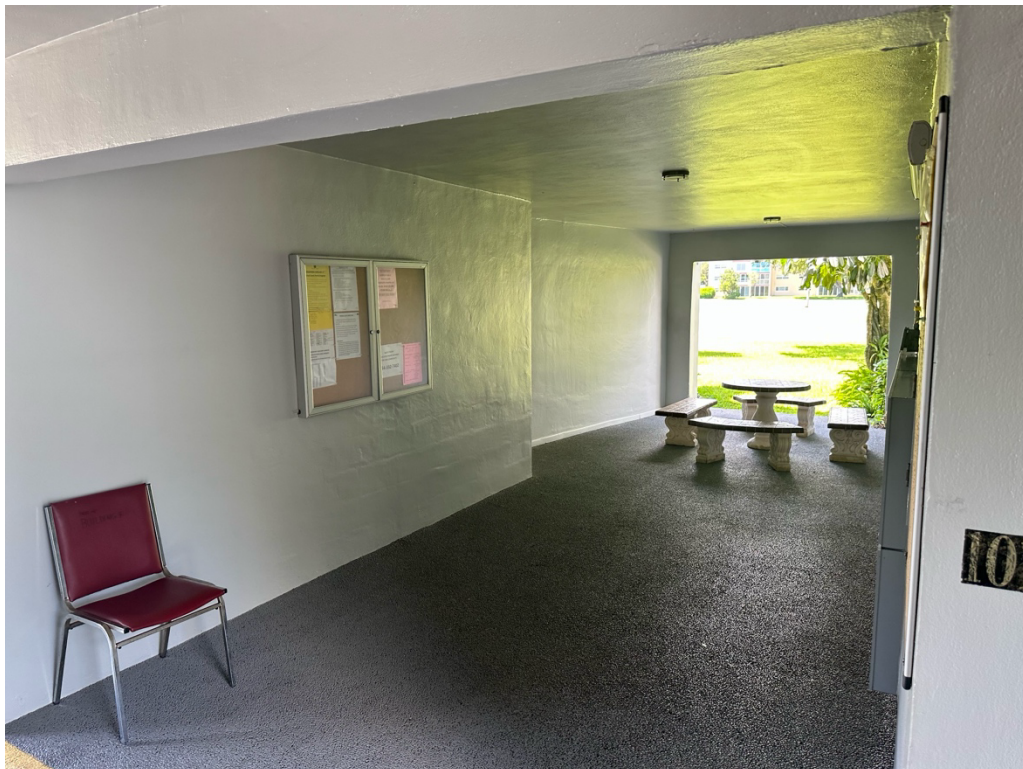
Condition: The exterior surface paint appear to be in satisfactory condition. The building has been recently painted. The exterior Chattahoochee appear to be in satisfactory condition. However, this type of floor finish promotes the accumulation of water, and it is widely known for hiding structural damage. Based on our experience, we highly recommend the exterior Chattahoochee floor finish to be removed and replaced with a sloped waterproofing system.

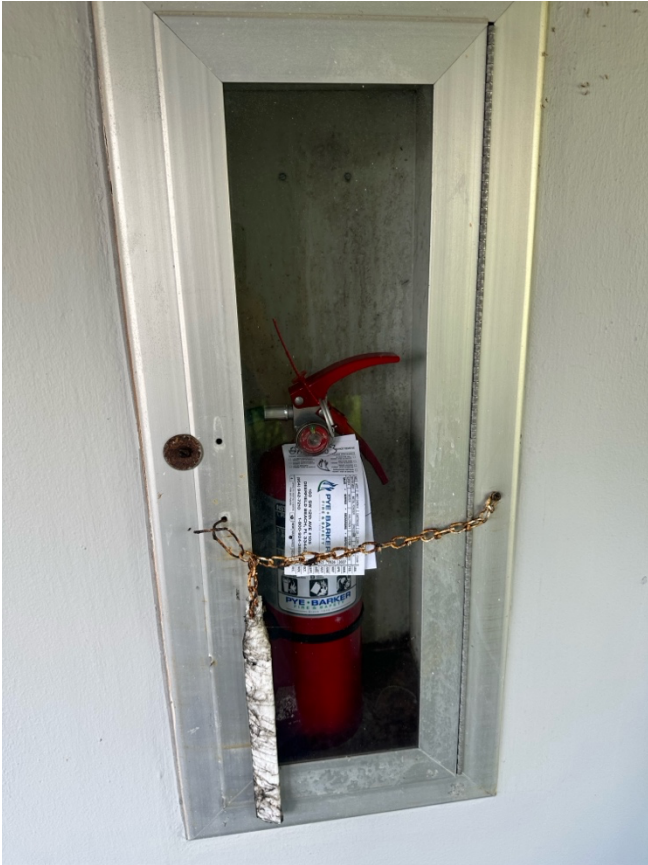
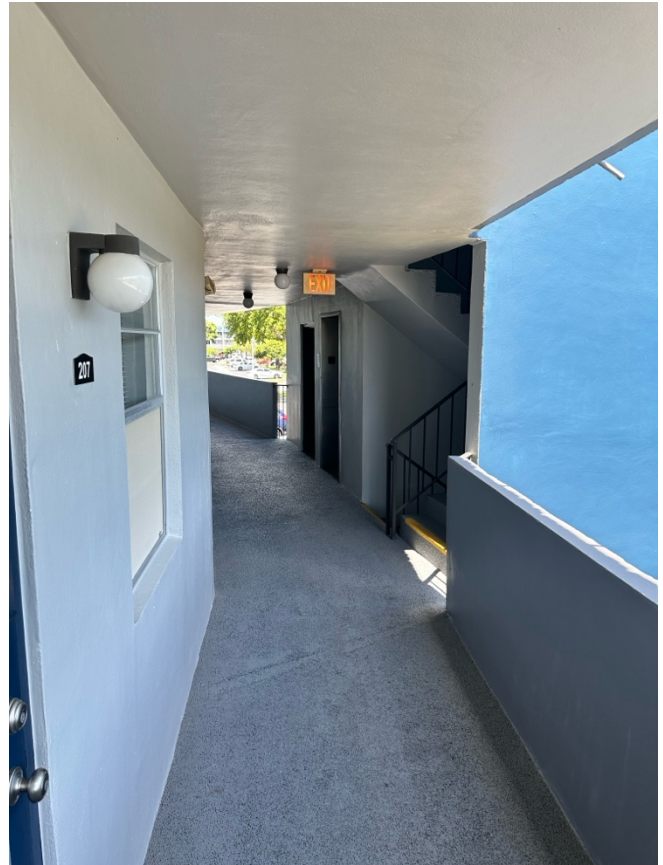
Condition: The fire protection systems appear to be in satisfactory condition.

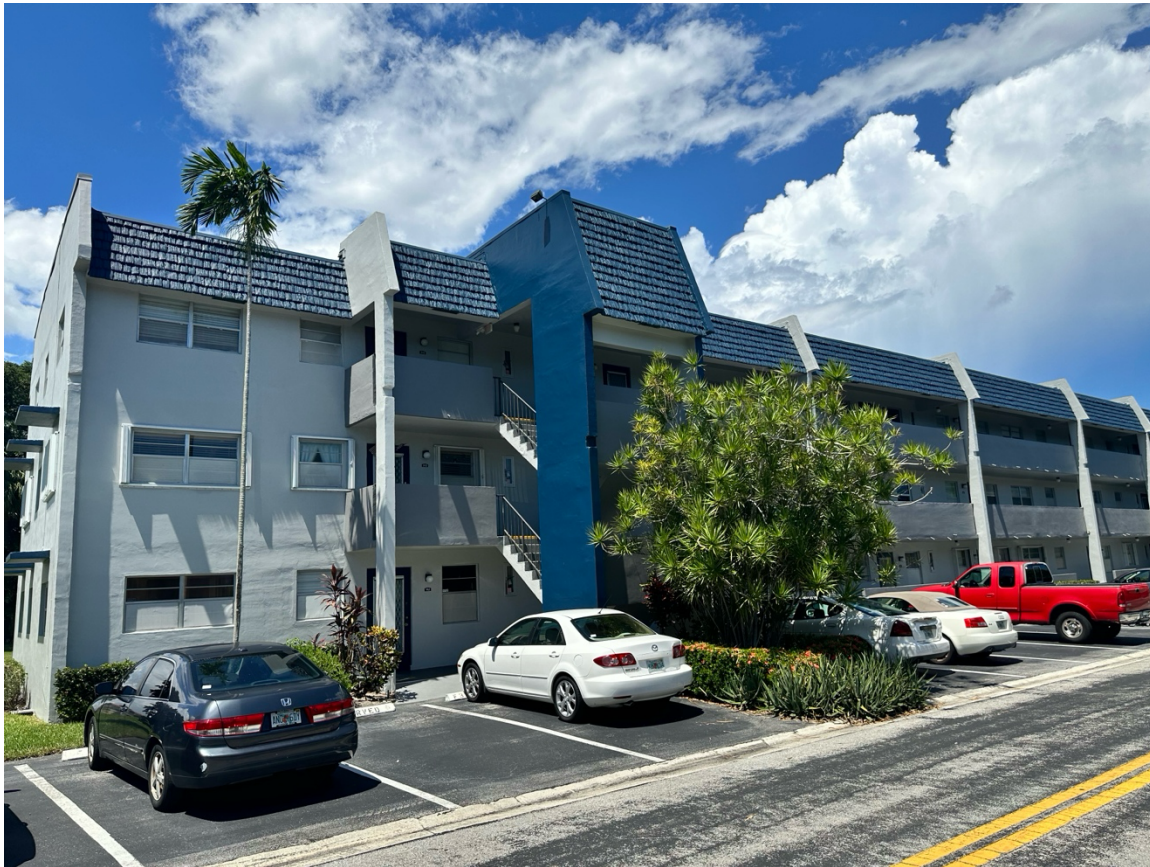
Condition: The railings appear to be in satisfactory condition.
