STRUCTURAL INTEGRITY RESERVE STUDY

***Oriole Golf & Tennis Club Condominium One
Bldg. G (7817)***

7817 Golf Circle Drive, Margate, FL 33063

Inspected on: September, 2023

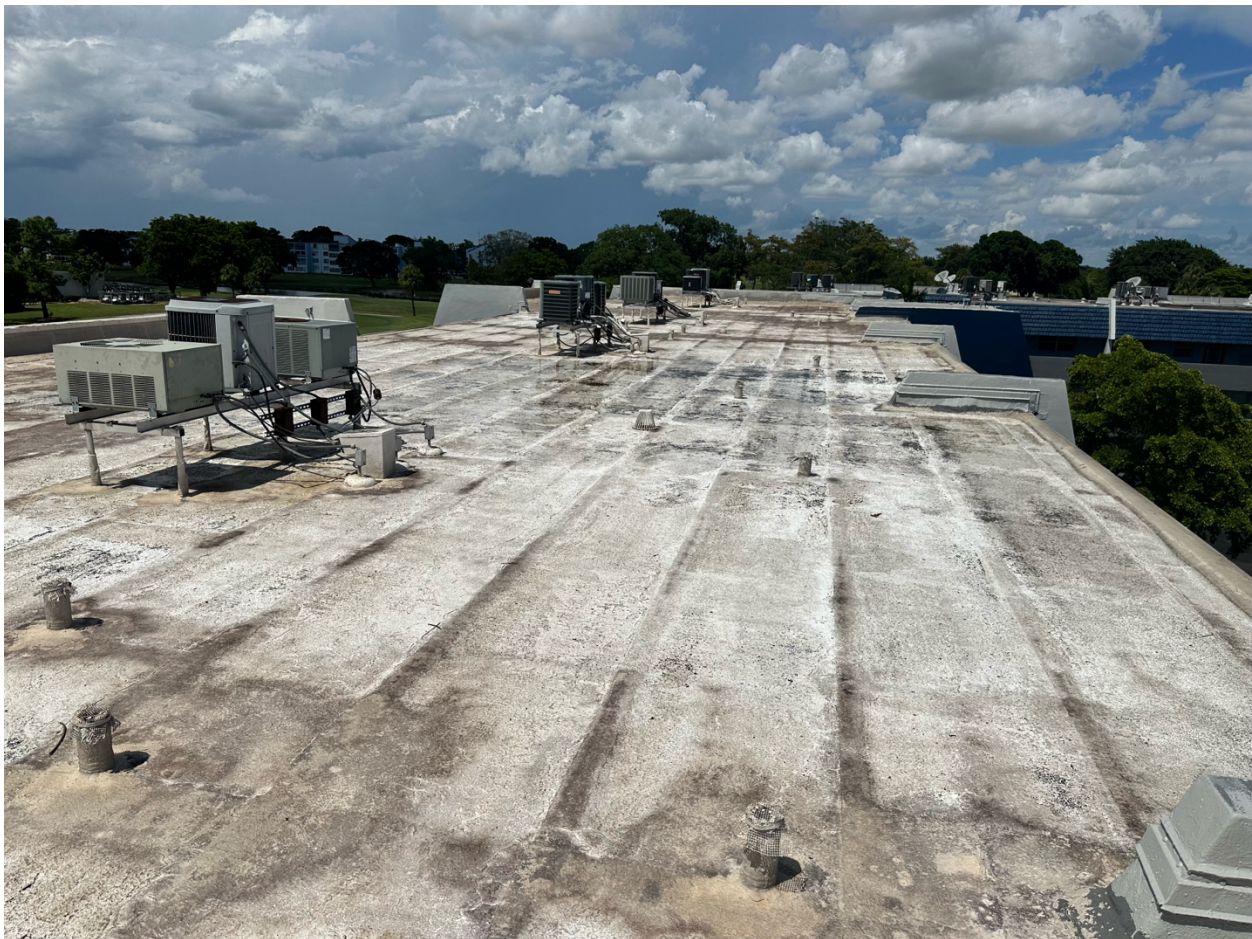
Condition: The roof surface appears to be in satisfactory condition with slight surface deterioration or granule loss. According to the information provided, all the roofs of the Oriole Golf & Tennis Club One have been provided with a silicone reflective coating within the last 5-years. The addition of the reflective coating can extend the useful life of the roof surface if proper maintenance is given.

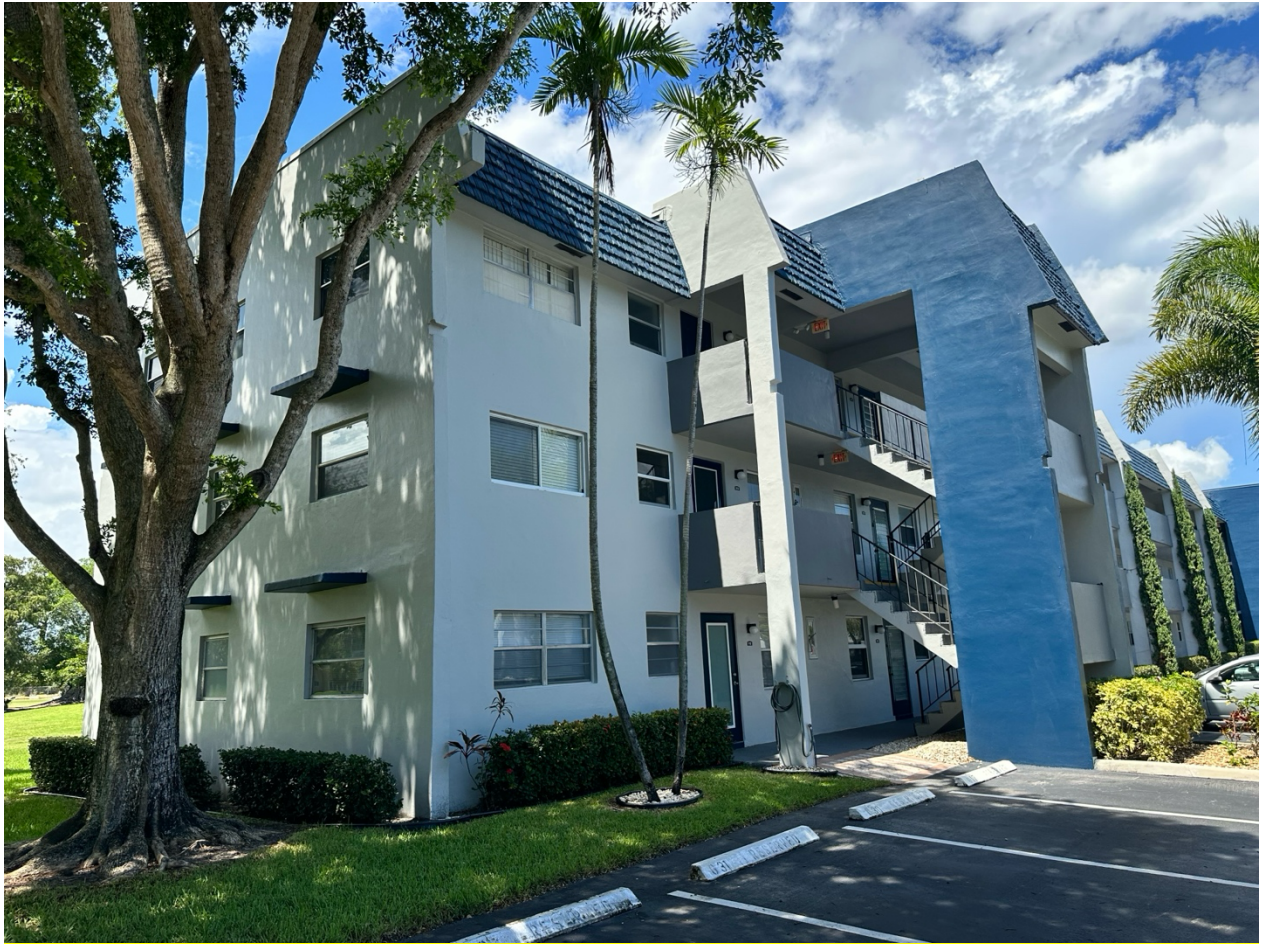
Condition: The general condition of the concrete load bearing structural systems, including visible the framing columns, tie-beams, and concrete floor systems appears to be in satisfactory condition have been found in satisfactory condition.

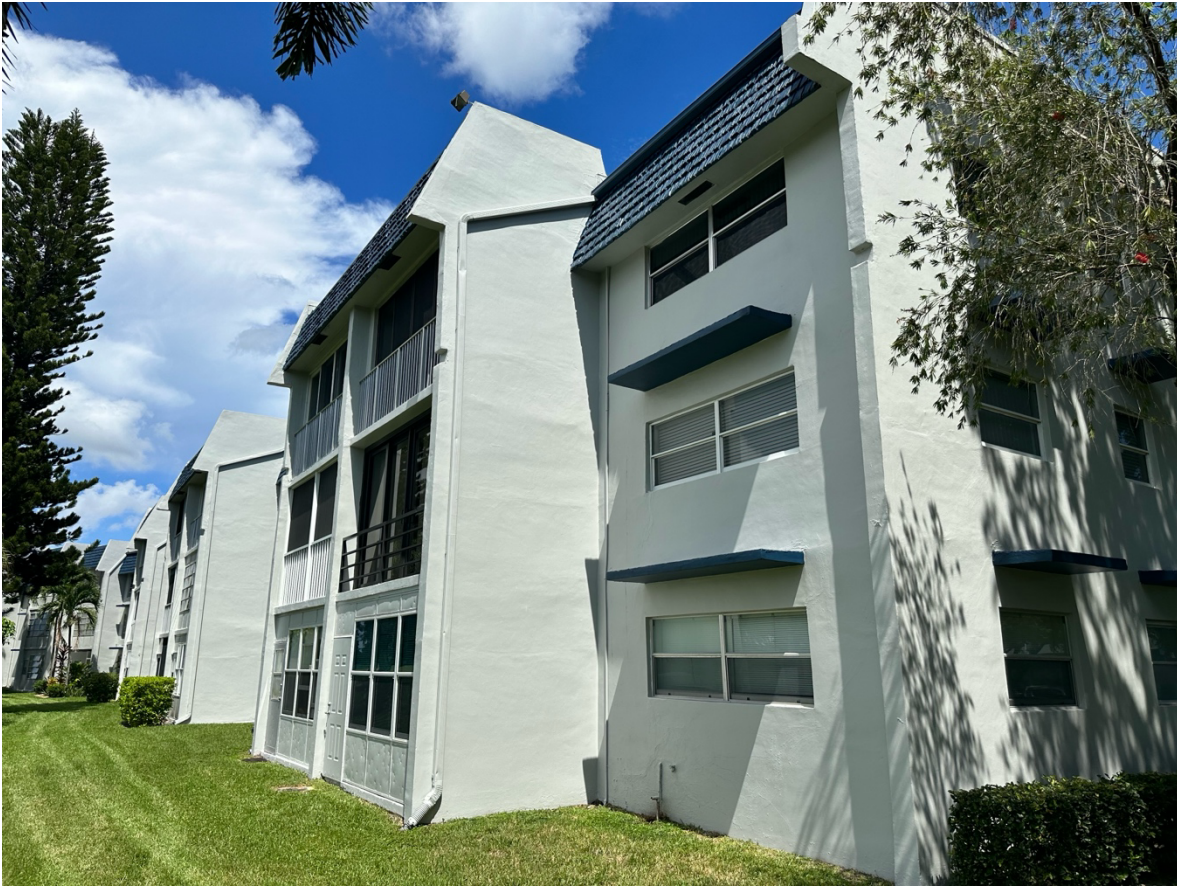
Condition: The exterior stucco surface appears to be in satisfactory condition. However, stucco delamination and conspicuous signs of concrete spalling have been noted in the exterior corridors/catwalks of the building.

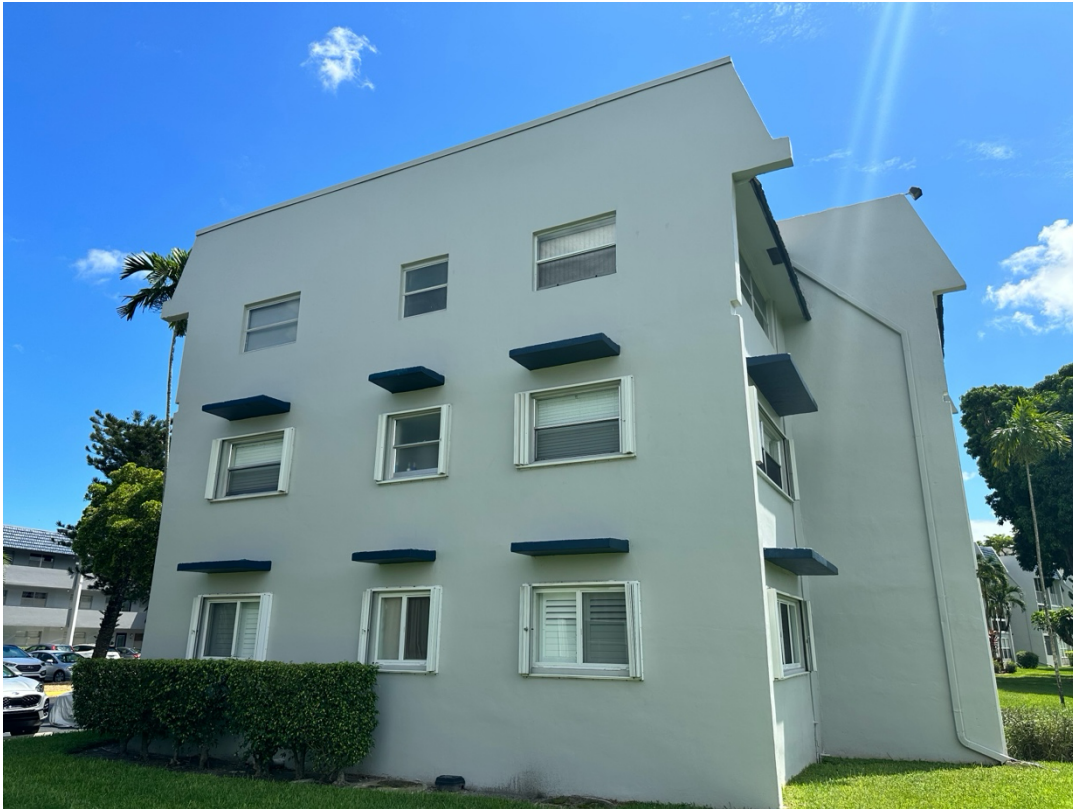
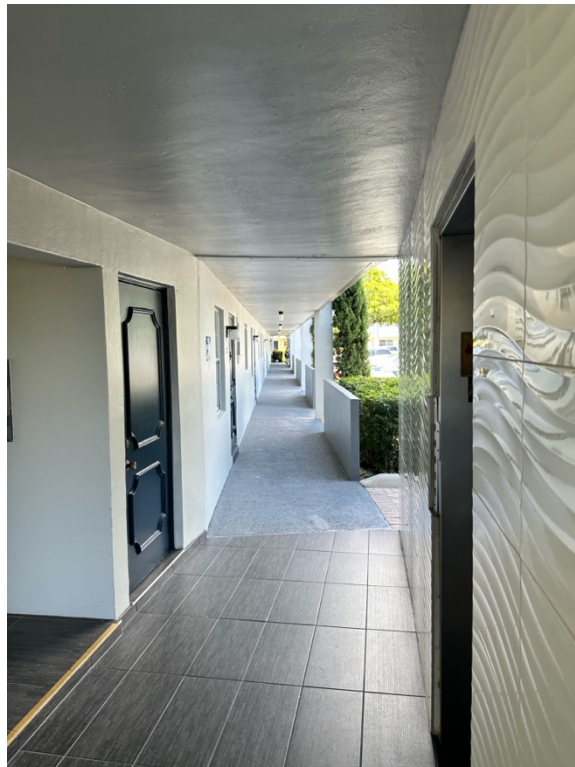
Condition: The exterior surface paint appear to be in satisfactory condition. The building has been recently painted. The exterior Chattahoochee appear to be in satisfactory condition. However, this type of floor finish promotes the accumulation of water, and it is widely known for hiding structural damage. Based on our experience, we highly recommend the exterior Chattahoochee floor finish to be removed and replaced with a sloped waterproofing system.

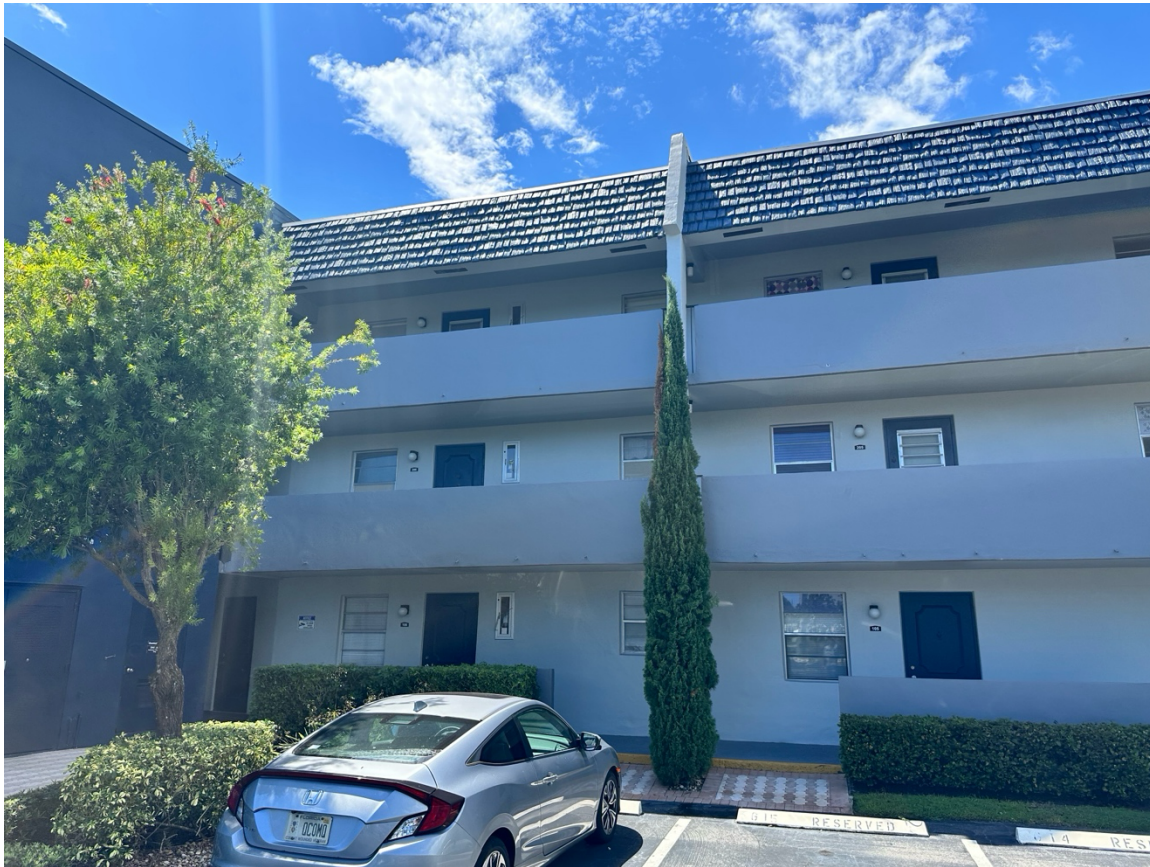
Condition: The railings appear to be in satisfactory condition.
