**STRUCTURAL INTEGRITY RESERVE STUDY**

***Oriole Golf & Tennis Club Condominium One  
Bldg. H (7807)***

*7807 Golf Circle Drive, Margate, FL 33063*

*Inspected on: September, 2023*

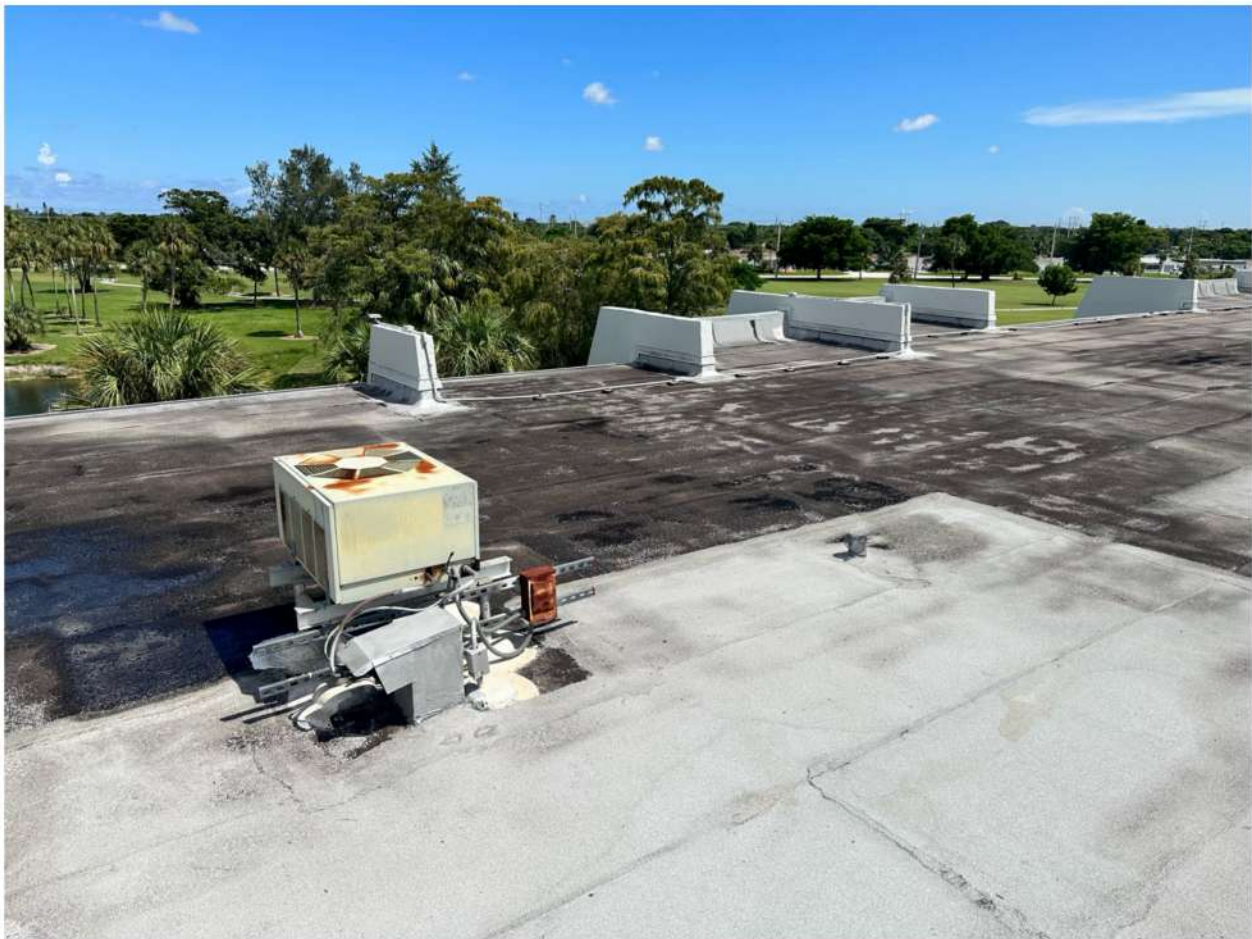
**Condition:** The roof surface appears to be in satisfactory condition with slight surface deterioration or granule loss.

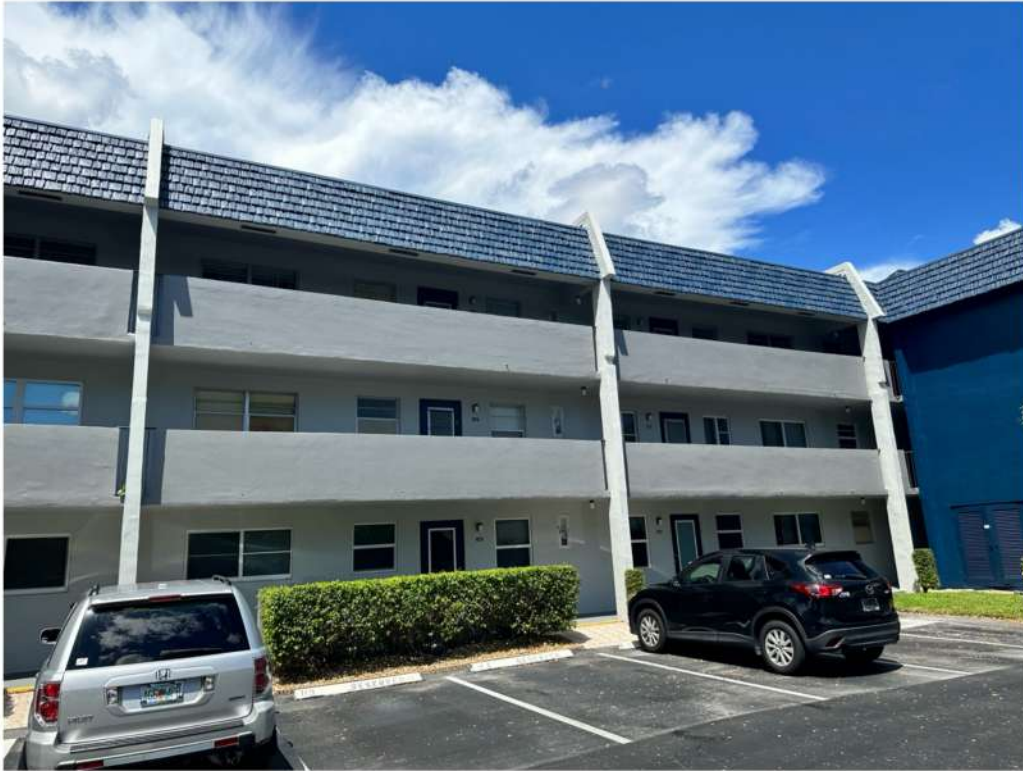
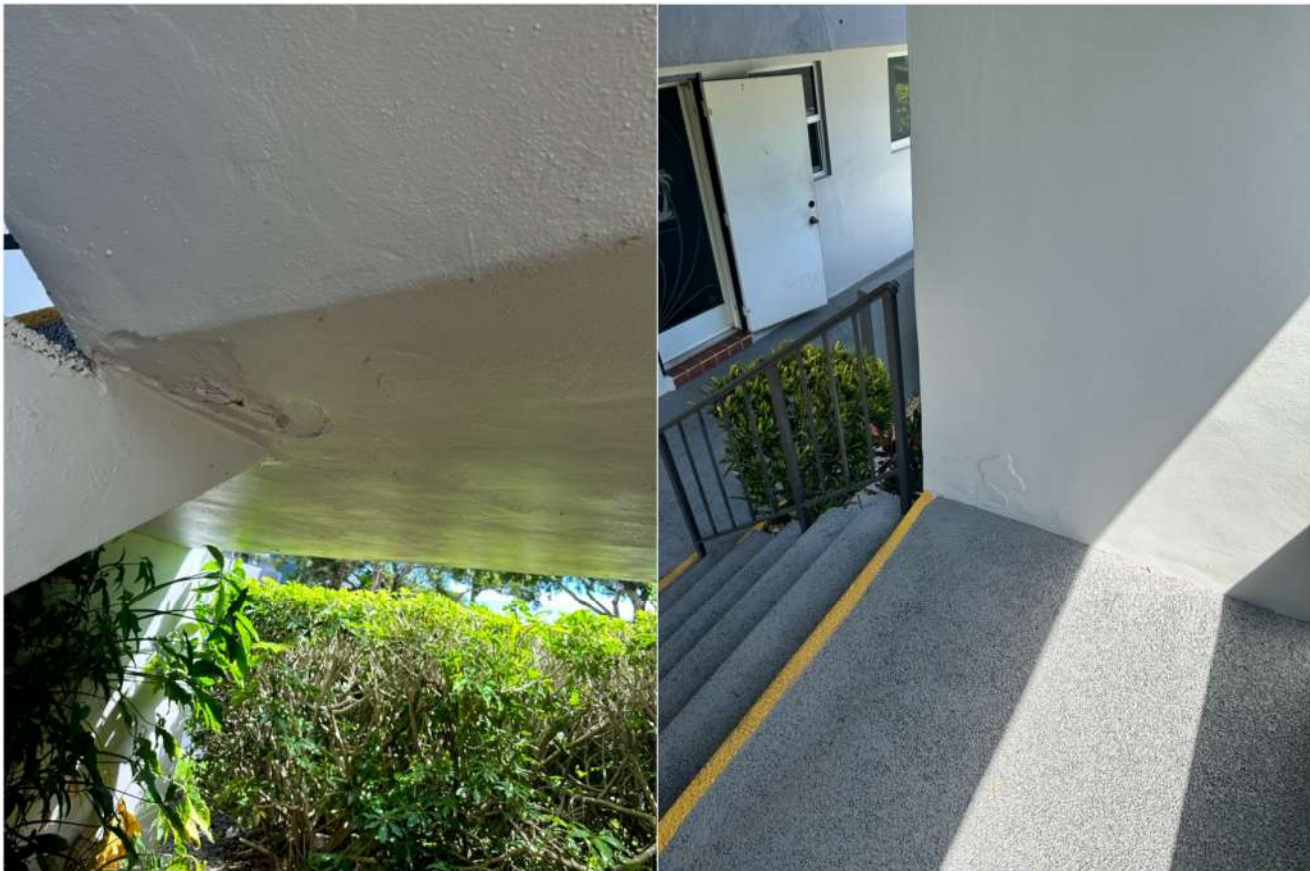
**Condition:** The general condition of the concrete load bearing structural systems, including visible the framing columns, tie-beams, and concrete floor systems appears to be in satisfactory condition have been found in satisfactory condition. However, concrete spalling and exposed rebar requiring concrete repairs have been noted in the exterior corridors/catwalks & storage rooms of the building.

**Estimated Cost of Replacement:** Concrete repairs are typically done on a unit-price basis and should be repaired as damages appear. Refer to the table presented at the end of this report for our recommendation based on our experience and the size of the building.

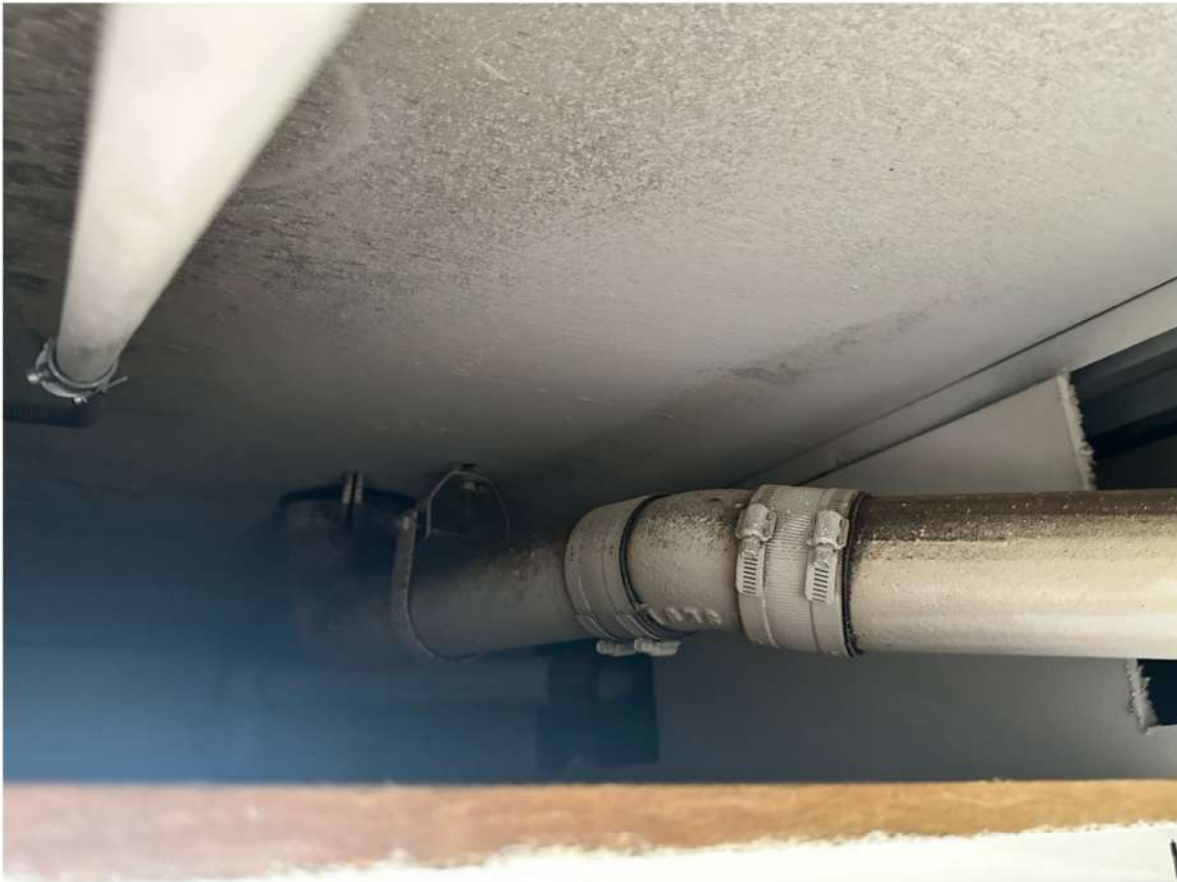
**Condition:** The plumbing system appears to be in satisfactory condition. It is important to note that it is rarely possible to visually inspect and examine all the concealed construction, nor should be generally necessary. Our conclusions are based upon our experience and deficiencies found in the visible and readily accessible areas.

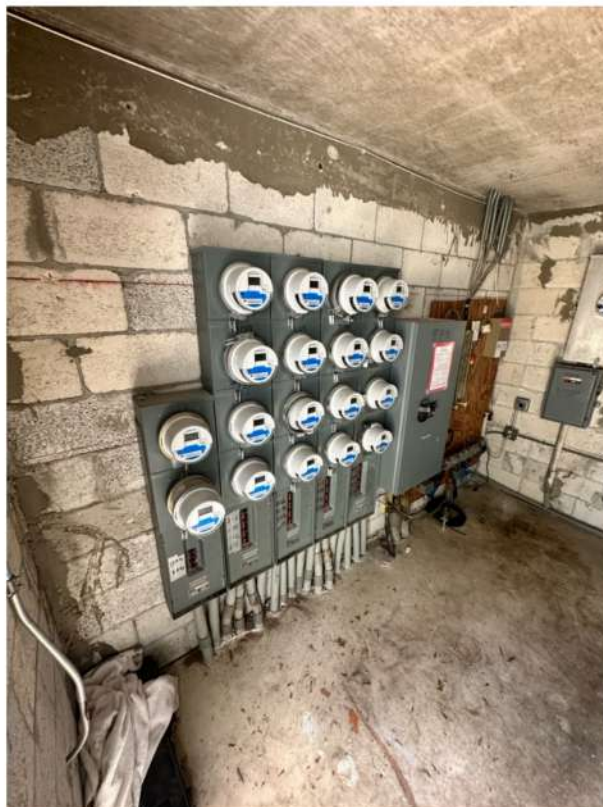
**Condition:** The electrical system(s) appears to be in satisfactory condition.

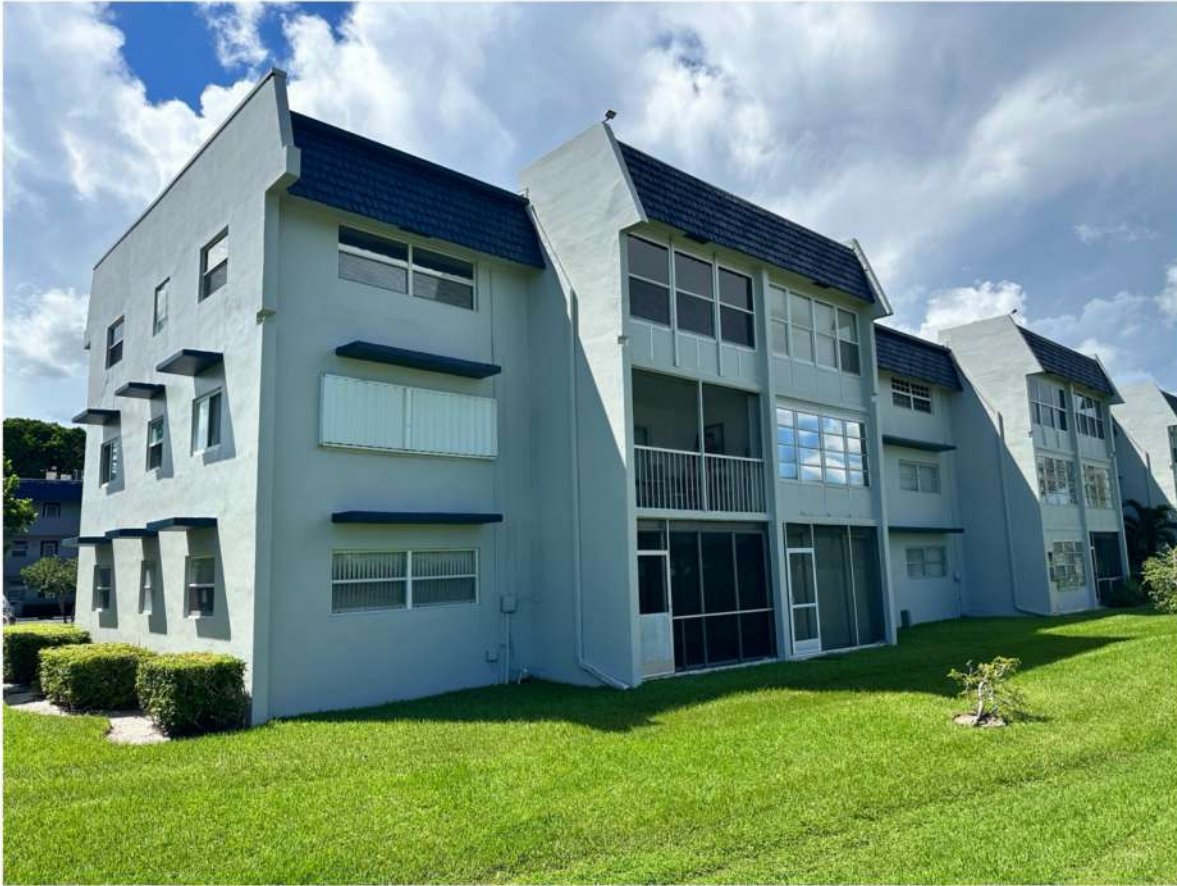
**Condition:** The exterior stucco surface appears to be in satisfactory condition. However, stucco delamination and conspicuous signs of concrete spalling have been noted in the exterior corridors/catwalks of the building.

**Estimated Cost of Replacement:** The removal and replacement of all the stucco finish is rarely required. It is typically repaired as required in the building for general maintenance. Therefore, we assume that 10% of all exterior surfaces are required to be replaced at once. See the table presented at the end of this report for our recommendation based on our experience and the size of the building. (The exact amount of area needing replacement will be discretionary based on the actual future conditions and the desired appearance).

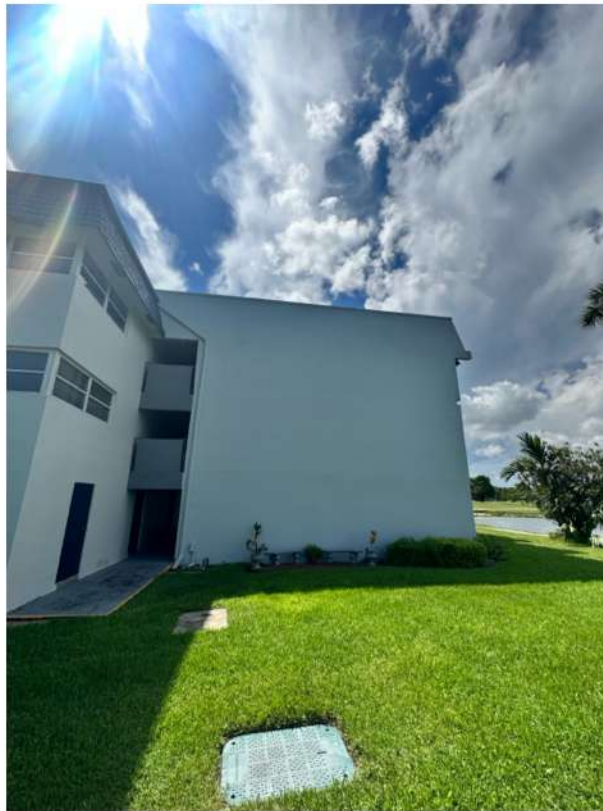
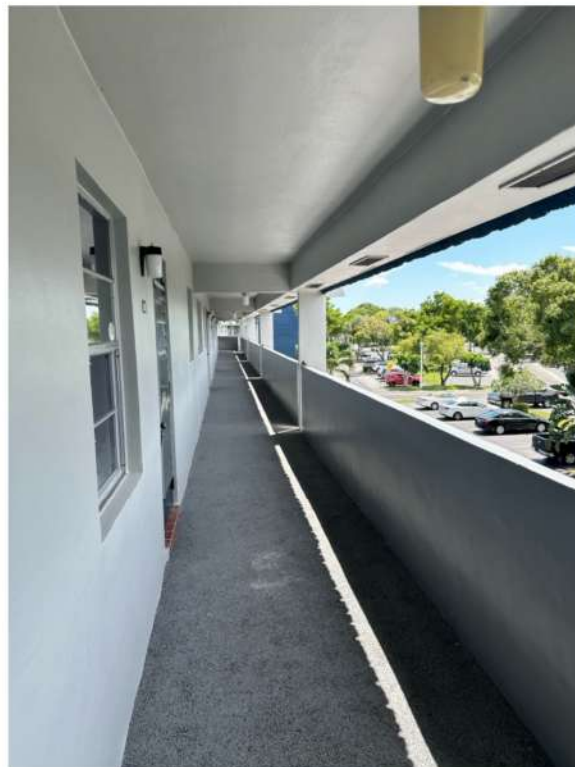
**Condition:** The exterior surface paint appear to be in satisfactory condition. The building has been recently painted. The exterior Chattahoochee appear to be in satisfactory condition. However, this type of floor finish promotes the accumulation of water, and it is widely known for hiding structural damage. Based on our experience, we highly recommend the exterior Chattahoochee floor finish to be removed and replaced with a sloped waterproofing system.

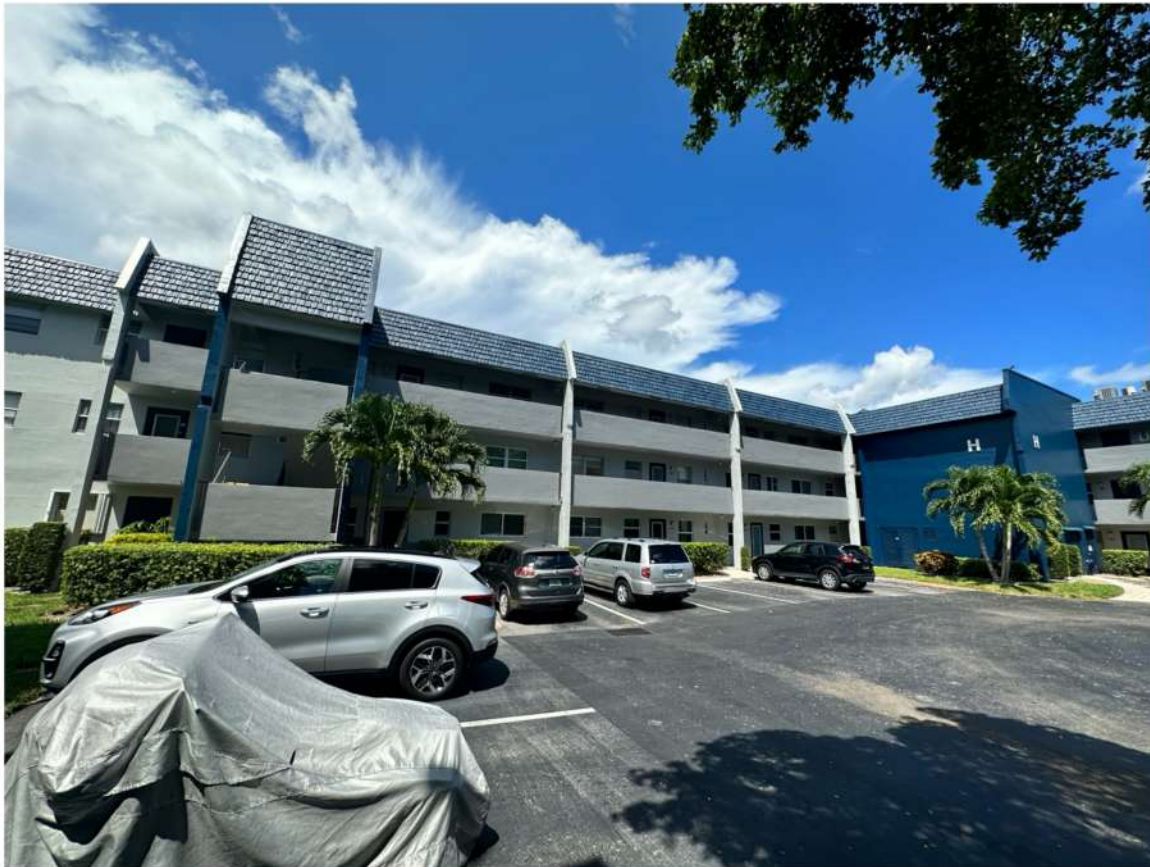
**Condition:** The railings appear to be in satisfactory condition.
