**STRUCTURAL INTEGRITY RESERVE STUDY**

***Oriole Golf & Tennis Club Condominium One  
Bldg. J (7797)***

*7797 Golf Circle Drive, Margate, FL 33063*

*Prepared on: October, 2023*

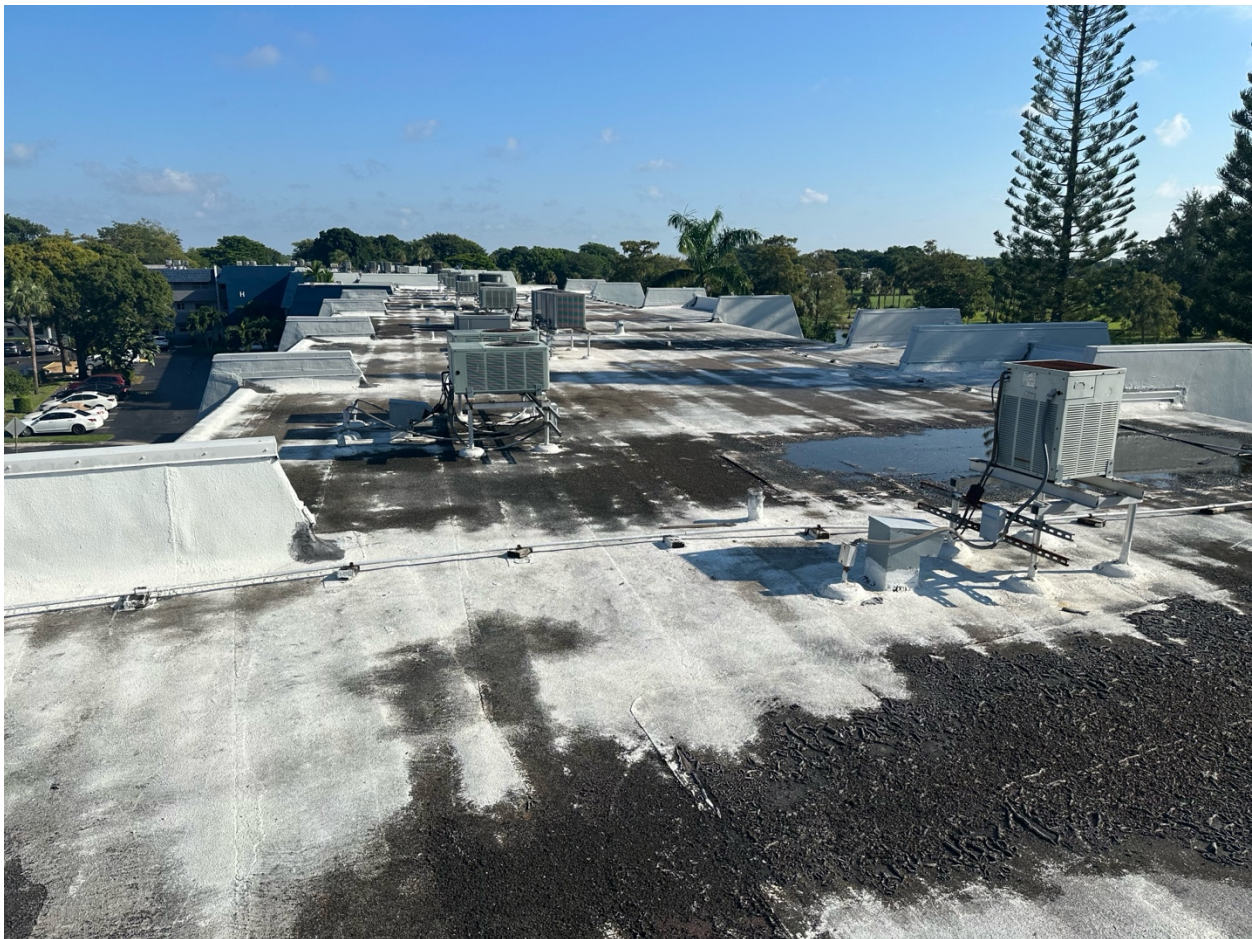
**Condition:** The roof surface appears to be in satisfactory condition with slight surface deterioration or granule loss. According to the information provided, all the roofs of the Oriole Golf & Tennis Club One have been provided with a silicone reflective coating within the last 5-years. The addition of the reflective coating can extend the useful life of the roof surface if proper maintenance is given.

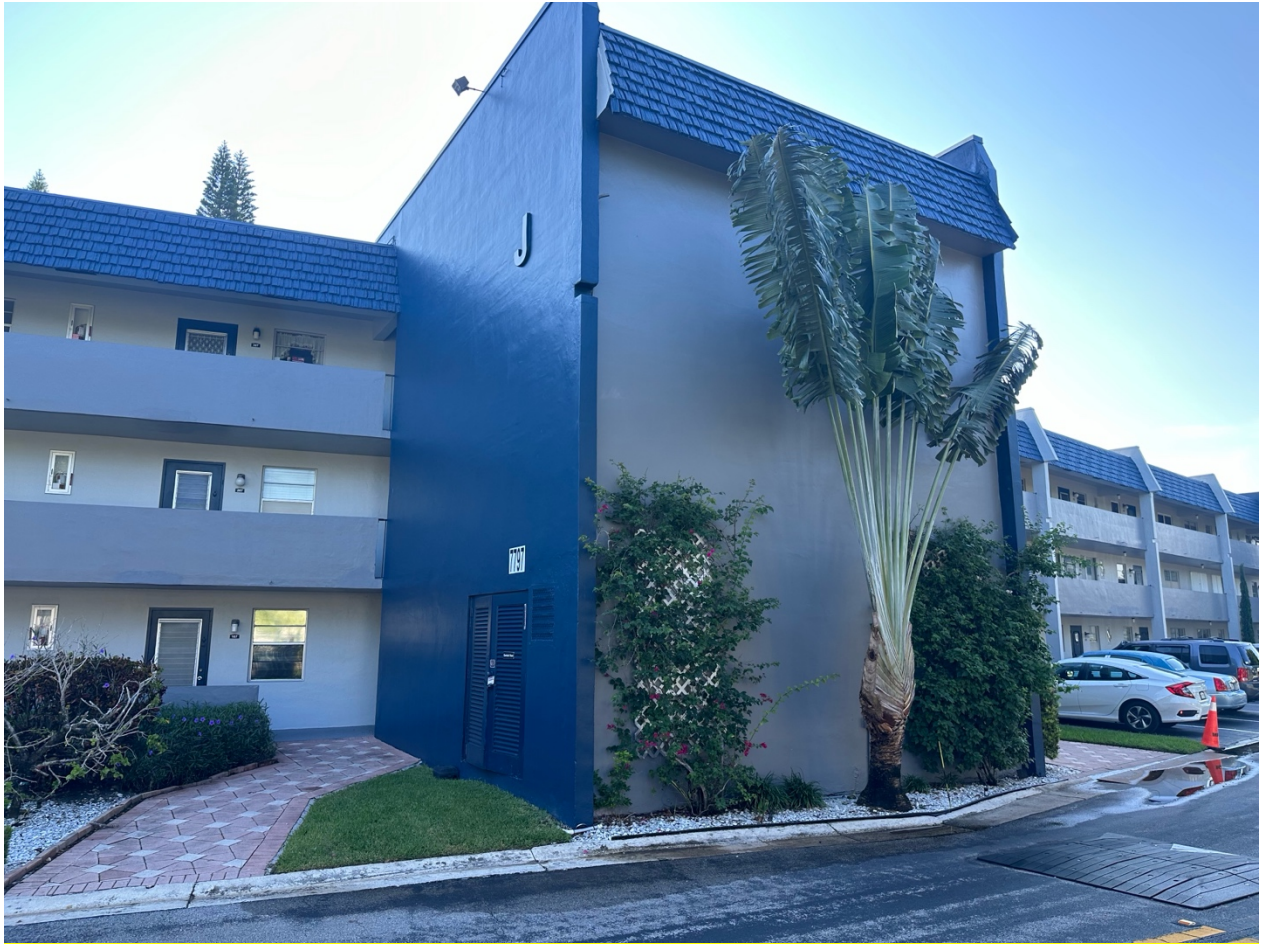
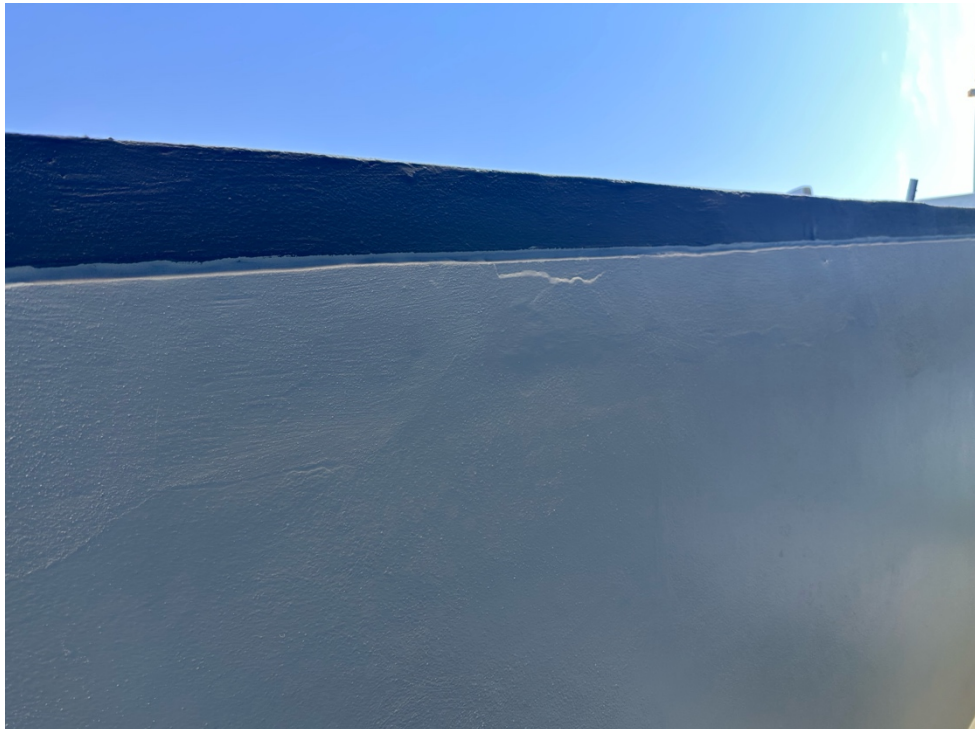
**Condition:** The general condition of the concrete load bearing structural systems, including visible the framing columns, tie-beams, and concrete floor systems appears to be in satisfactory condition have been found in satisfactory condition. However, conspicuous signs of concrete spalling requiring concrete repairs have been noted in the exterior corridors/catwalks of the building.

**Estimated Cost of Replacement:** Concrete repairs are typically done on a unit-price basis and should be repaired as damages appear. Refer to the table presented at the end of this report for our recommendation based on our experience and the size of the building.

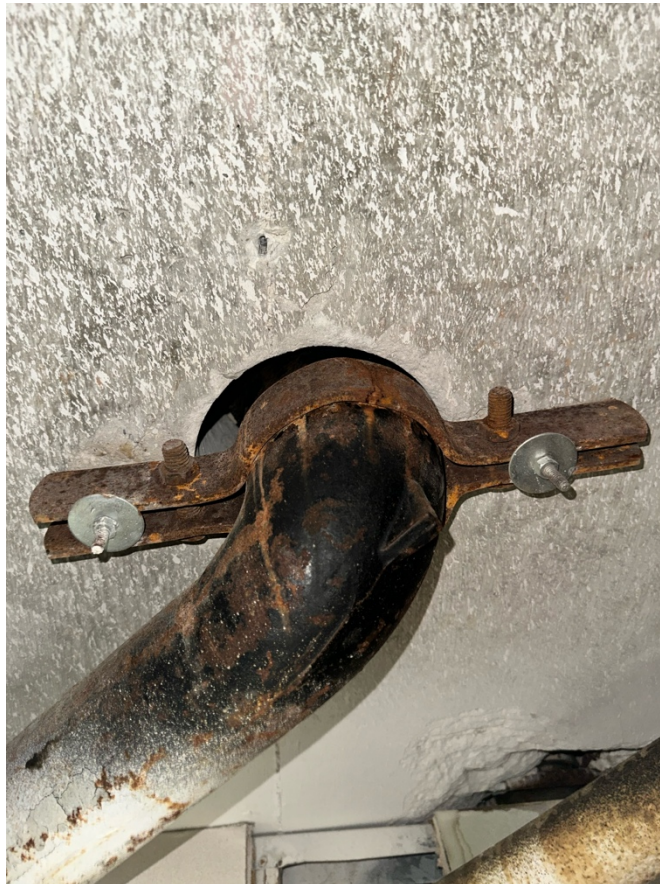
**Condition:** The plumbing system appears to be in satisfactory condition. It is important to note that it is rarely possible to visually inspect and examine all the concealed construction, nor should be generally necessary. Our conclusions are based upon our experience and deficiencies found in the visible and readily accessible areas.

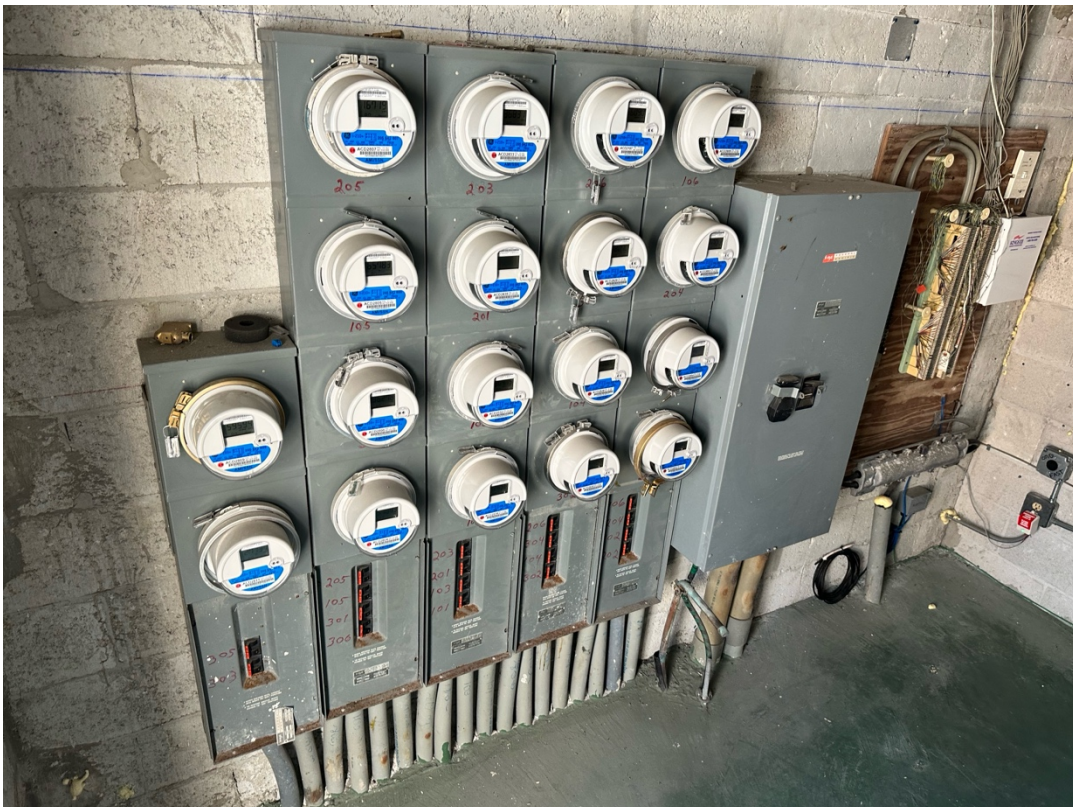
**Condition:** The electrical system(s) appears to be in satisfactory condition.

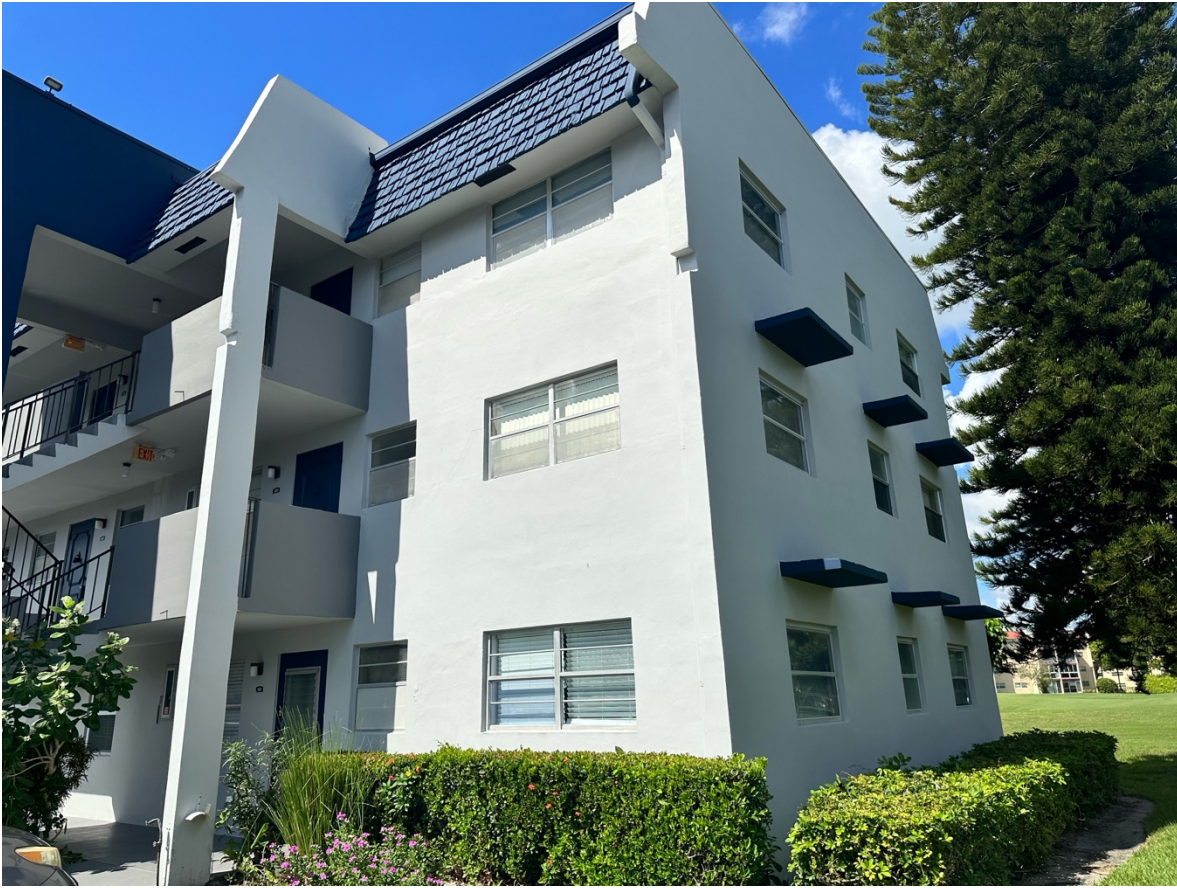
**Condition:** The exterior stucco surface appears to be in satisfactory condition. However, stucco delamination and conspicuous signs of concrete spalling have been noted in the exterior corridors/catwalks of the building.

**Estimated Cost of Replacement:** The removal and replacement of all the stucco finish is rarely required. It is typically repaired as required in the building for general maintenance. Therefore, we assume that 10% of all exterior surfaces are required to be replaced at once. See the table presented at the end of this report for our recommendation based on our experience and the size of the building. (The exact amount of area needing replacement will be discretionary based on the actual future conditions and the desired appearance).

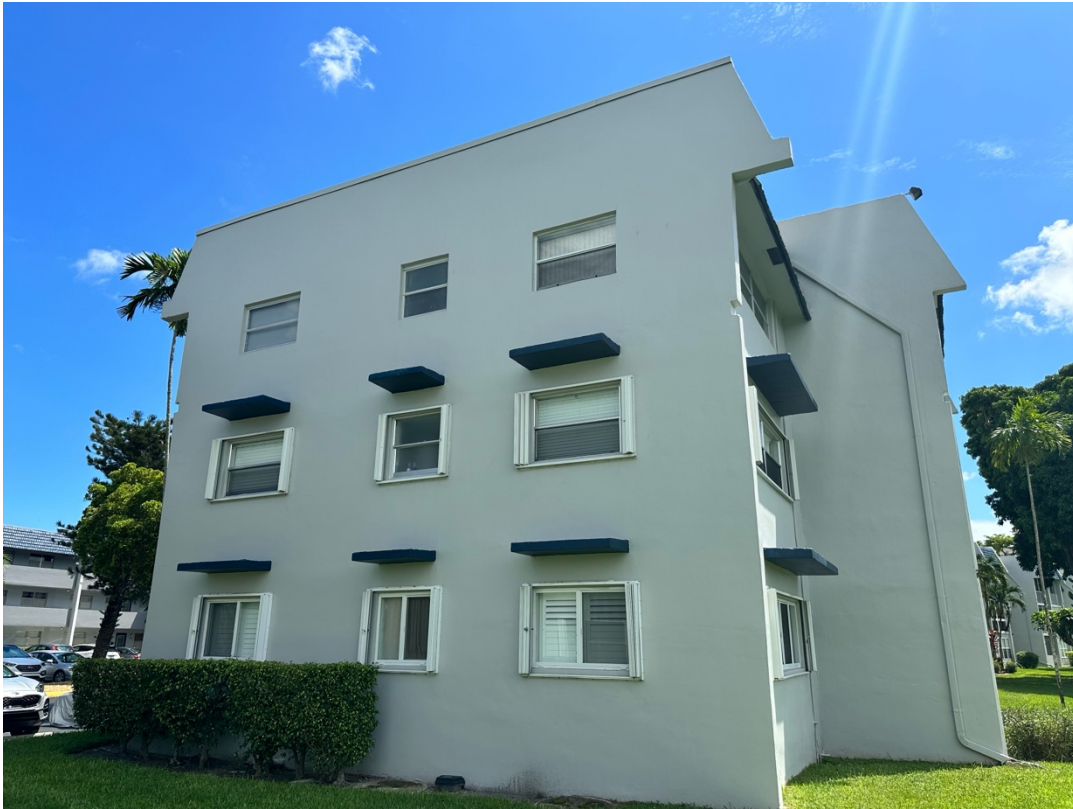
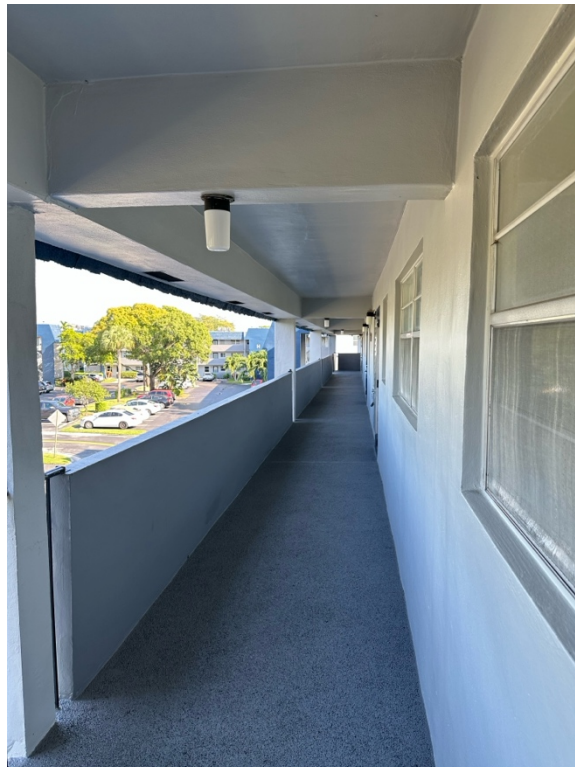
**Condition:** The exterior surface paint appear to be in satisfactory condition. The building has been recently painted. The exterior Chattahoochee appear to be in satisfactory condition. However, this type of floor finish promotes the accumulation of water, and it is widely known for hiding structural damage. Based on our experience, we highly recommend the exterior Chattahoochee floor finish to be removed and replaced with a sloped waterproofing system.

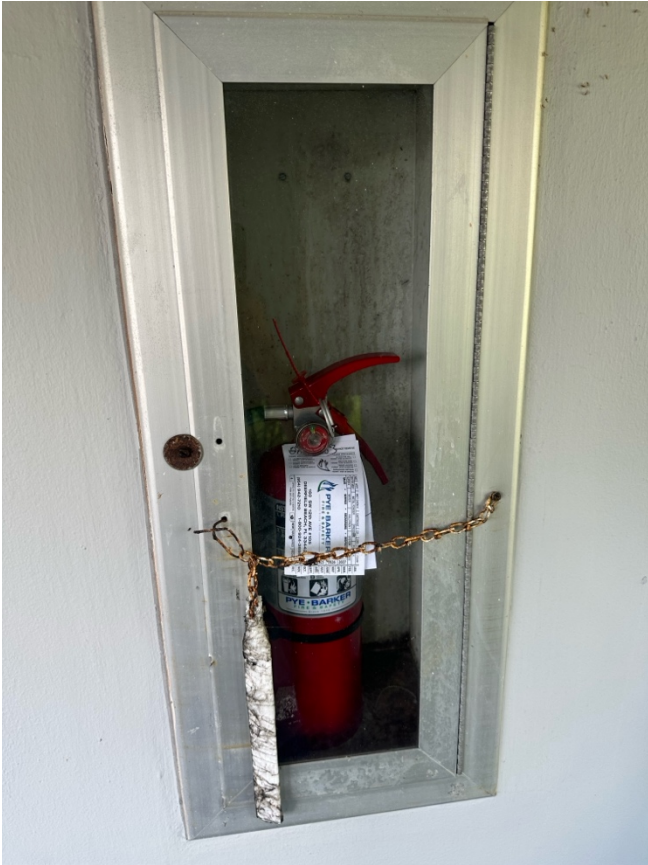
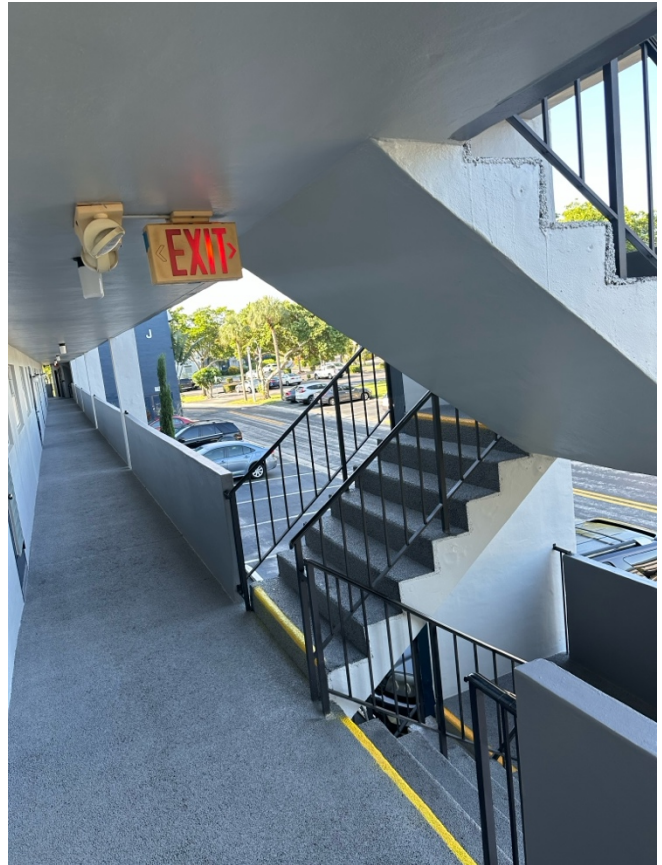
**Condition:** The fire protection systems appear to be in satisfactory condition.

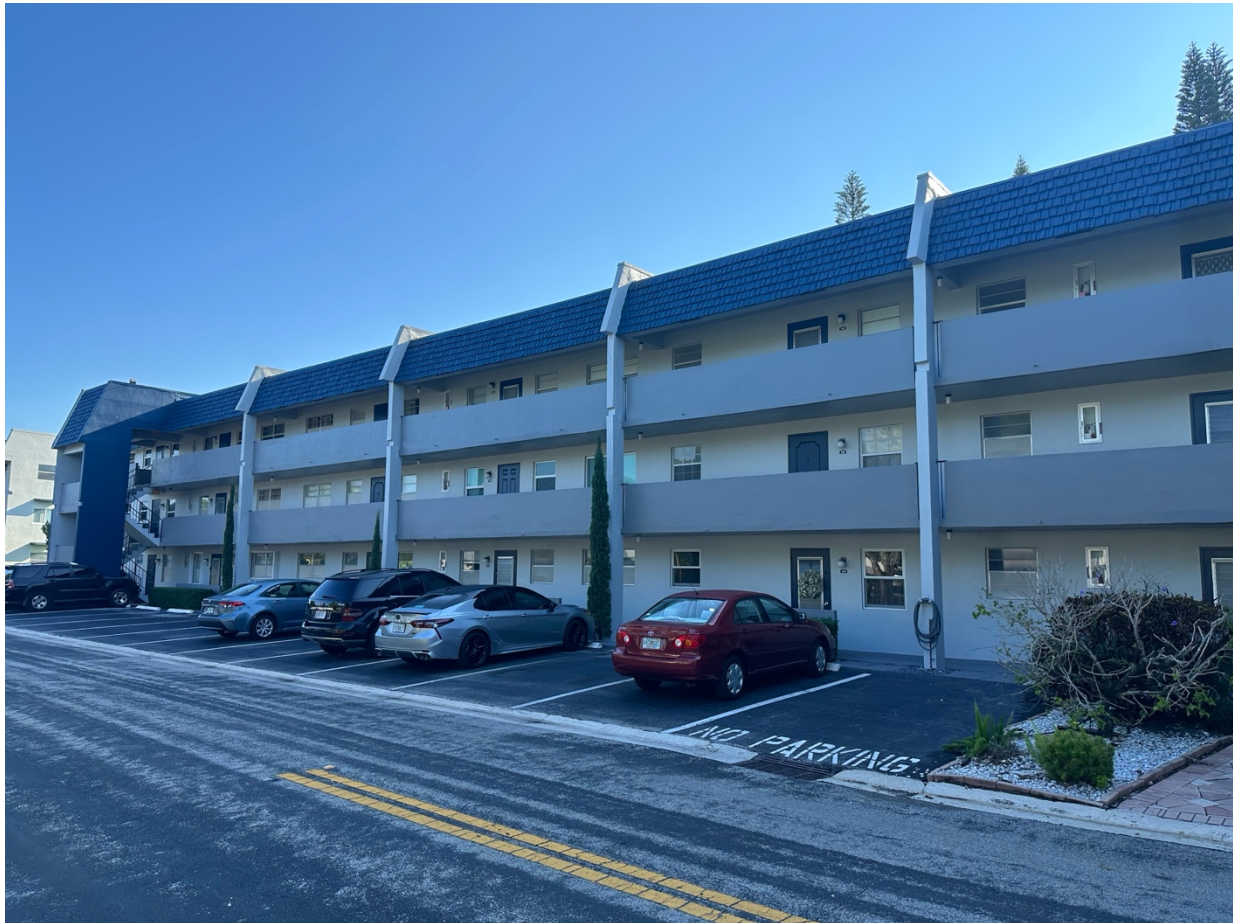
**Condition:** The railings appear to be in satisfactory condition.
