STRUCTURAL INTEGRITY RESERVE STUDY

***Oriole Golf & Tennis Club Condominium One
Bldg. K (7787)***

7787 Golf Circle Drive, Margate, FL 33063

Inspected on: September, 2023

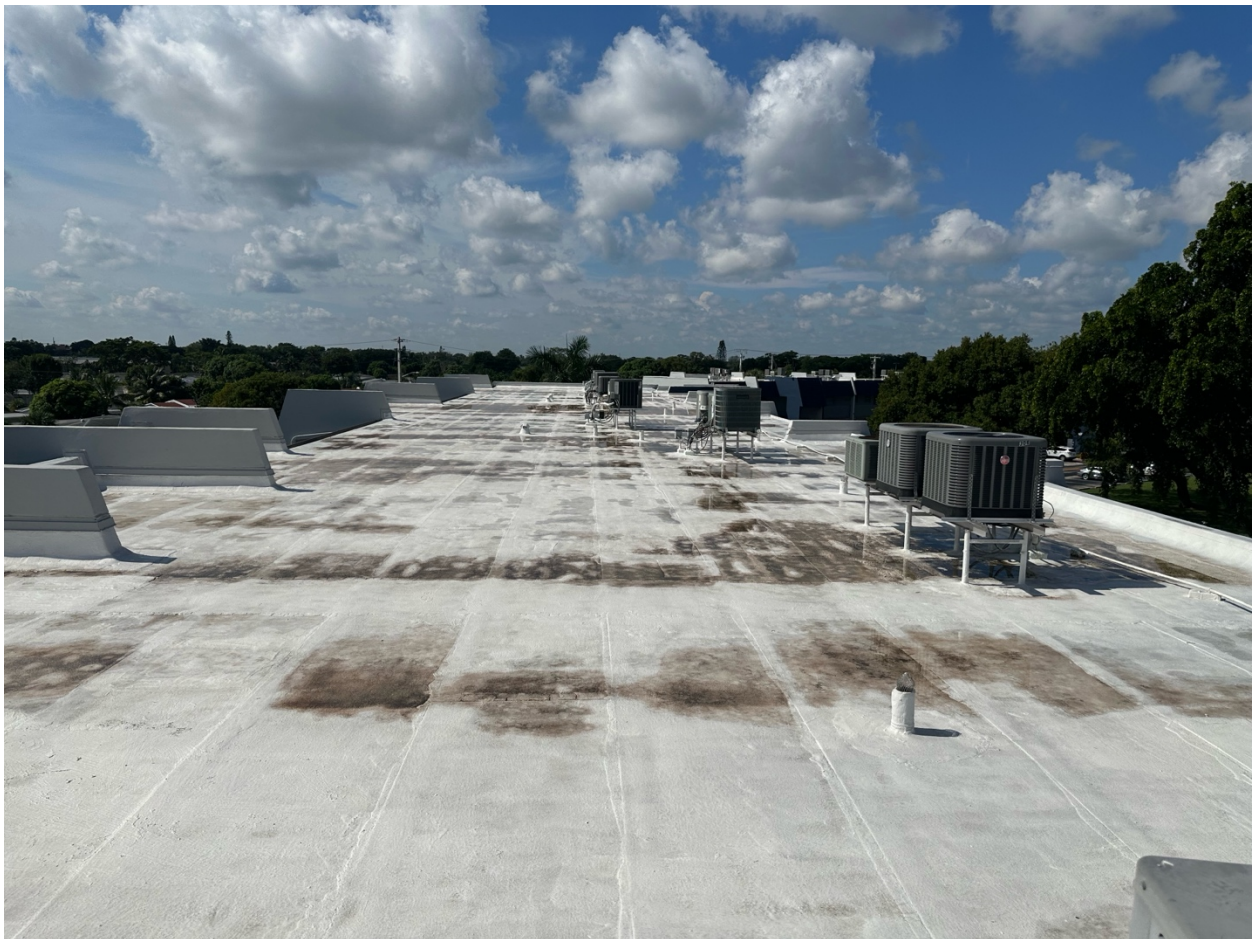
Condition: The roof surface appears to be in satisfactory condition with slight surface deterioration or granule loss. According to the information provided, all the roofs of the Oriole Golf & Tennis Club One have been provided with a silicone reflective coating within the last 5-years. The addition of the reflective coating can extend the useful life of the roof surface if proper maintenance is given.

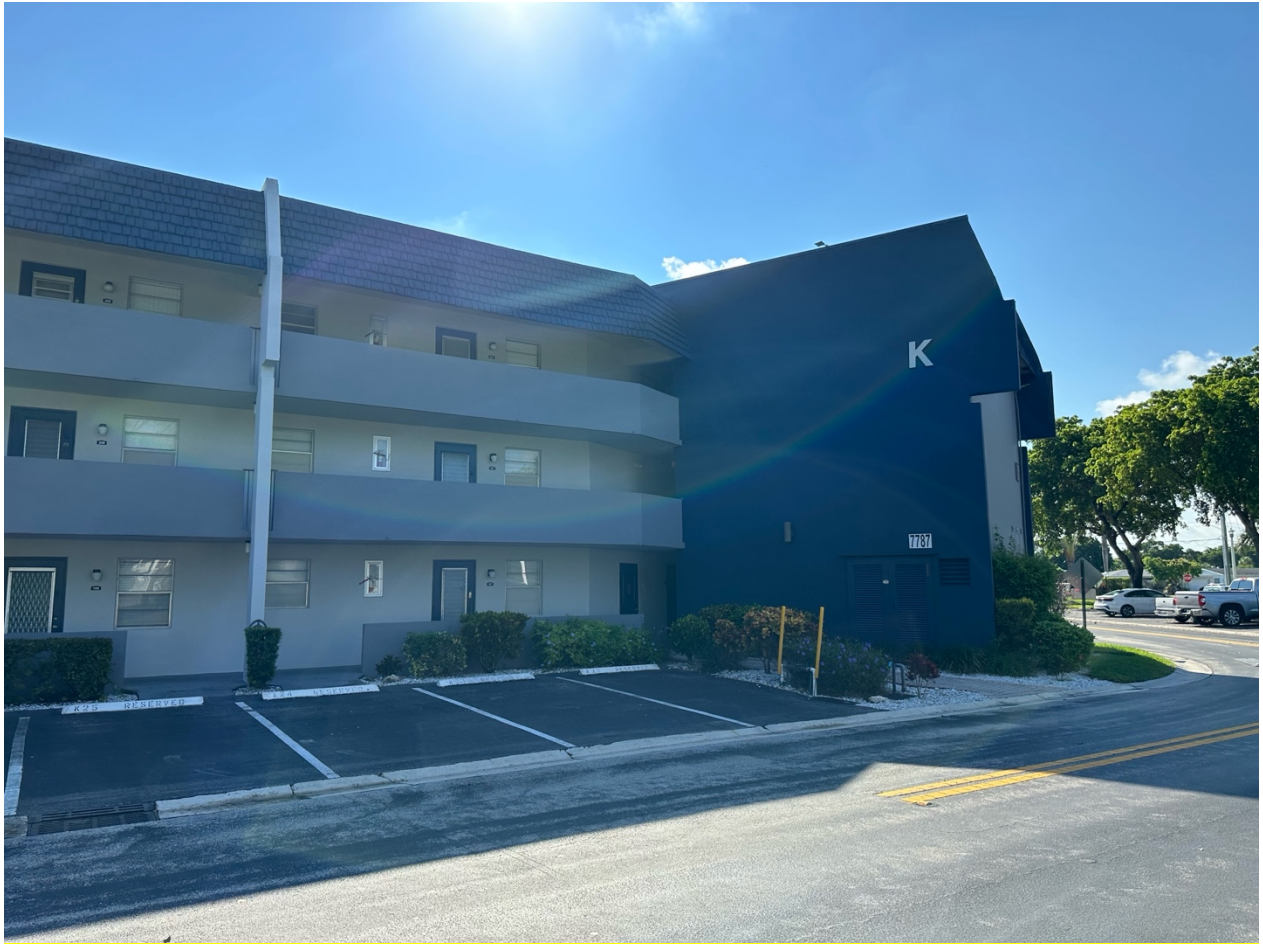
Condition: The general condition of the concrete load bearing structural systems, including visible the framing columns, tie-beams, and concrete floor systems appears to be in satisfactory condition have been found in satisfactory condition. However, conspicuous signs of concrete spalling requiring concrete repairs have been noted in the exterior corridors/catwalks of the building.

Remaining Lifespan: Although concrete is a very durable material, due to the location's proximity to the coast, spalling due to rebar corrosion usually manifests before the concrete naturally deteriorates. It is important to note that it is rarely possible to visually inspect and examine all the concealed construction, nor should be generally necessary. Our conclusions are based upon our experience and conditions examined in the exterior typical structural members of the building. Refer to the table presented at the end of this report.

Estimated Cost of Replacement: Concrete repairs are typically done on a unit-price basis and should be repaired as damages appear. Refer to the table presented at the end of this report for our recommendation based on our experience and the size of the building.

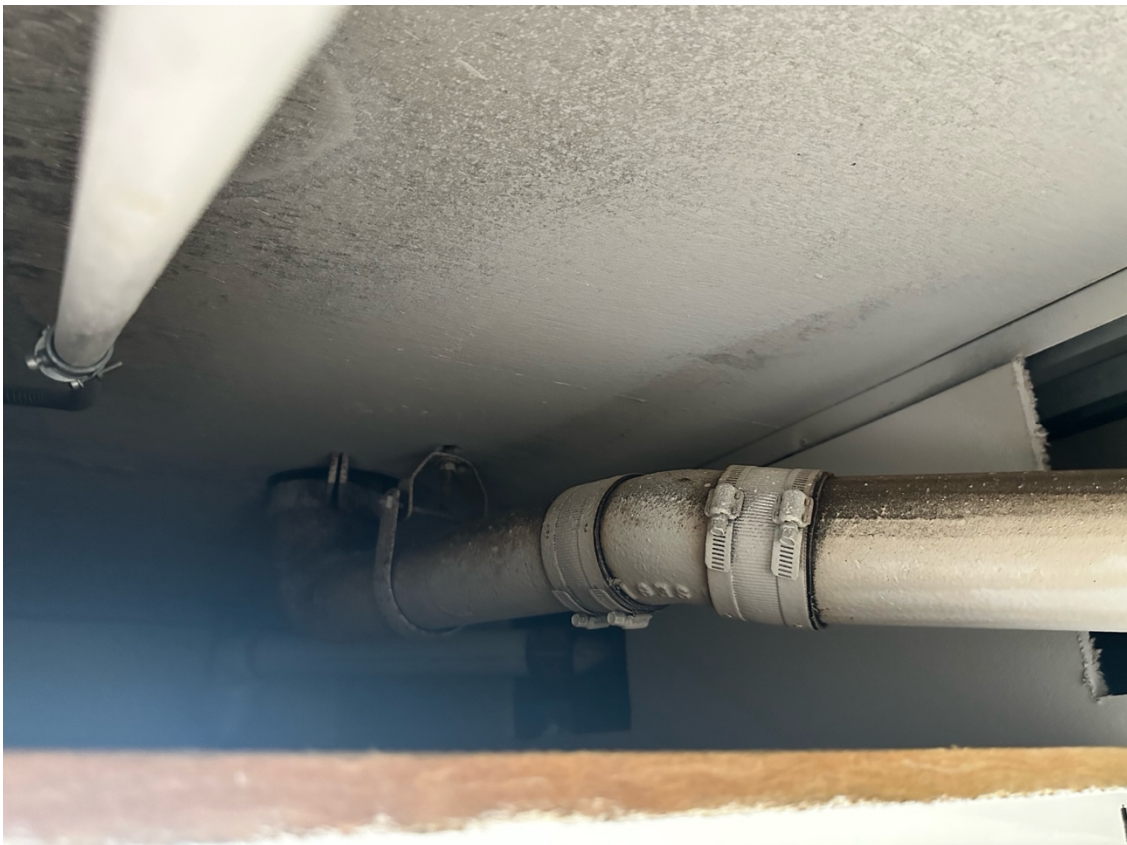
Condition: The plumbing system appears to be in satisfactory condition. It is important to note that it is rarely possible to visually inspect and examine all the concealed construction, nor should be generally necessary. Our conclusions are based upon our experience and deficiencies found in the visible and readily accessible areas.

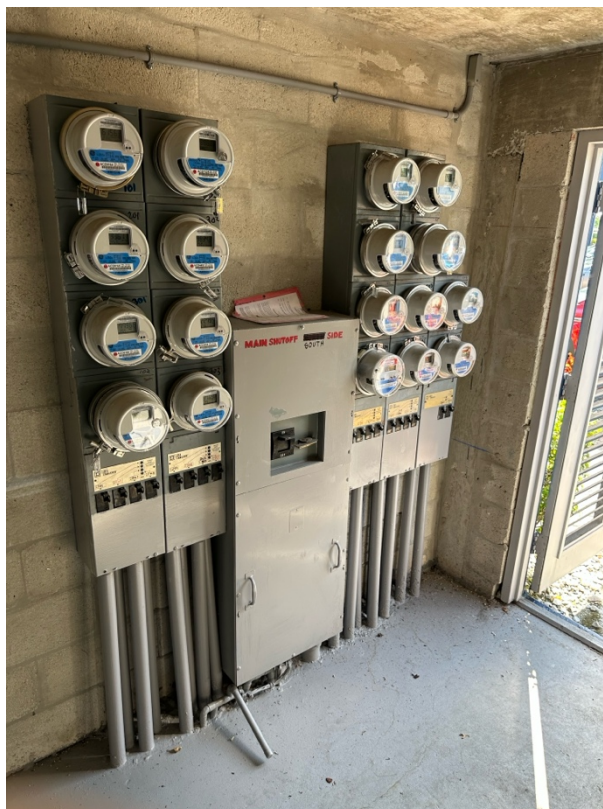
Condition: The electrical system(s) appears to be in satisfactory condition.

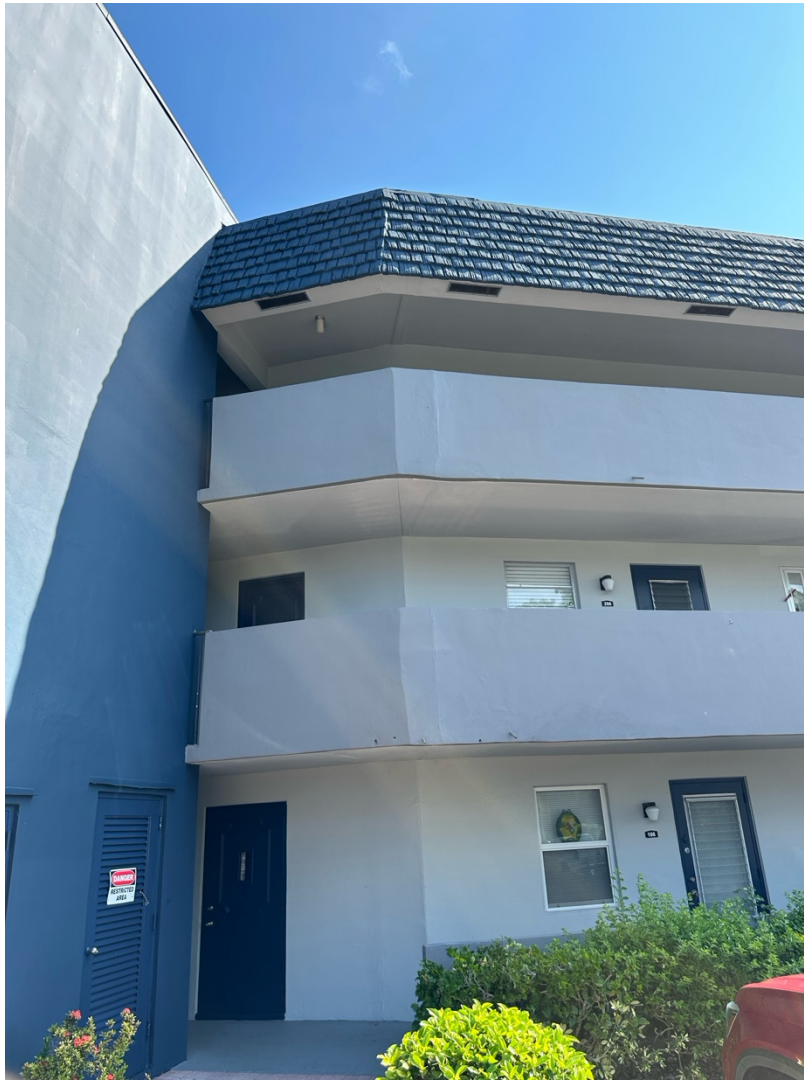
Condition: The exterior stucco surface appears to be in satisfactory condition. However, stucco delamination and conspicuous signs of concrete spalling have been noted in the exterior corridors/catwalks of the building.

Estimated Cost of Replacement: The removal and replacement of all the stucco finish is rarely required. It is typically repaired as required in the building for general maintenance. Therefore, we assume that 10% of all exterior surfaces are required to be replaced at once. See the table presented at the end of this report for our recommendation based on our experience and the size of the building. (The exact amount of area needing replacement will be discretionary based on the actual future conditions and the desired appearance).

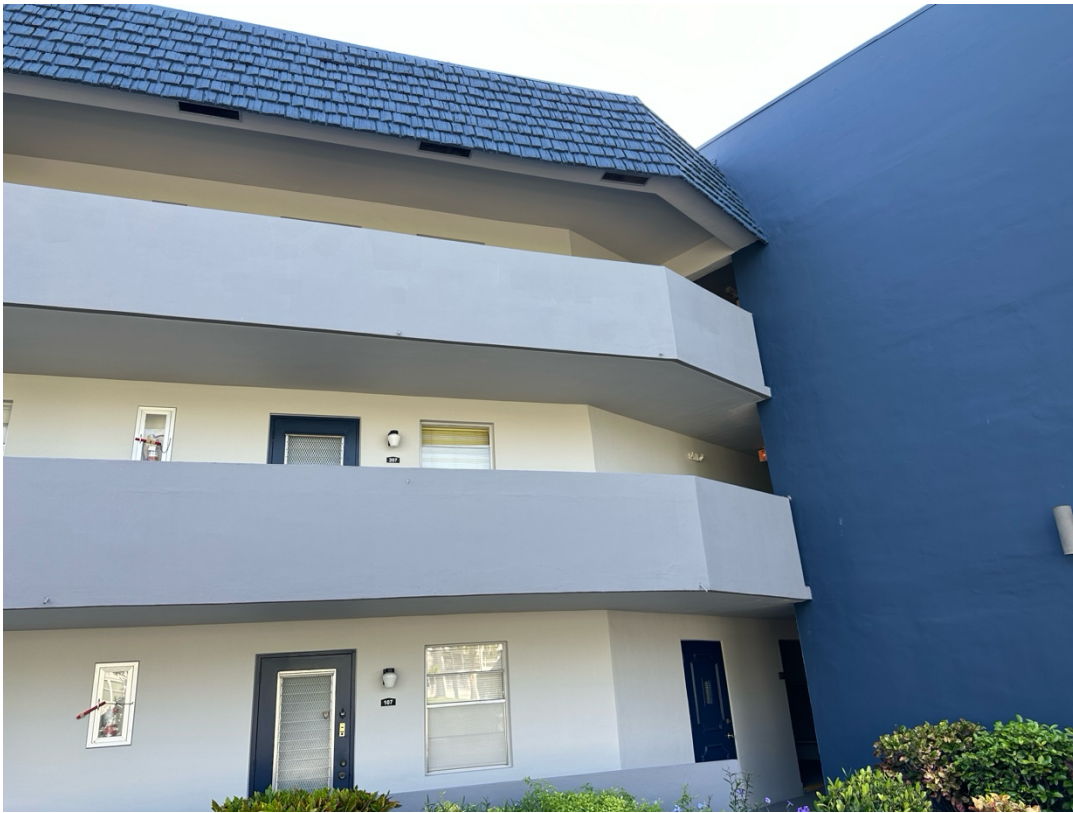
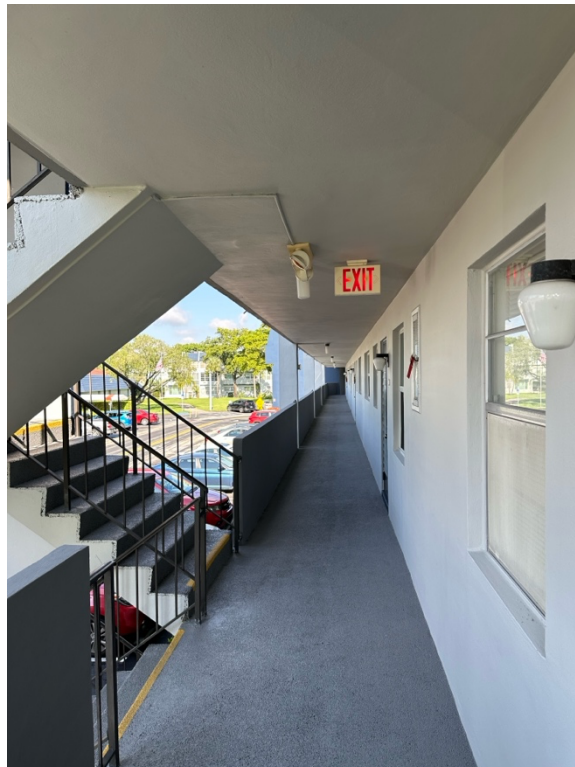
Condition: The exterior surface paint appear to be in satisfactory condition. The building has been recently painted. The exterior Chattahoochee appear to be in satisfactory condition. However, this type of floor finish promotes the accumulation of water, and it is widely known for hiding structural damage. Based on our experience, we highly recommend the exterior Chattahoochee floor finish to be removed and replaced with a sloped waterproofing system.

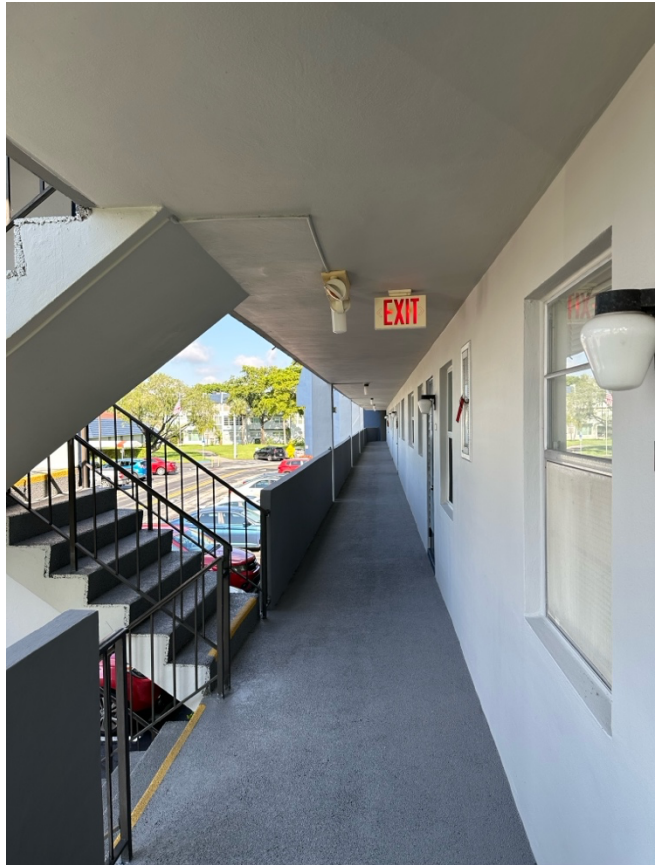
Condition: The fire protection systems appear to be in satisfactory condition.

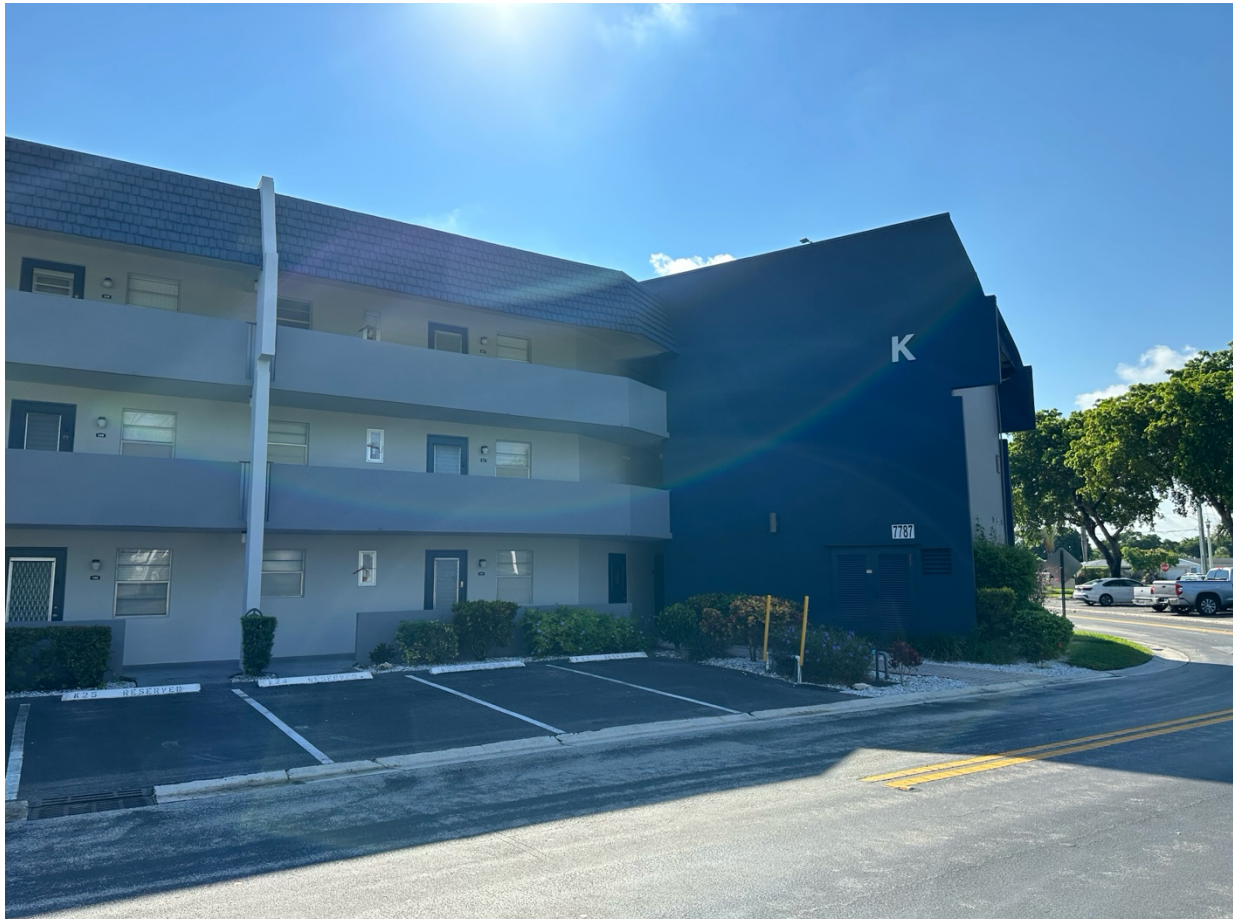
Condition: The railings appear to be in satisfactory condition.
