STRUCTURAL INTEGRITY RESERVE STUDY

***Oriole Golf & Tennis Club Condominium One
Bldg. L (7897)***

7897 Golf Circle Drive, Margate, FL 33063

Inspected on: September, 2023

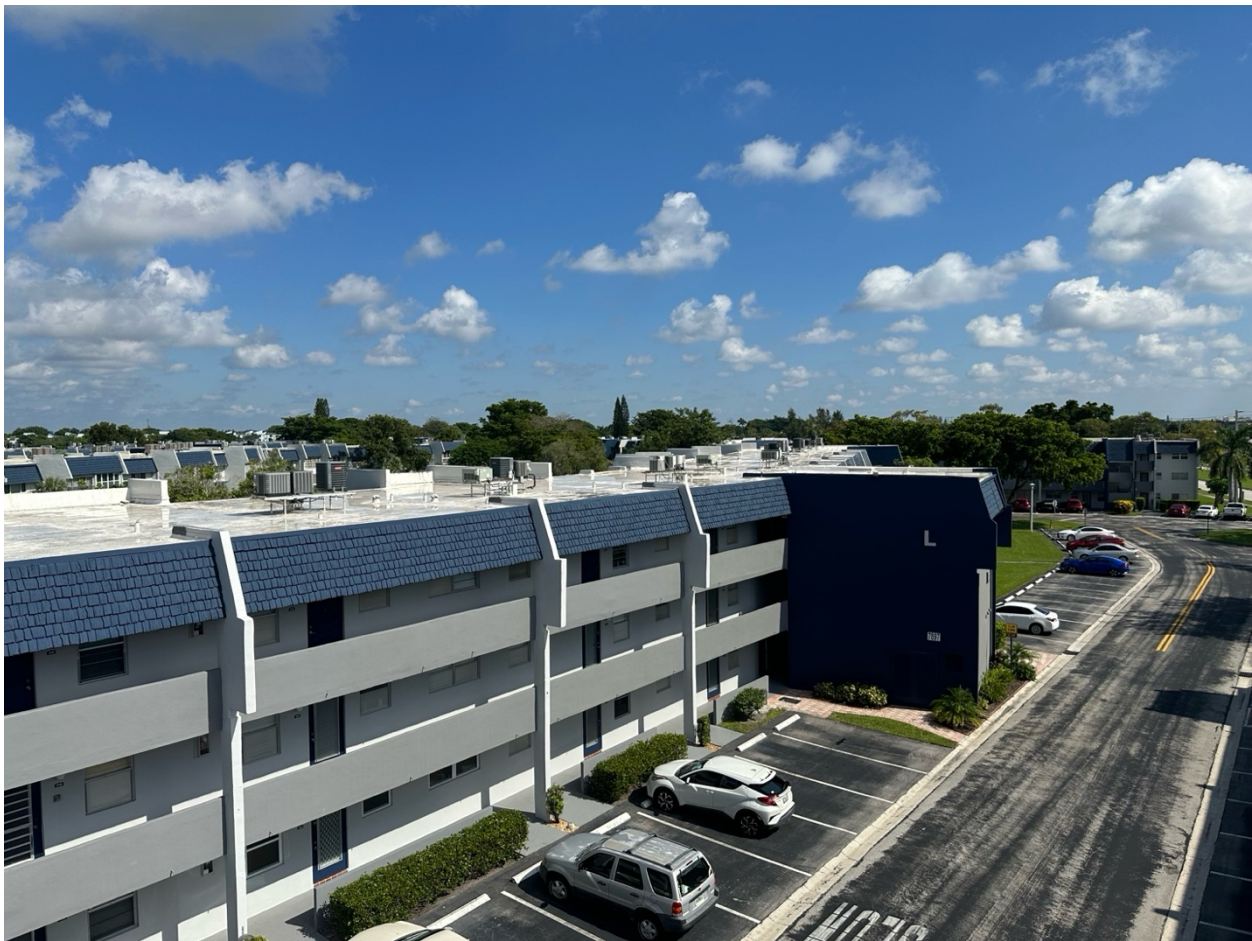
Condition: The roof surface appears to be in satisfactory condition with slight surface deterioration or granule loss. According to the information provided, all the roofs of the Oriole Golf & Tennis Club One have been provided with a silicone reflective coating within the last 5-years. The addition of the reflective coating can extend the useful life of the roof surface if proper maintenance is given.

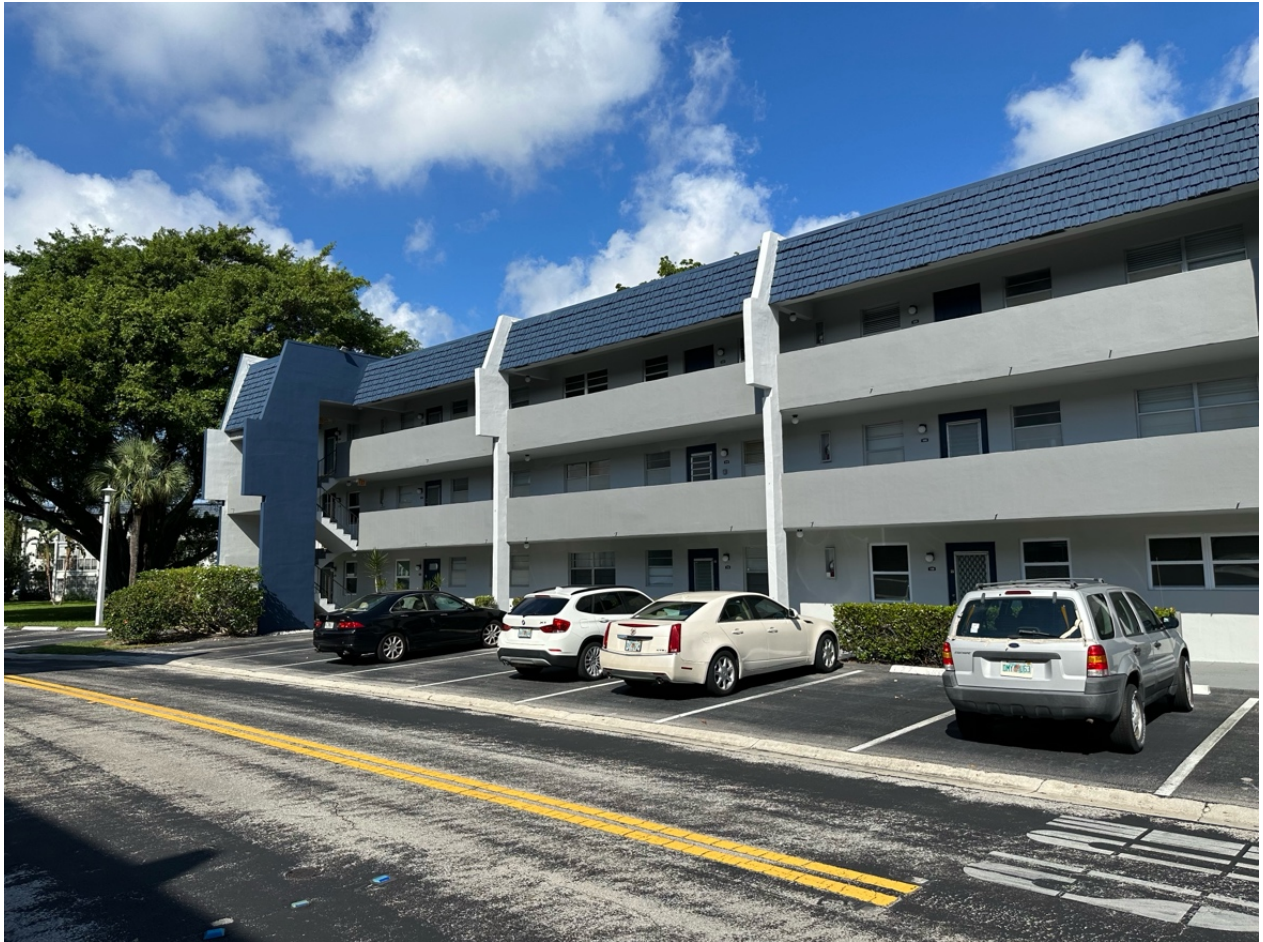
Condition: The general condition of the concrete load bearing structural systems, including visible the framing columns, tie-beams, and concrete floor systems appears to be in satisfactory condition have been found in satisfactory condition.

Remaining Lifespan: Although concrete is a very durable material, due to the location's proximity to the coast, spalling due to rebar corrosion usually manifests before the concrete naturally deteriorates. It is important to note that it is rarely possible to visually inspect and examine all the concealed construction, nor should be generally necessary. Our conclusions are based upon our experience and conditions examined in the exterior typical structural members of the building. Refer to the table presented at the end of this report.

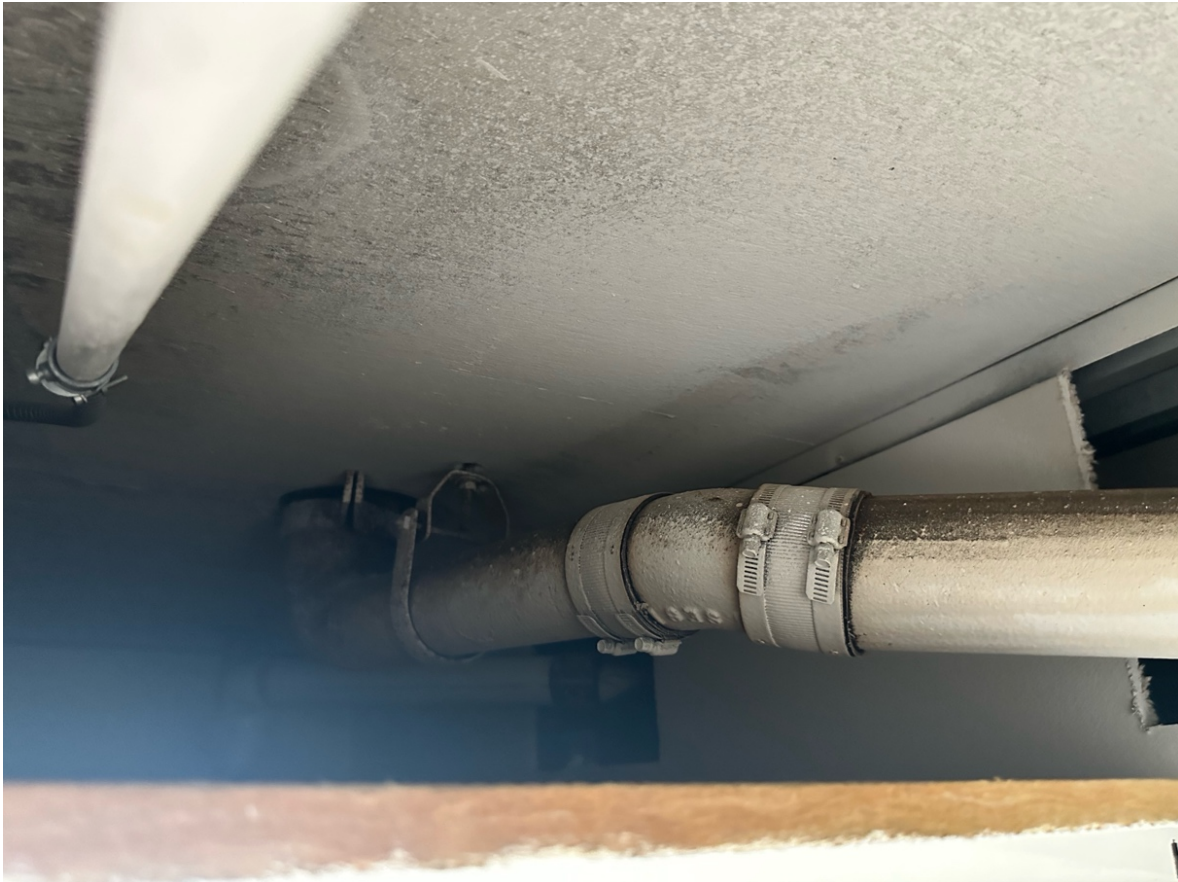
Condition: The plumbing system appears to be in satisfactory condition. It is important to note that it is rarely possible to visually inspect and examine all the concealed construction, nor should be generally necessary. Our conclusions are based upon our experience and deficiencies found in the visible and readily accessible areas.

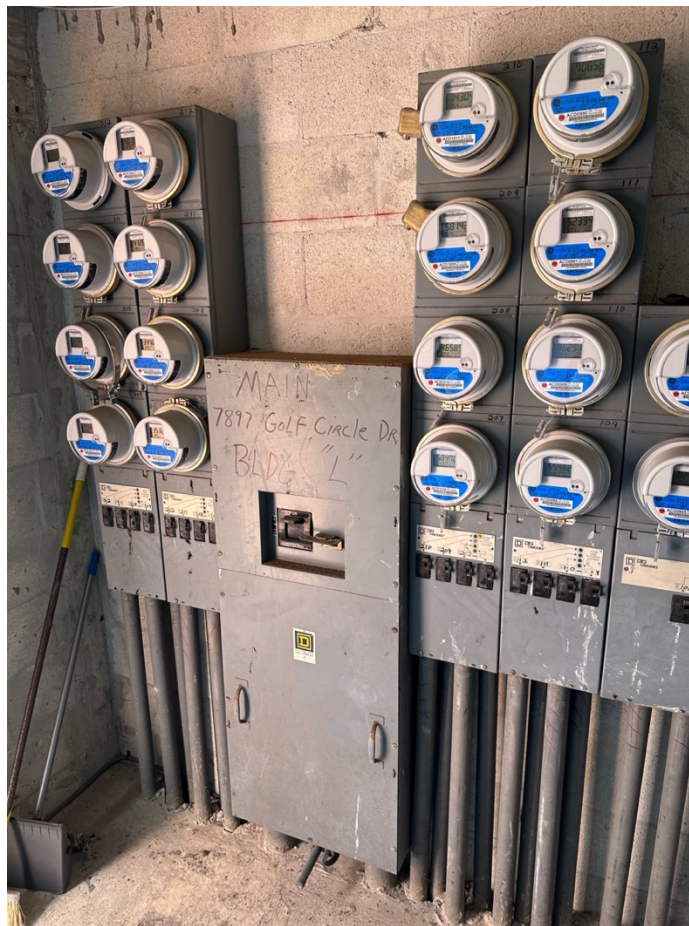
Condition: The electrical system(s) appears to be in satisfactory condition.

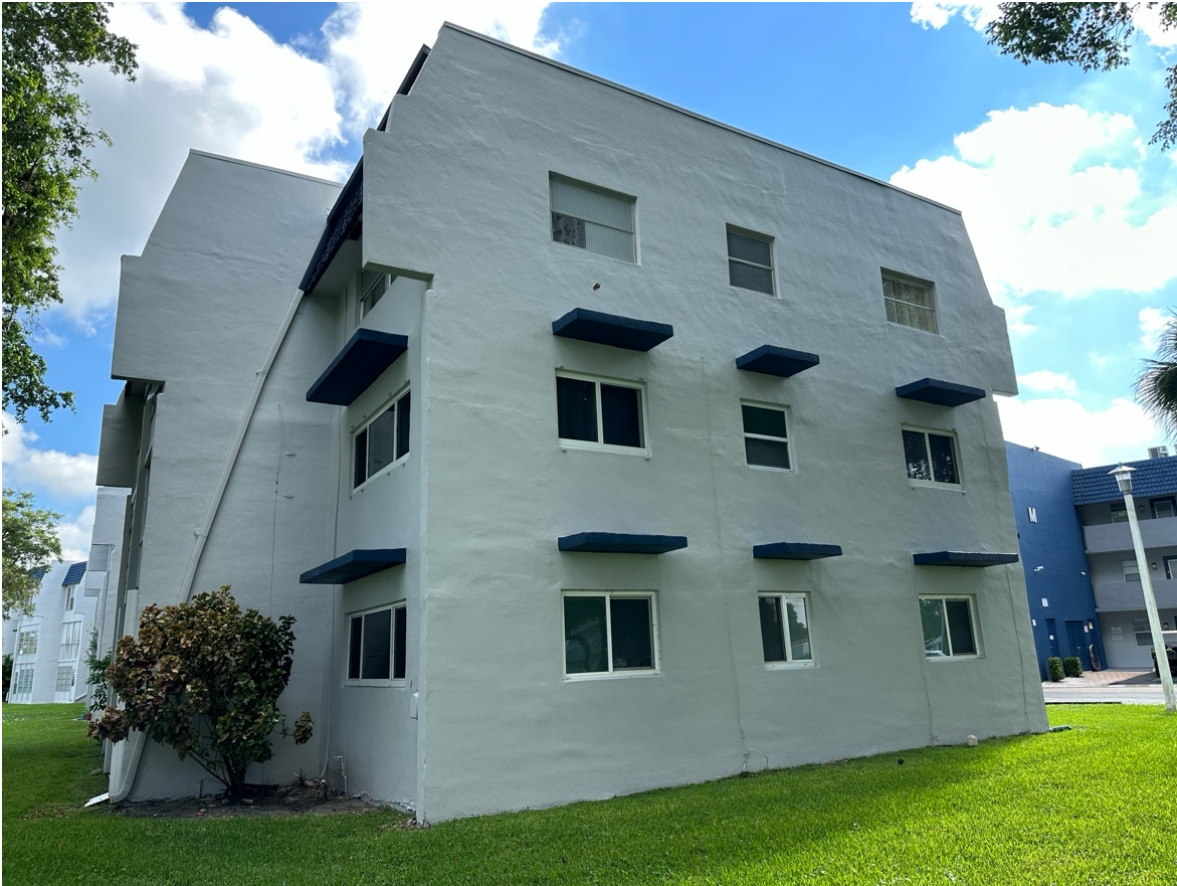
Condition: The exterior stucco surface appears to be in satisfactory condition. However, stucco delamination and conspicuous signs of concrete spalling have been noted in the exterior corridors/catwalks of the building.

Remaining Lifespan: Although the stucco is a very durable material, due to the location's proximity to the coast, spalling due to rebar corrosion usually manifests before the stucco naturally deteriorates. Refer to the table presented at the end of this report.

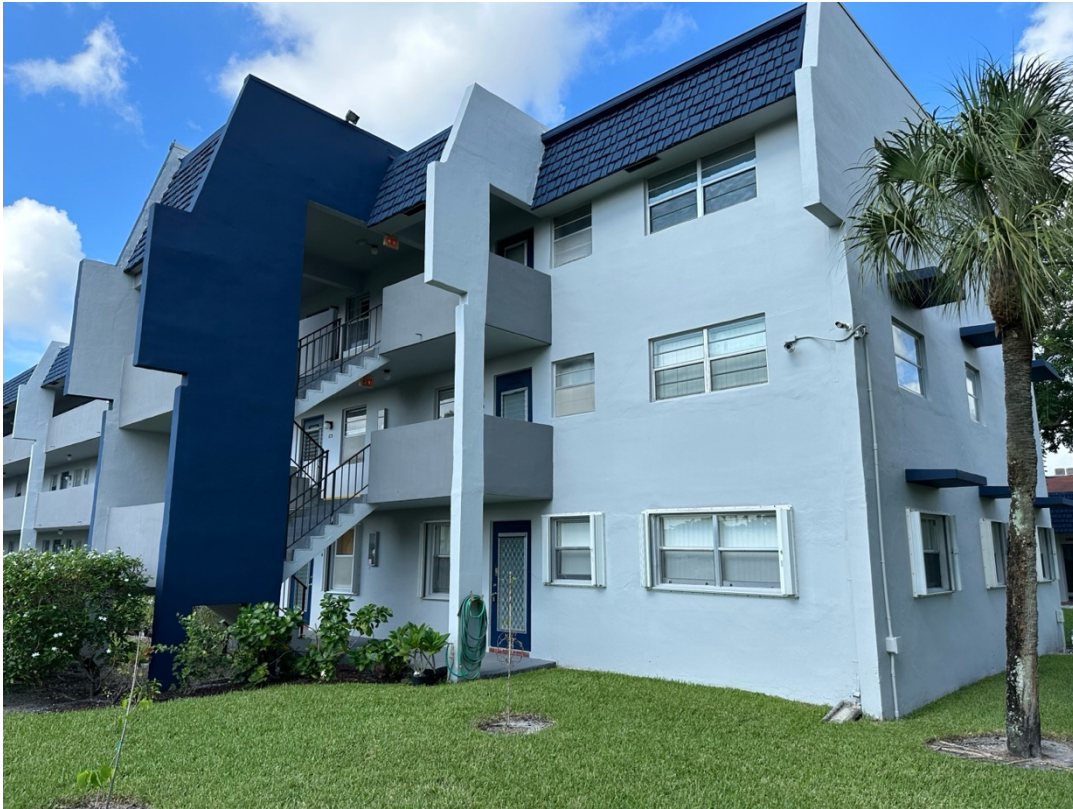
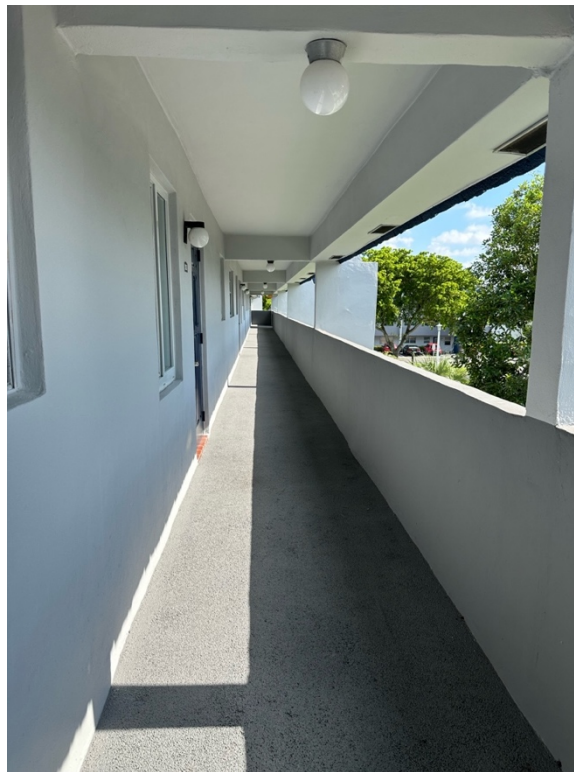
Condition: The exterior surface paint appear to be in satisfactory condition. The building has been recently painted. The exterior Chattahoochee appear to be in satisfactory condition. However, this type of floor finish promotes the accumulation of water, and it is widely known for hiding structural damage. Based on our experience, we highly recommend the exterior Chattahoochee floor finish to be removed and replaced with a sloped waterproofing system.

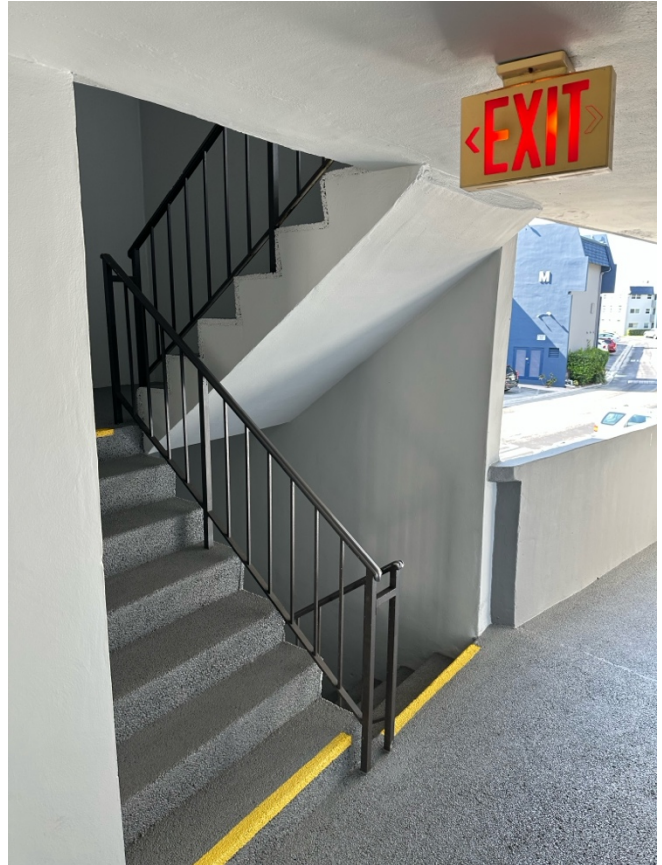
Condition: The fire protection systems appear to be in satisfactory condition.

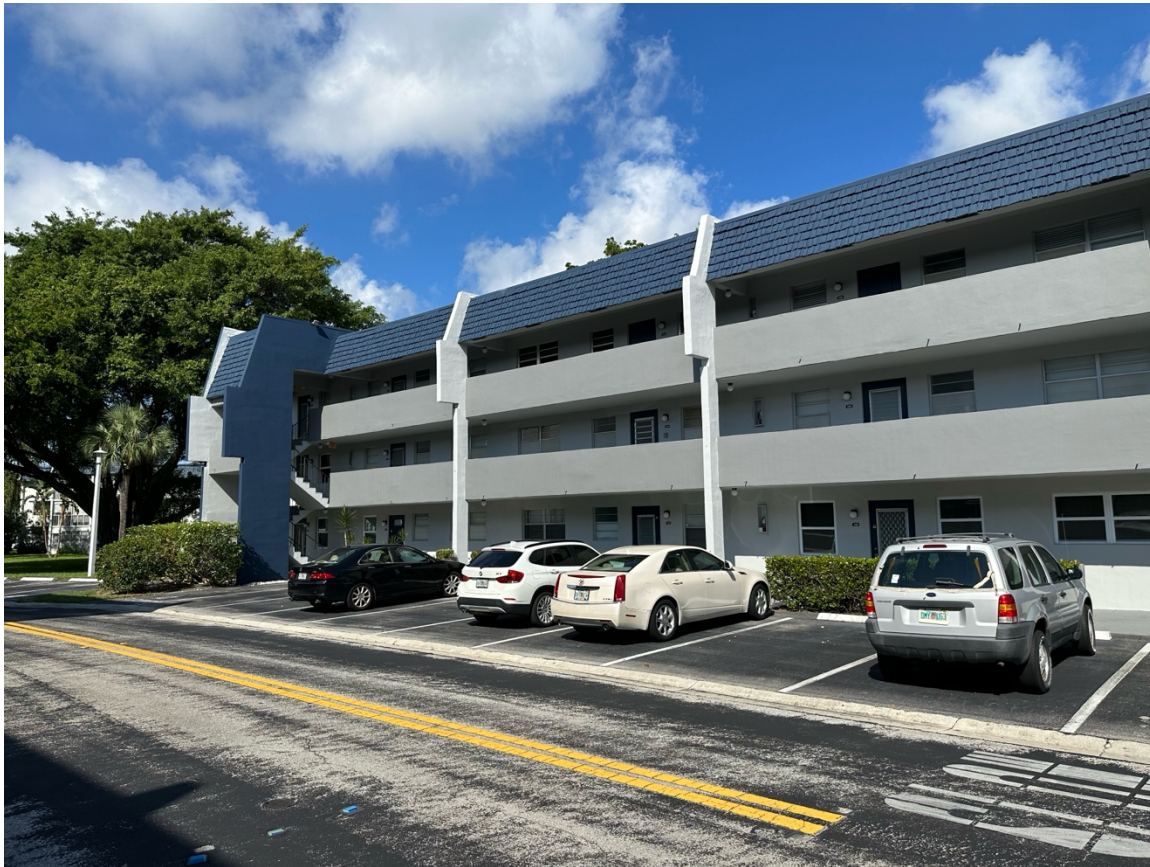
Condition: The railings appear to be in satisfactory condition.
