**STRUCTURAL INTEGRITY RESERVE STUDY**

***Oriole Golf & Tennis Club Condominium One  
Bldg. M (7887)***

*7887 Golf Circle Drive, Margate, FL 33063*

*Inspected on: September, 2023*

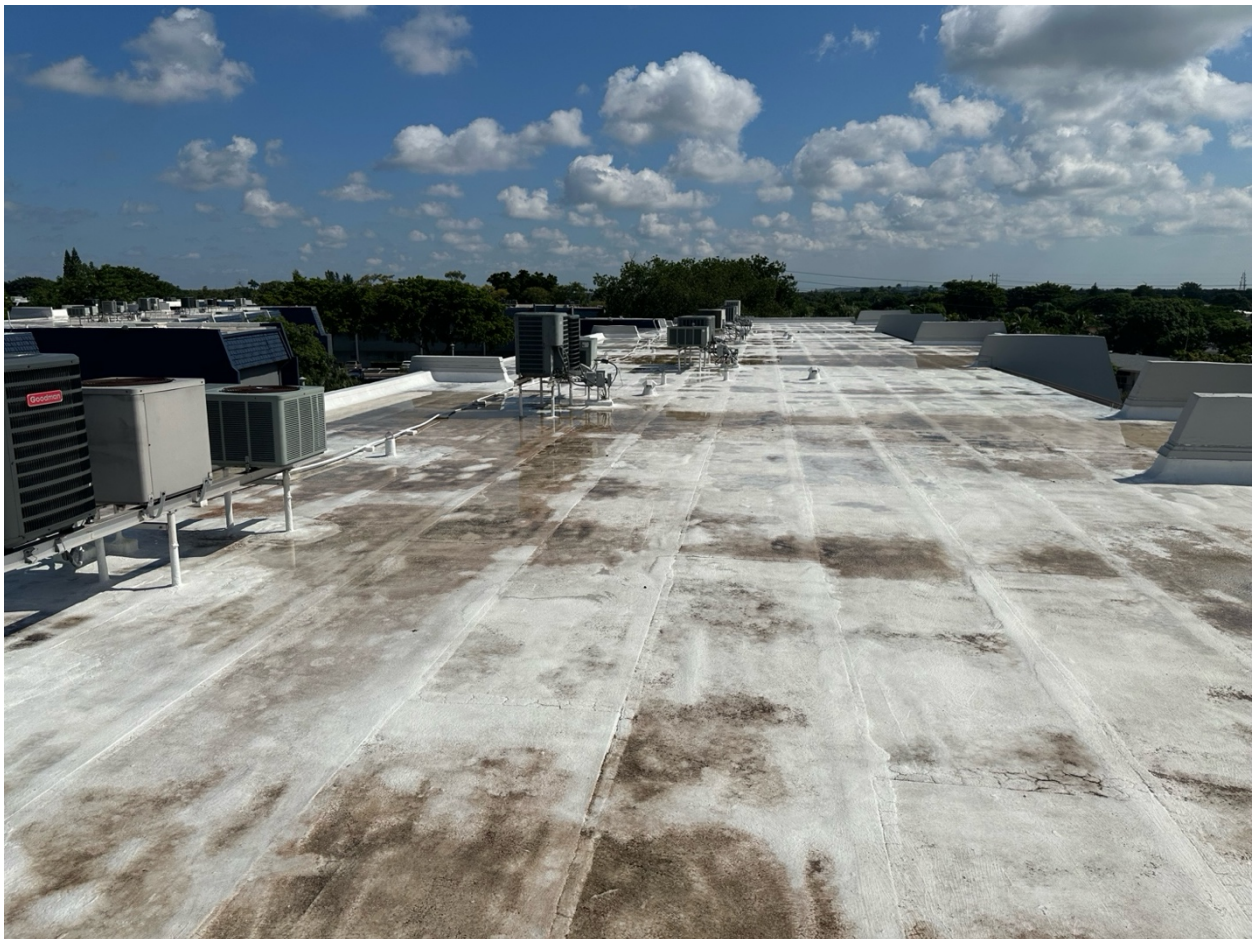
**Condition:** The roof surface appears to be in satisfactory condition with slight surface deterioration or granule loss. According to the information provided, all the roofs of the Oriole Golf & Tennis Club One have been provided with a silicone reflective coating within the last 5-years. The addition of the reflective coating can extend the useful life of the roof surface if proper maintenance is given.

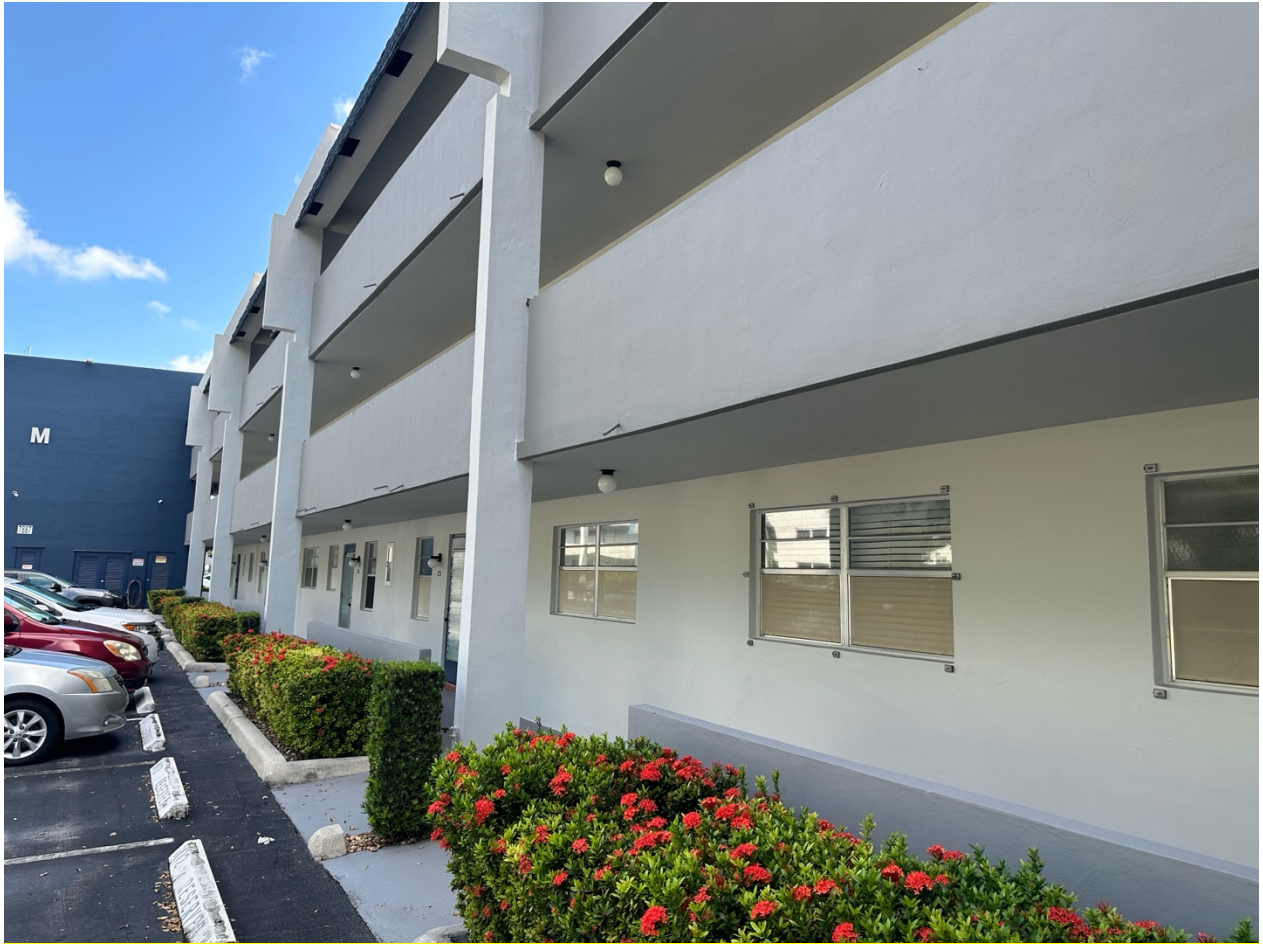
**Condition:** The general condition of the concrete load bearing structural systems, including visible the framing columns, tie-beams, and concrete floor systems appears to be in satisfactory condition have been found in satisfactory condition.

**Remaining Lifespan:** Although concrete is a very durable material, due to the location's proximity to the coast, spalling due to rebar corrosion usually manifests before the concrete naturally deteriorates. It is important to note that it is rarely possible to visually inspect and examine all the concealed construction, nor should be generally necessary. Our conclusions are based upon our experience and conditions examined in the exterior typical structural members of the building. Refer to the table presented at the end of this report.

**Estimated Cost of Replacement:** Concrete repairs are typically done on a unit-price basis and should be repaired as damages appear. Refer to the table presented at the end of this report for our recommendation based on our experience and the size of the building.

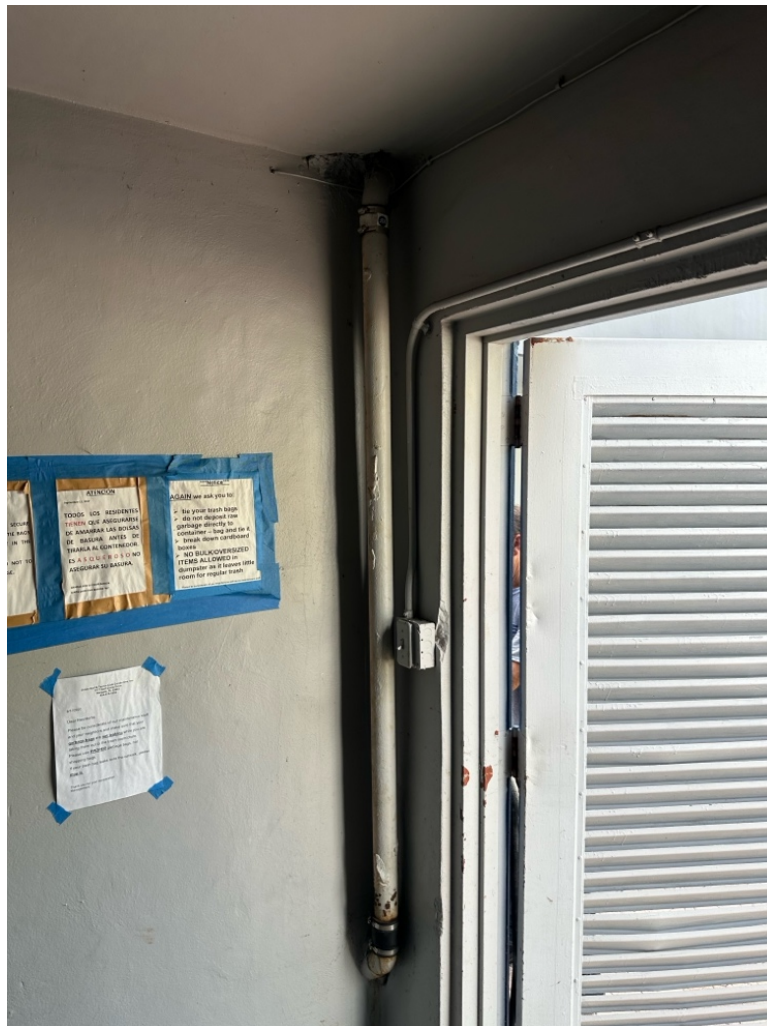
**Condition:** The plumbing system appears to be in satisfactory condition. It is important to note that it is rarely possible to visually inspect and examine all the concealed construction, nor should be generally necessary. Our conclusions are based upon our experience and deficiencies found in the visible and readily accessible areas.

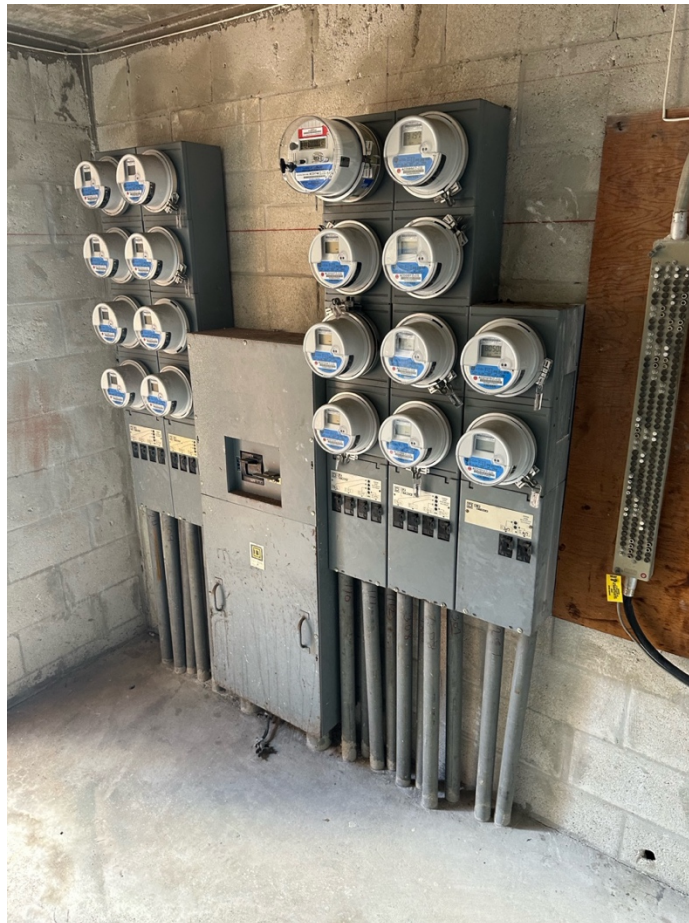
**Condition:** The electrical system(s) appears to be in satisfactory condition.

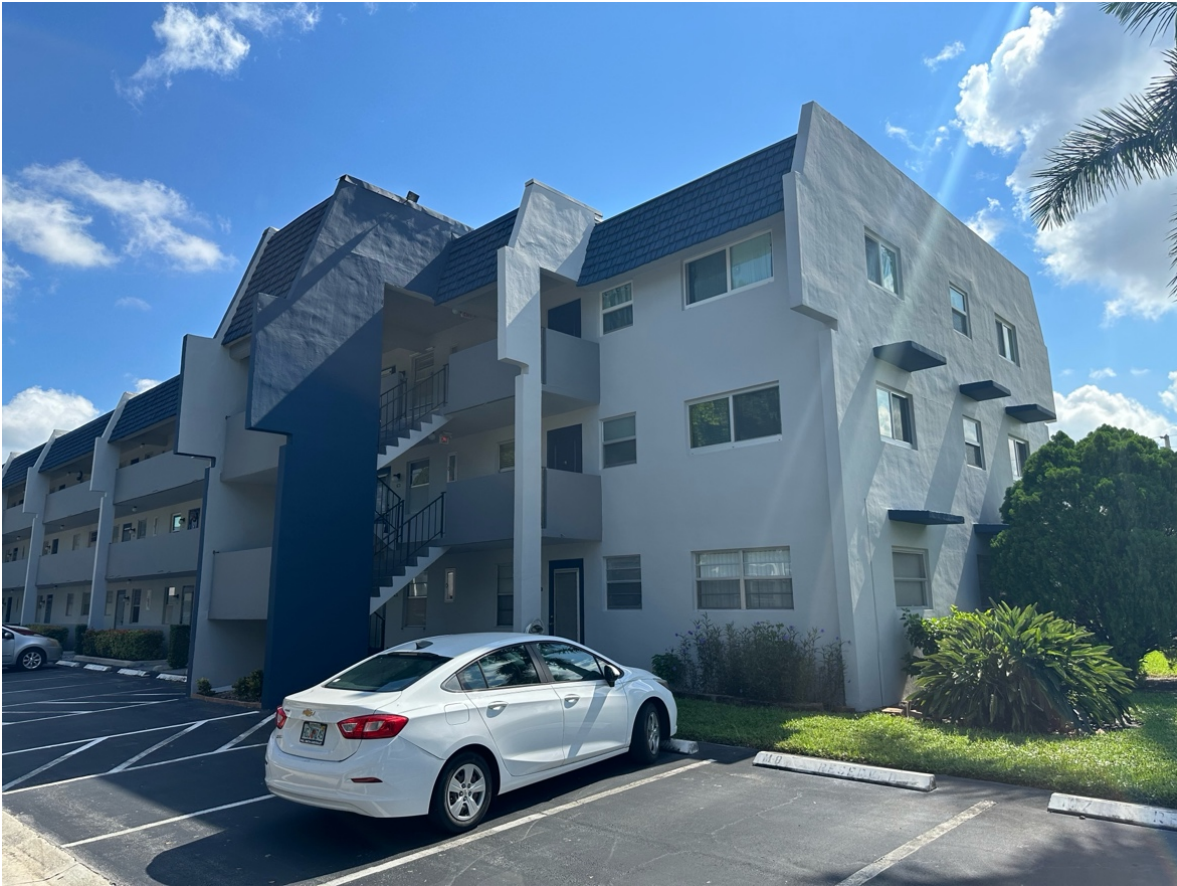
**Condition:** The exterior stucco surface appears to be in satisfactory condition. However, stucco delamination and conspicuous signs of concrete spalling have been noted in the exterior corridors/catwalks of the building.

**Remaining Lifespan:** Although the stucco is a very durable material, due to the location's proximity to the coast, spalling due to rebar corrosion usually manifests before the stucco naturally deteriorates. Refer to the table presented at the end of this report.

**Estimated Cost of Replacement:** The removal and replacement of all the stucco finish is rarely required. It is typically repaired as required in the building for general maintenance. Therefore, we assume that 10% of all exterior surfaces are required to be replaced at once. See the table presented at the end of this report for our recommendation based on our experience and the size of the building. (The exact amount of area needing replacement will be discretionary based on the actual future conditions and the desired appearance).

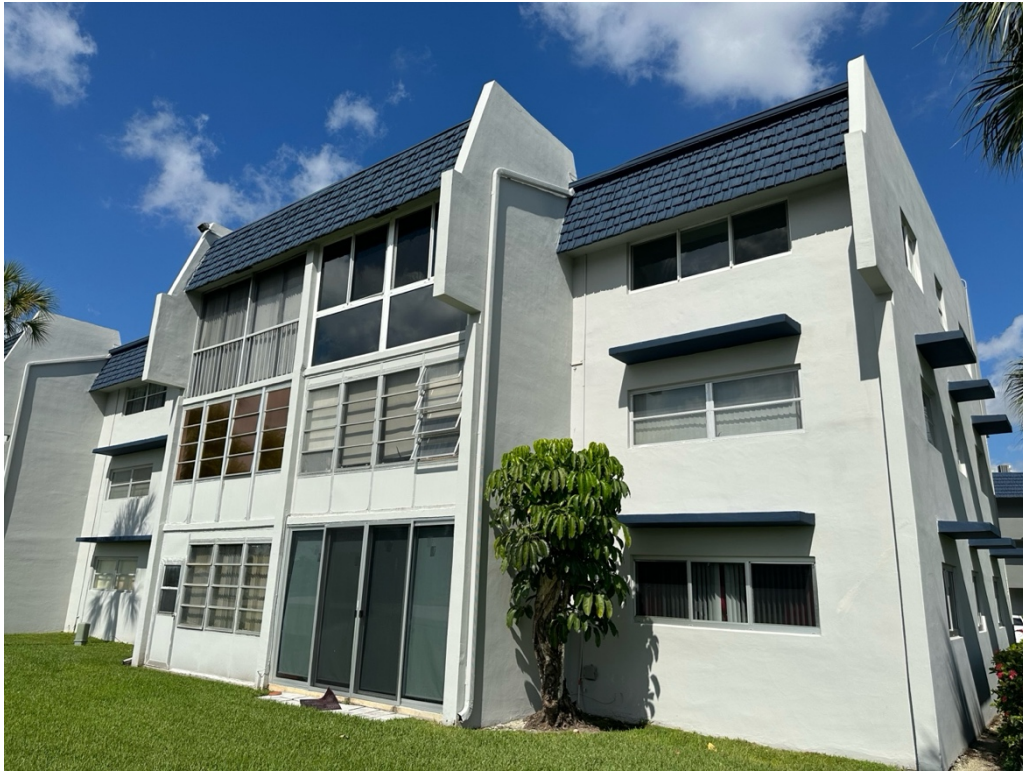
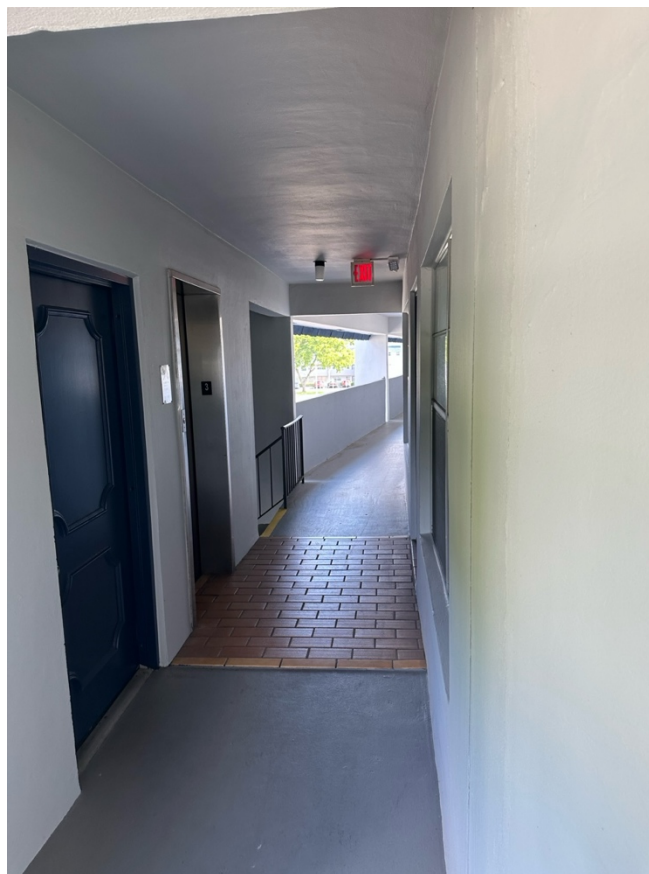
**Condition:** The exterior surface paint & exterior waterproofing appear to be in satisfactory condition.

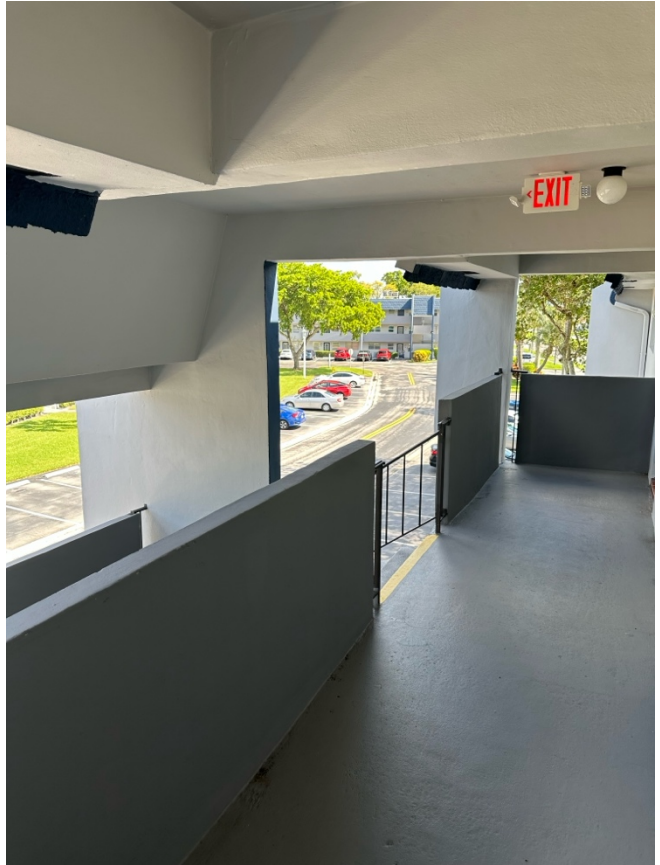
**Condition:** The fire protection systems appear to be in satisfactory condition.

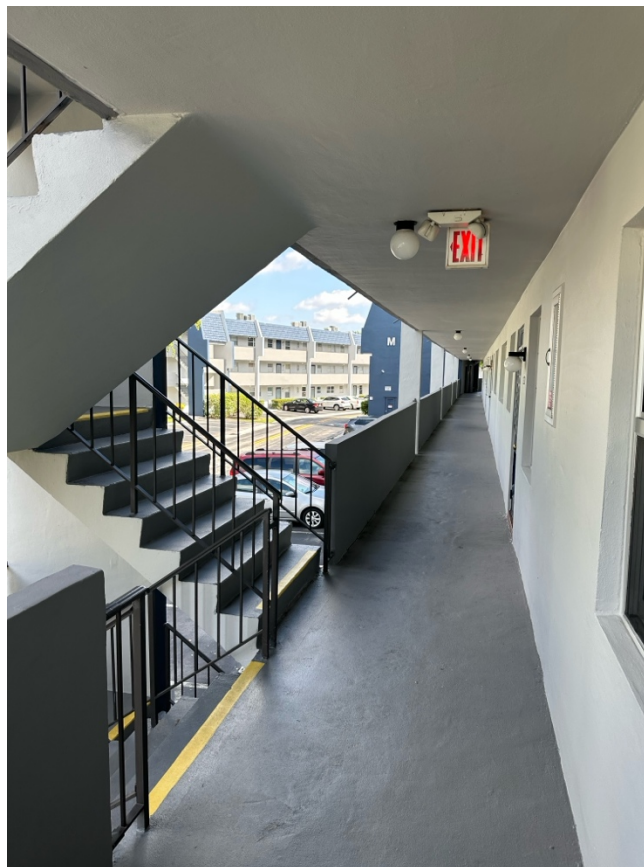
**Condition:** The railings appear to be in satisfactory condition.
